Expertise

Protocol number: 48408163
Order No. / Reference: 27210119
Inspection date: 29 Oct 2026

Manufacturer: Opel	Model: Astra Sports Tourer 1.5 D Automatik Business Edition
VIN: VXKFCYHZTP1061778

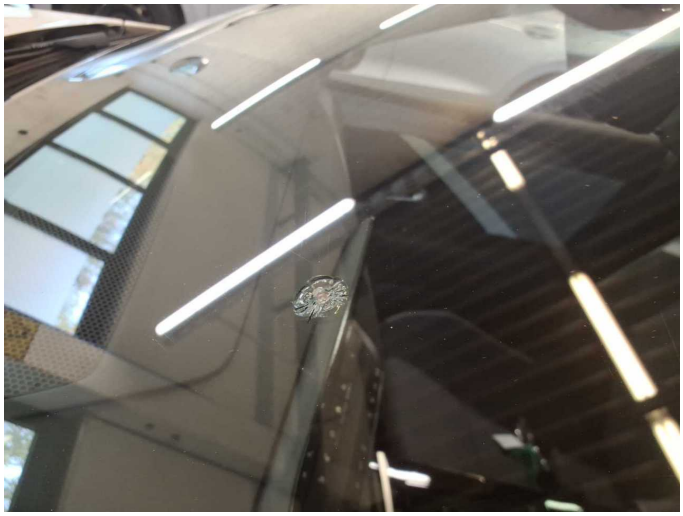
Damage 6: Vehicle glazing: Windscreen (kein Staubschutz) - Stone chips - Replace
