Expertise

Protocol number: 48443633
Order No. / Reference: 27198658
Inspection date: 28 Oct 2026

Manufacturer: Seat	Model: Arona 1.0 TSI OPF Xperience
VIN: VSSZZZKJZNR046573

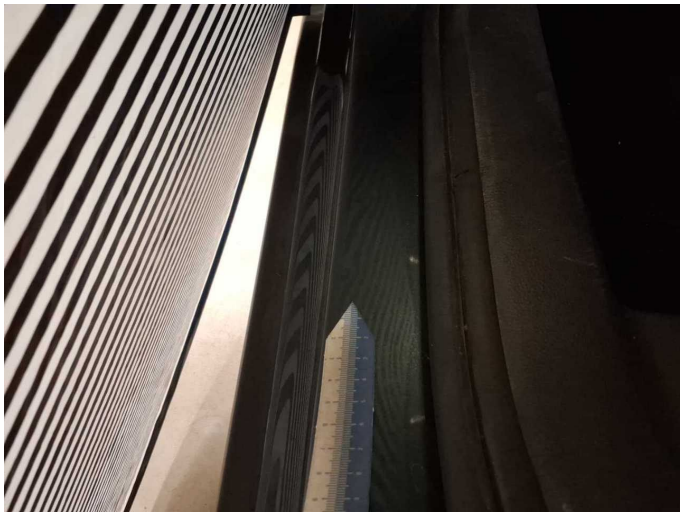
Damage 14: Side panel - rear left side: Sill - Dent / paintcoat damage - Smart repair

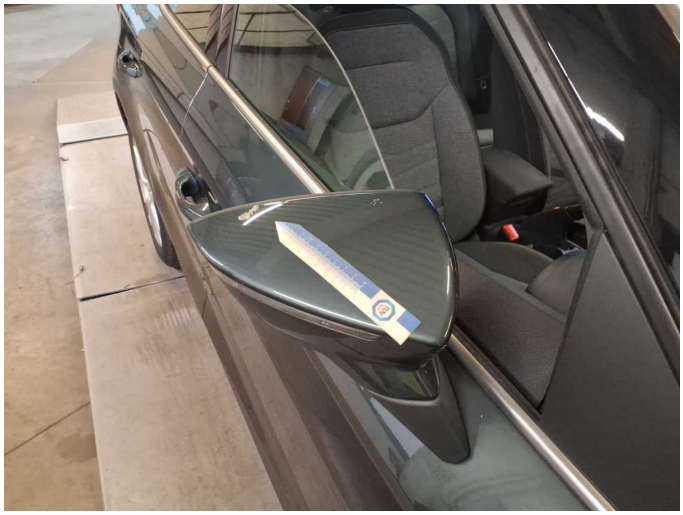
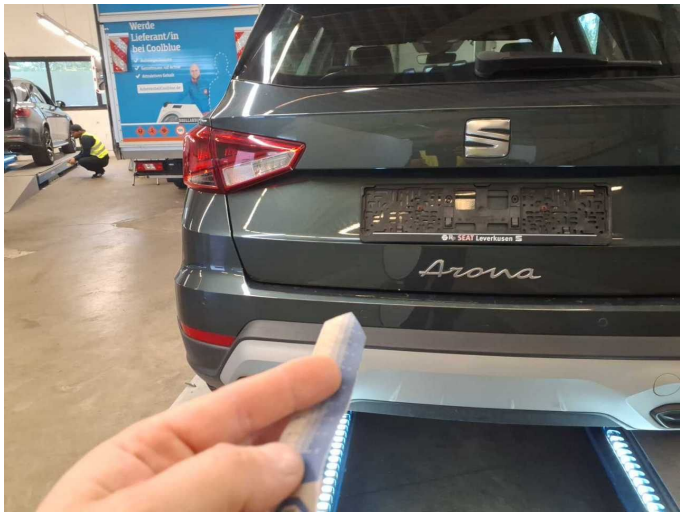
Damage 17: Wing mirror - right side: Cap (Soll Schwarz sein) - Unprofessionally repaired - Replace

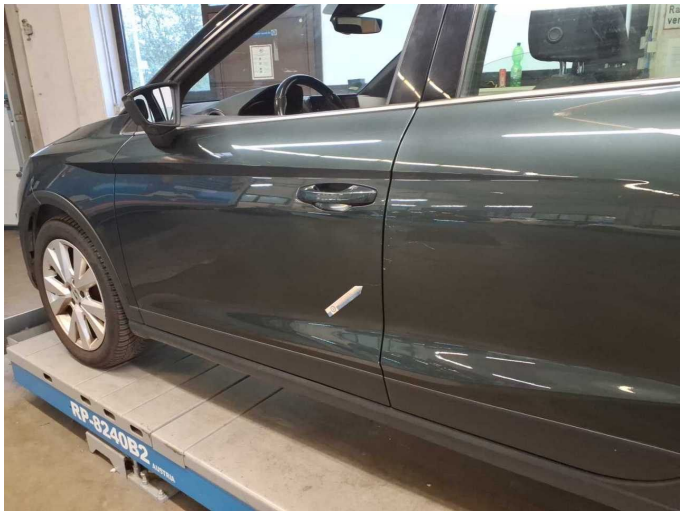
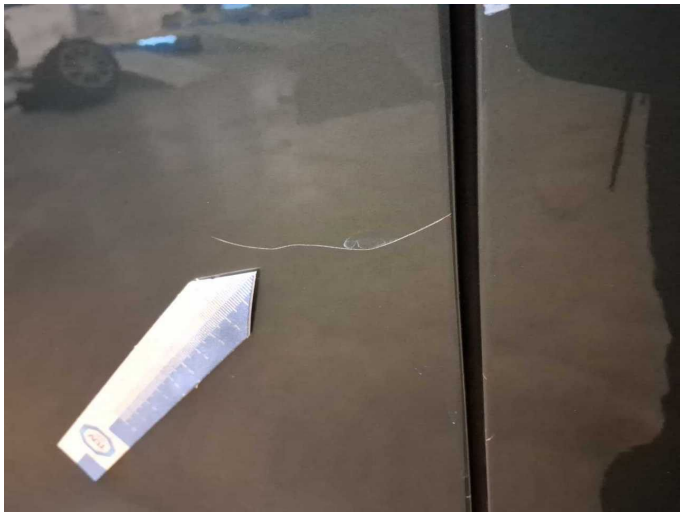
Damage 19: Door - front left side: Door - Scratch(es) - Paint

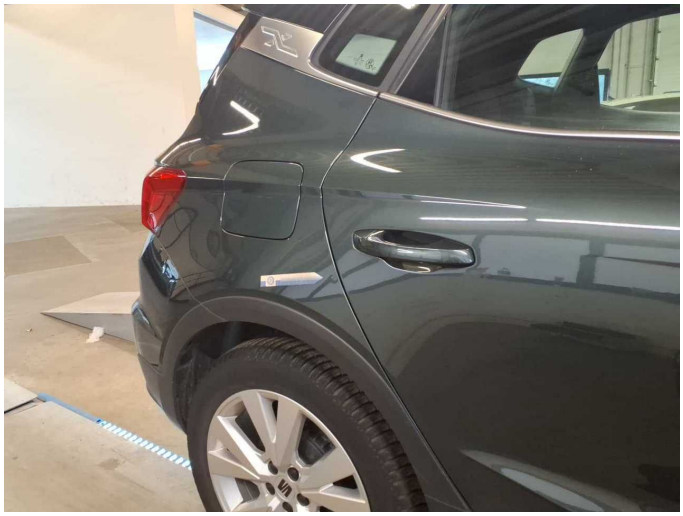
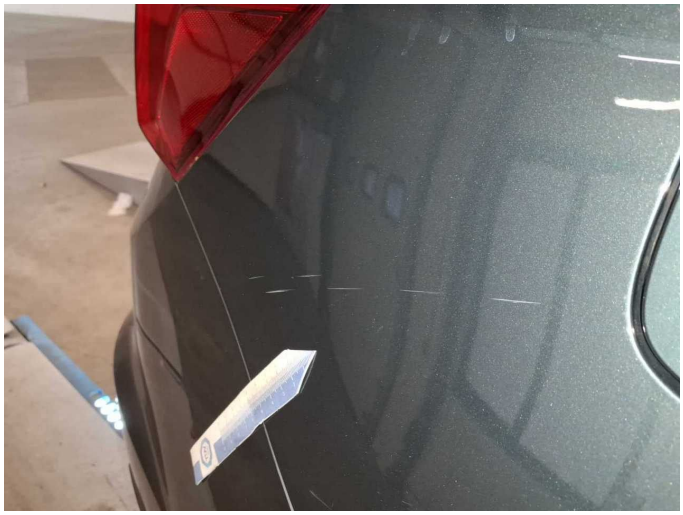
Damage 20: Side panel - rear right side: Side panel - Dent / paintcoat damage - Repair and paint

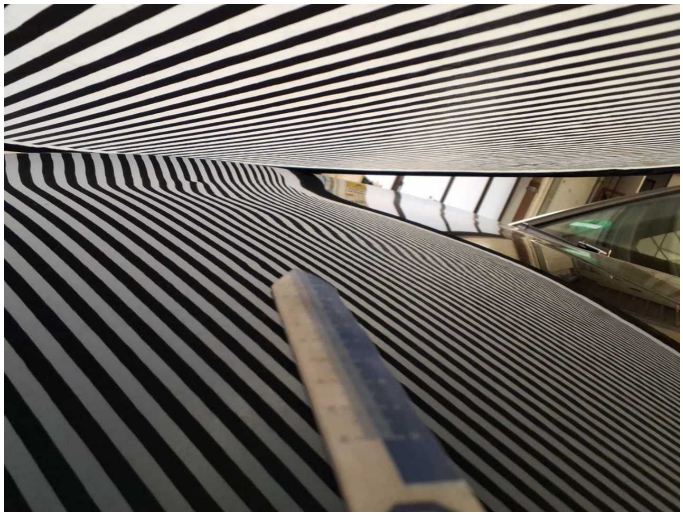
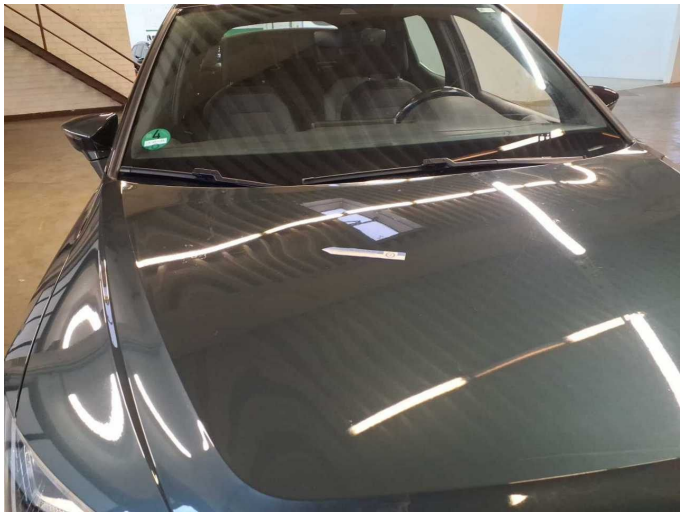
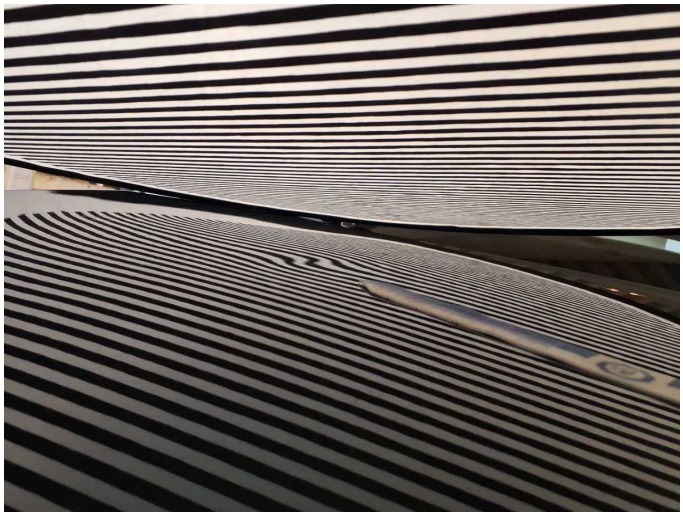
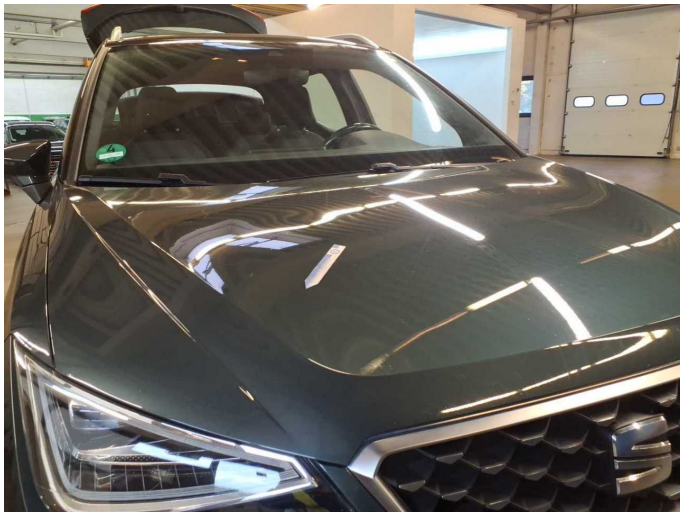
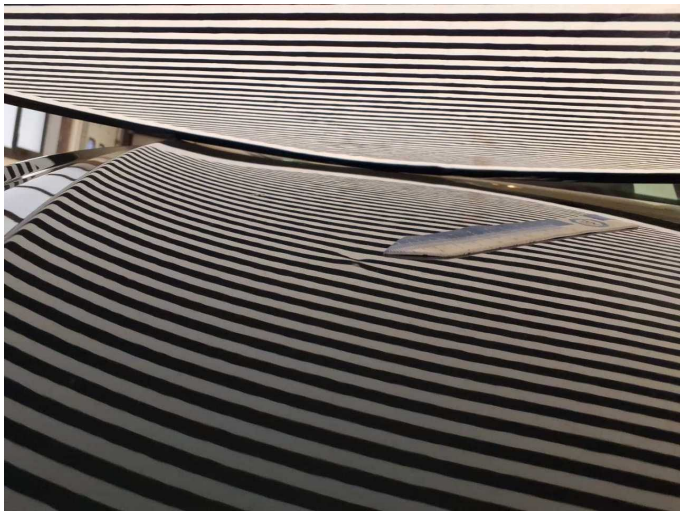
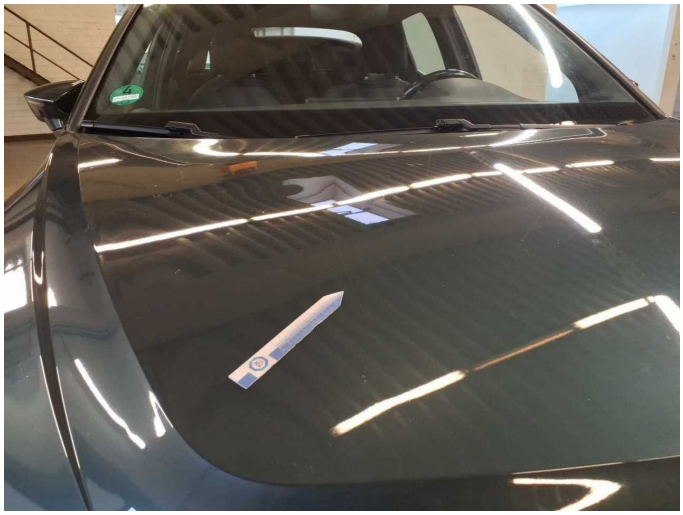
Damage 21: Bonnet: Bonnet (Kratzer) - Deformed - Repair and paint
