Expertise

Protocol number: 48139790
Order No. / Reference: 27009326-1
Inspection date: 30 Sept 2026

Manufacturer: Opel	Model: Insignia Sports Tourer 2.0 Diesel Aut. Elegance
VIN: W0VZT8EP0N1025474

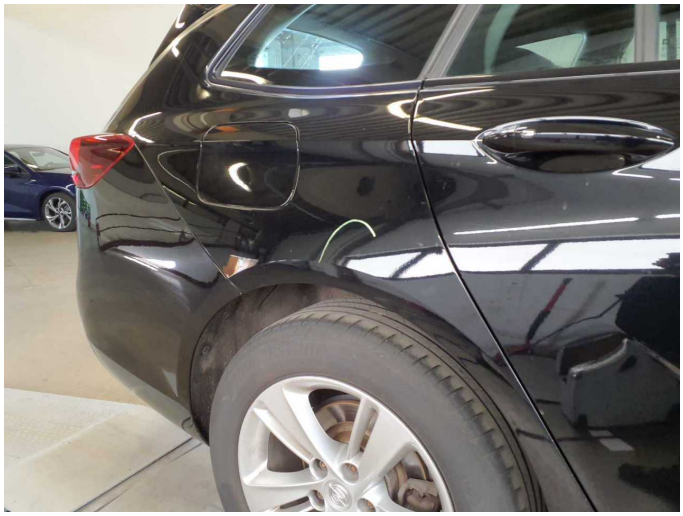
No.	Component group	Description
1	Side panel - rear right side	Side panel - dent(s) - Smooth repair work
2	Roof	Roof - dent(s) - Smooth repair work
3	Door - front right side	Door - dent(s) - Smooth repair work
4	Front bumper	Front bumper - Stone chips - Paint

Damage 1: Side panel - rear right side: Side panel - dent(s) - Smooth repair work

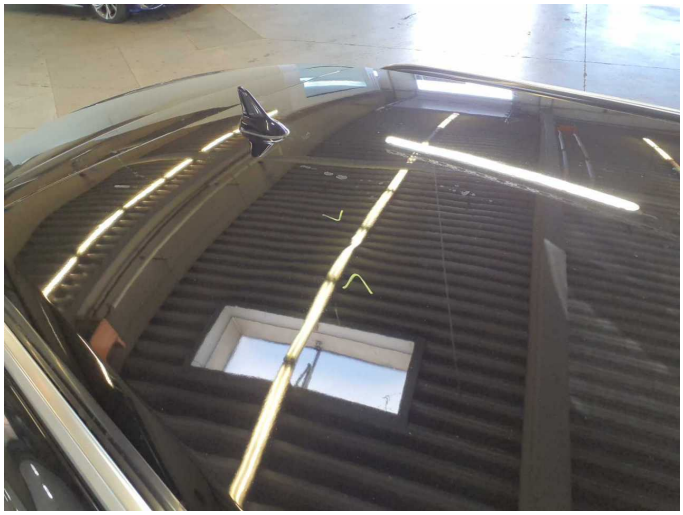
Damage 1: Side panel - rear right side: Side panel - dent(s) - Smooth repair work

Damage 2: Roof: Roof - dent(s) - Smooth repair work

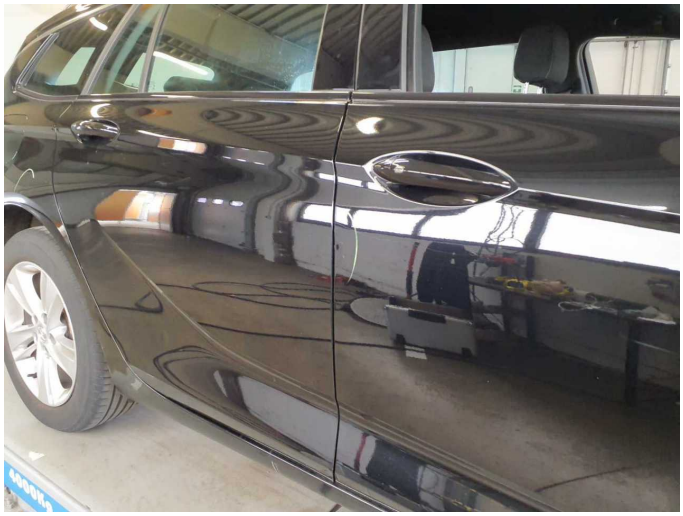
Damage 2: Roof: Roof - dent(s) - Smooth repair work

Damage 3: Door - front right side: Door - dent(s) - Smooth repair work
