TÜV SÜD Auto Partner GmbH
Wiesenring 2
04159 Leipzig

Expertise

Protocol number: 48587885
Order No. / Reference: 27112133
Inspection date: 5 Nov 2026

Manufacturer: Volkswagen	Model: Touran 1.5 TSI ACT OPF DSG Comfortline
VIN: WVGZZZ1TZMW037992

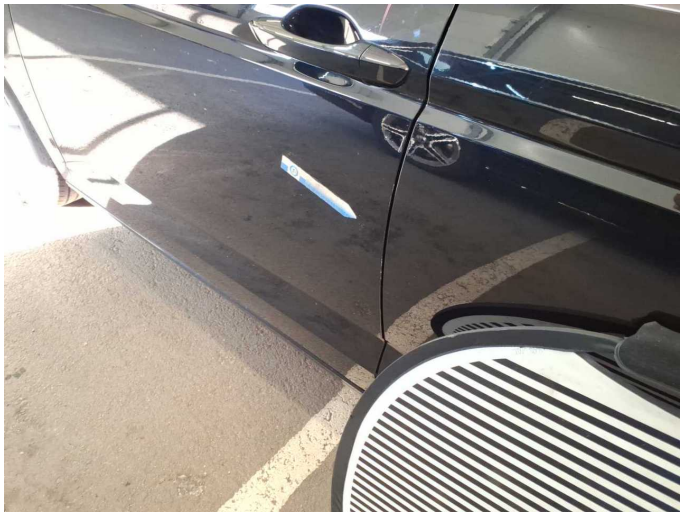
Damage 2: Door - front left side: Door edge - Scratch(es) - Smart repair

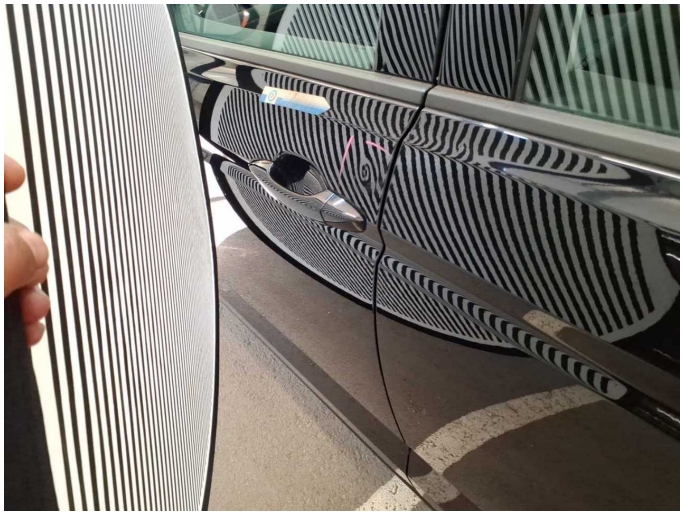
Damage 4: Door - front left side: Door - dent(s) - Smooth repair work

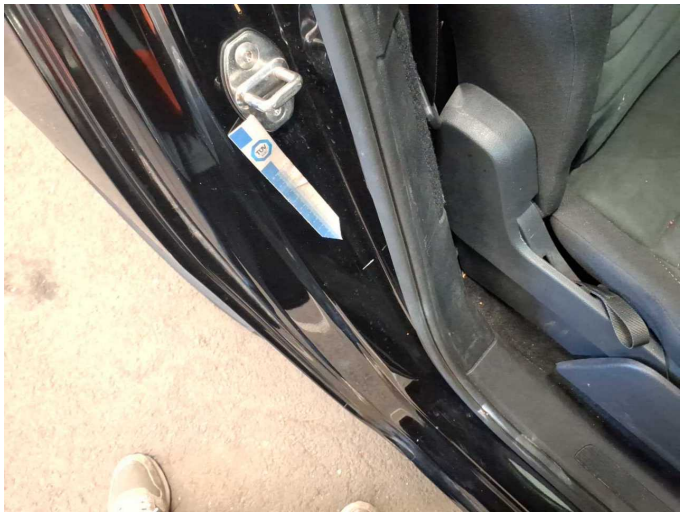
Damage 5: Side panel - rear right side: Sill - Scratch(es) - Smart repair

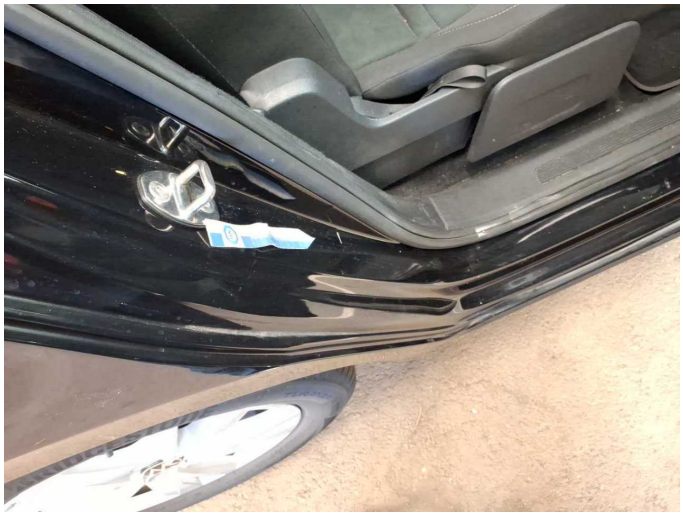
Damage 5: Side panel - rear right side: Sill - Scratch(es) - Smart repair

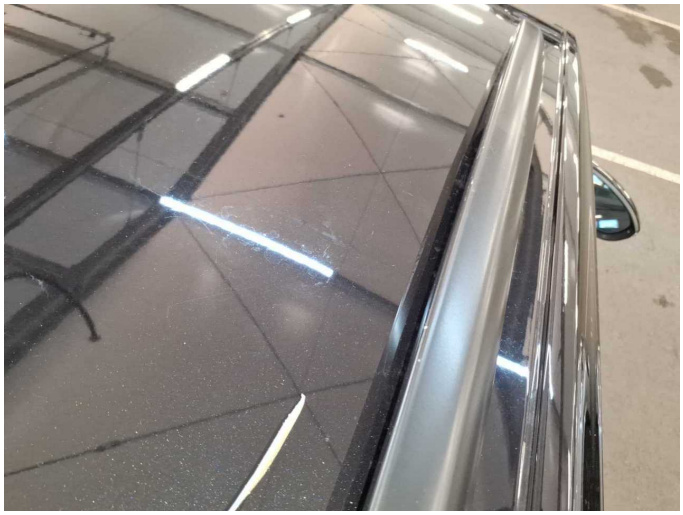
Damage 5: Side panel - rear right side: Sill - Scratch(es) - Smart repair

Damage 6: Roof: Roof rail - right side - Scratch(es) - Loss in value

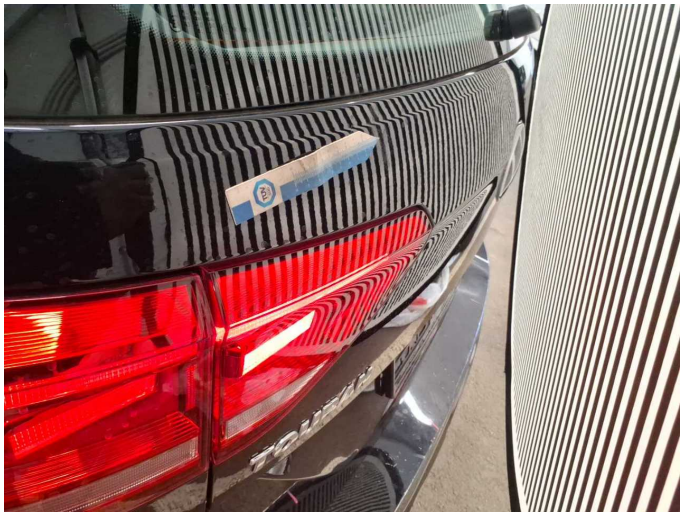
Damage 6: Roof: Roof rail - right side - Scratch(es) - Loss in value

Damage 7: Boot lid / rear door: Boot lid - dent(s) - Smooth repair work

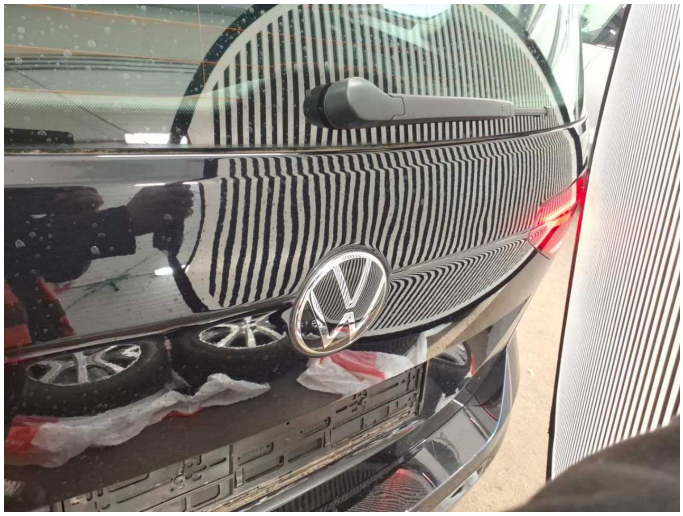
Damage 7: Boot lid / rear door: Boot lid - dent(s) - Smooth repair work

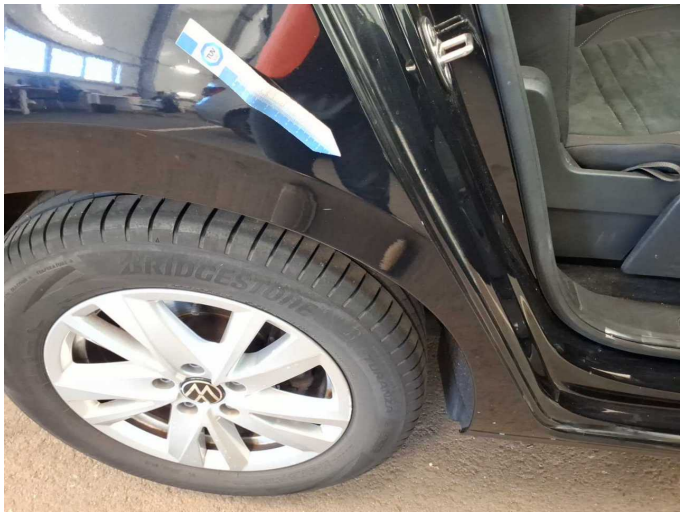
Damage 7: Boot lid / rear door: Boot lid - dent(s) - Smooth repair work

Damage 8: Side panel - rear right side: Side panel - Scratch(es) - Smart repair

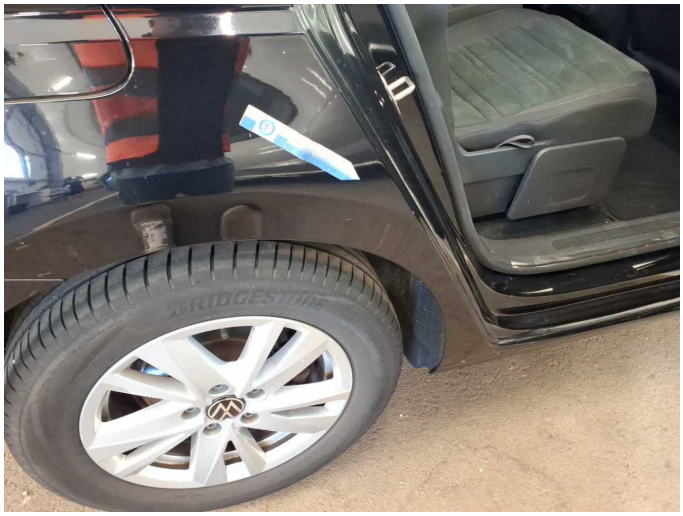
Damage 8: Side panel - rear right side: Side panel - Scratch(es) - Smart repair

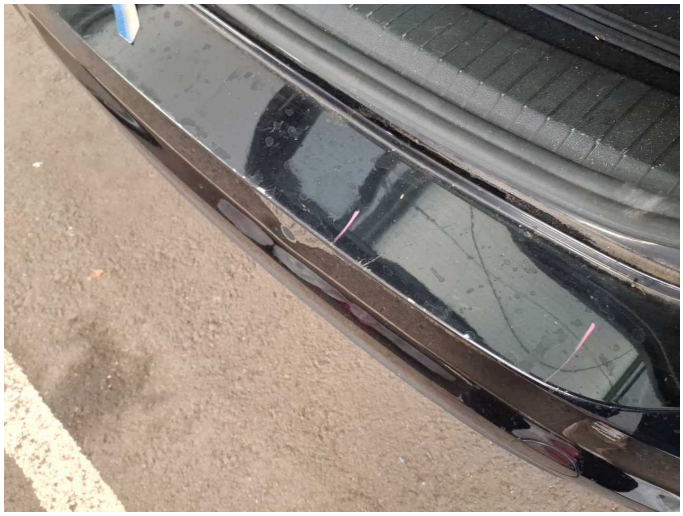
Damage 10: Rear bumper: Rear bumper - Scratched - Paint

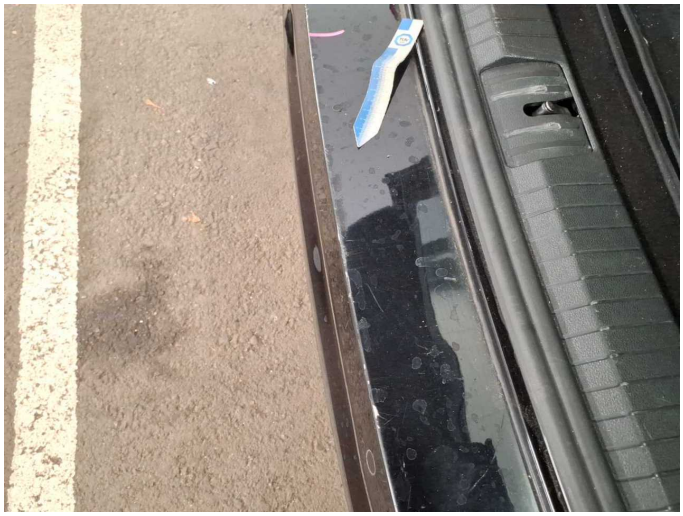
Damage 10: Rear bumper: Rear bumper - Scratched - Paint

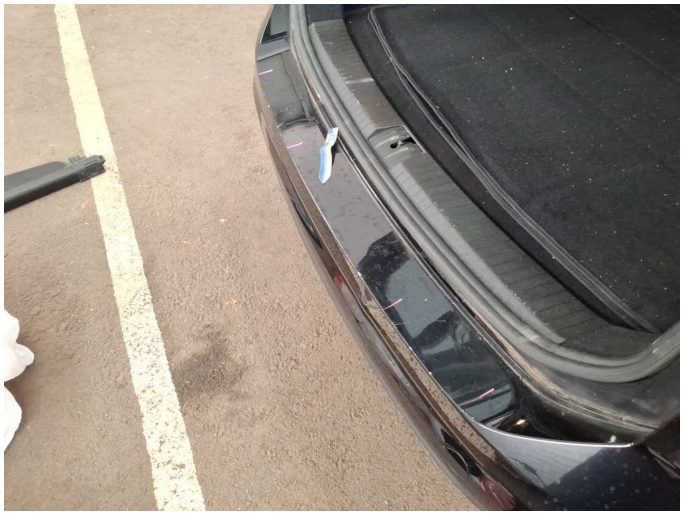
Damage 10: Rear bumper: Rear bumper - Scratched - Paint

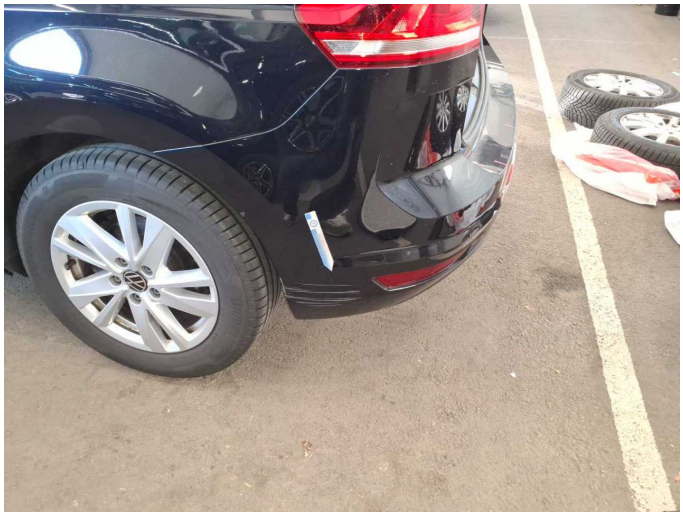
Damage 10: Rear bumper: Rear bumper - Scratched - Paint

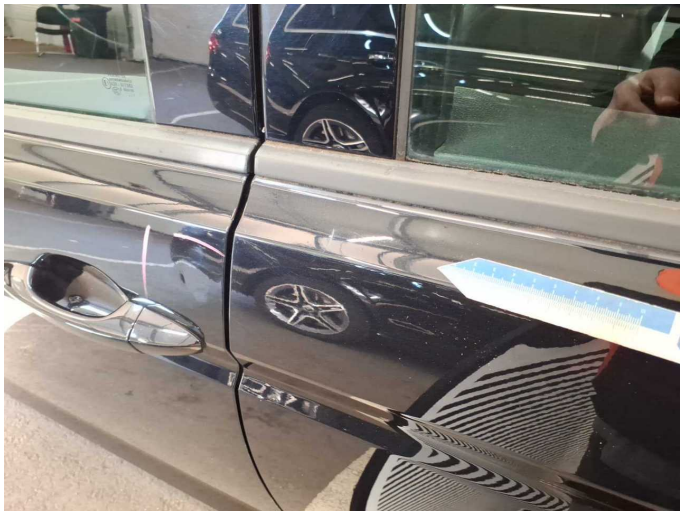
Damage 11: Door - rear left side: Door - Dent / paintcoat damage - Repair and paint

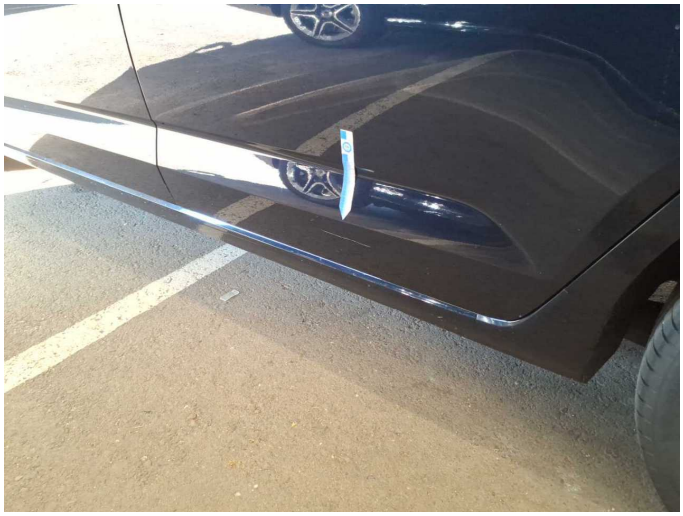
Damage 11: Door - rear left side: Door - Dent / paintcoat damage - Repair and paint

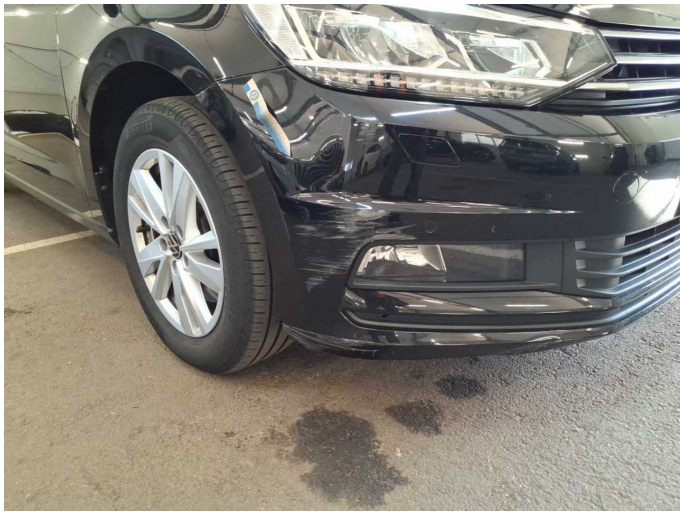
Damage 12: Front bumper: Front bumper - Scratched - Repair and paint

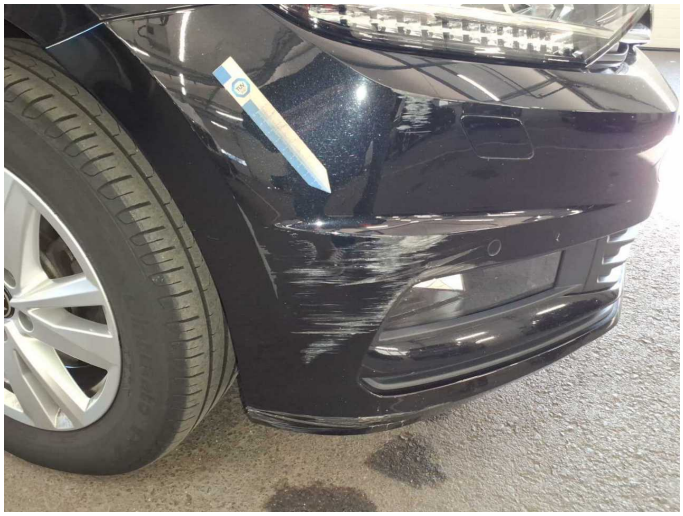
Damage 12: Front bumper: Front bumper - Scratched - Repair and paint

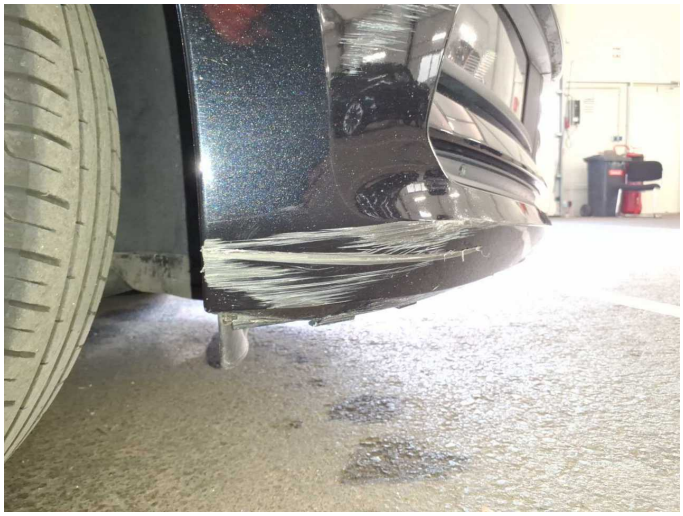
Damage 12: Front bumper: Front bumper - Scratched - Repair and paint

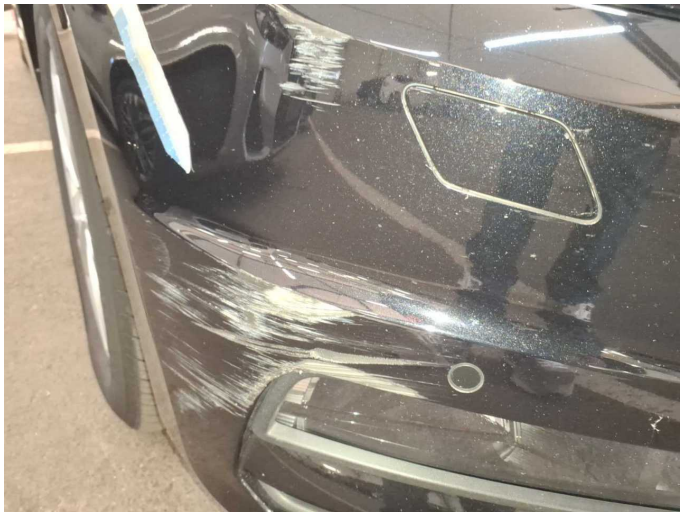
Damage 12: Front bumper: Front bumper - Scratched - Repair and paint

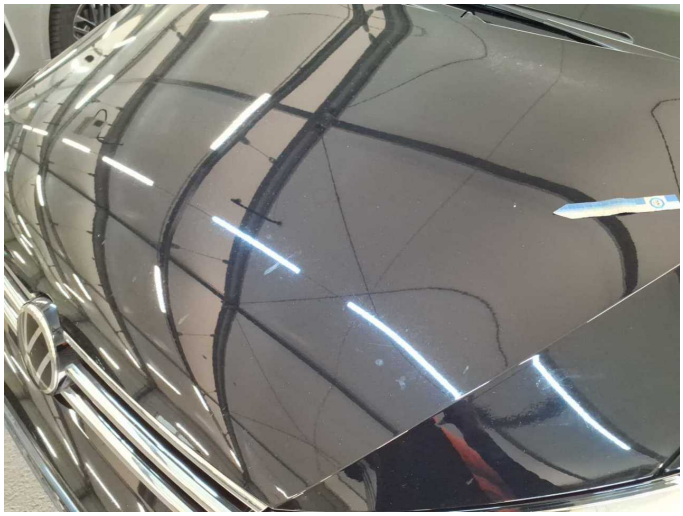
Wear and tear 1: Bonnet: Bonnet - Stone chips - No deduction

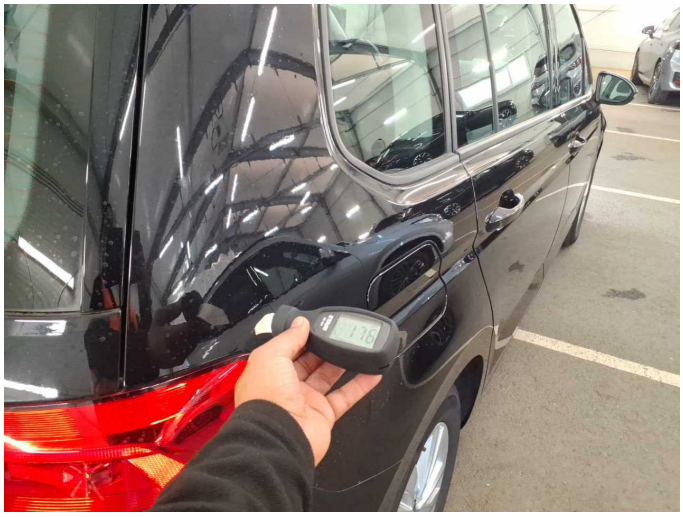
Side panel - rear right side	176 µm

Wear and tear 7: 2nd wheel set: 1 alloy rim (Nicht Bestandteil der Ausstattung) - Scratched - No deduction

Repainting 1: Side panel - rear right side
