ARVAL
BNP PARIBAS GROUP

2BHT464

INSPECTION REPORT

End of contract

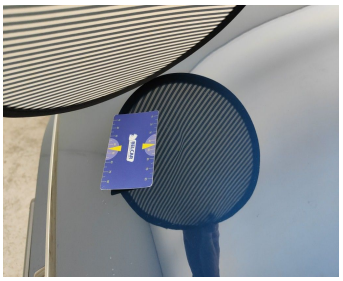
Wheel Two Tone Front Left // Repair-Chemical reaction

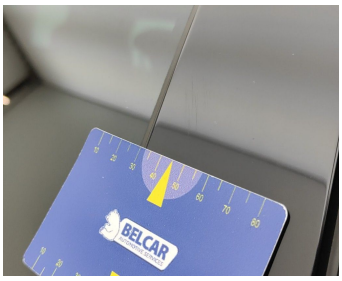
Front Bonnet // Smart Repair Small-dent

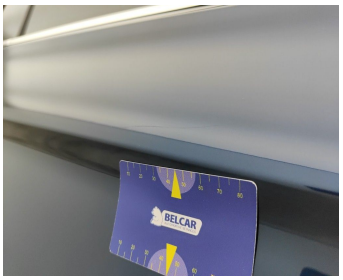
Rocker Panel Right // Smart Repair Medium-scratch + dent

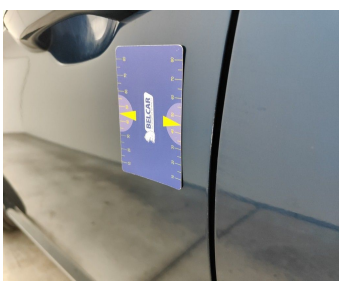
Wing Rear Left // Painting-scratch

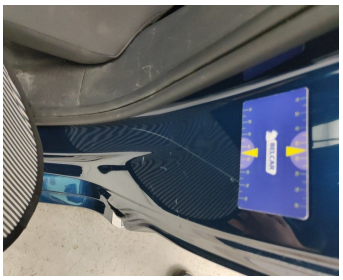
Bumper Front // Smart Repair Large-scratch

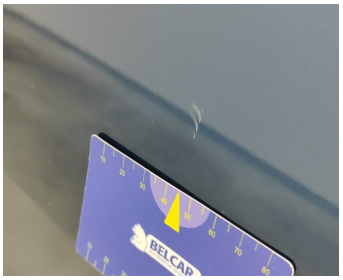
Rocker Panel Left // Smart Repair Medium-scratch

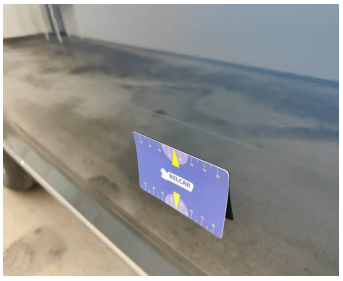
Bumper Rear // Painting-scratch

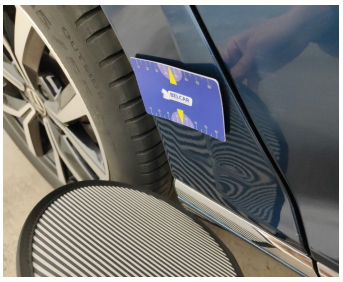
Door Rear Right // Painting-scratch

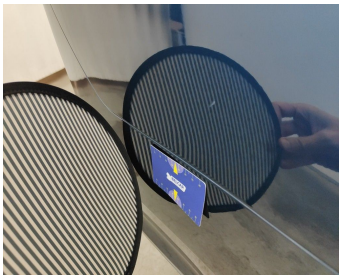
Wing Rear Right // Repair & Painting-scratch + dent
