Expertise

Protocol number: 48432433
Order No. / Reference: 27240219
Inspection date: 30 Oct 2026

Manufacturer: Ford	Model: Mondeo Turnier 2.0 EcoBlue Titanium
VIN: WF0FXXWPCFNY70478

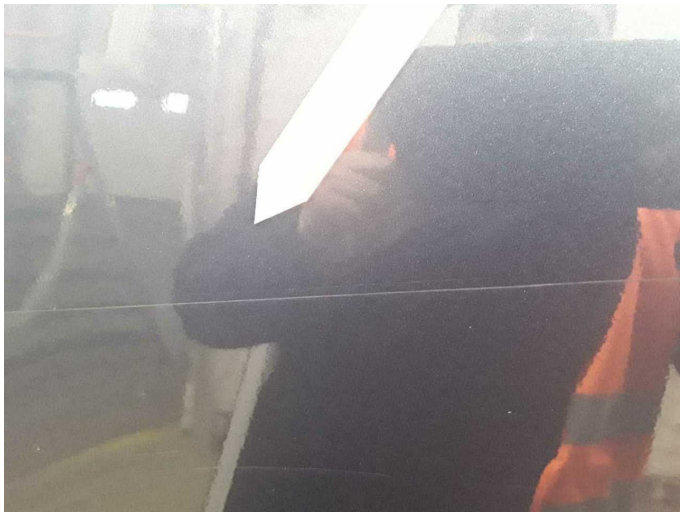
Damage 5: Door - rear right side: Door - Scratch(es) - Smart repair

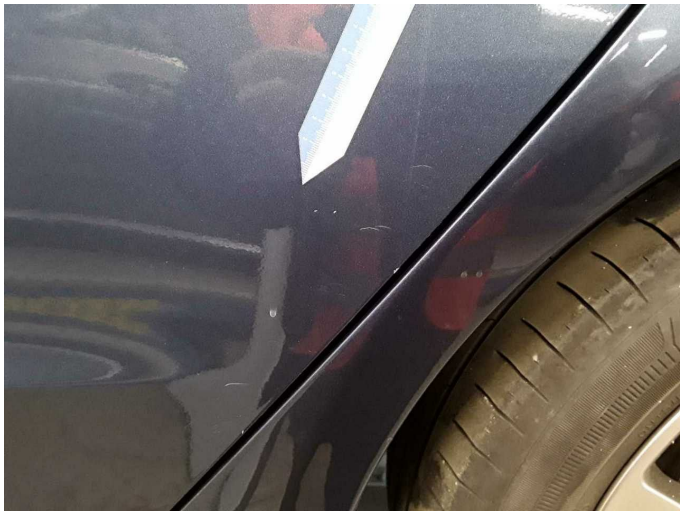
Damage 8: Door - rear left side: Door - Dent / paintcoat damage - Paint

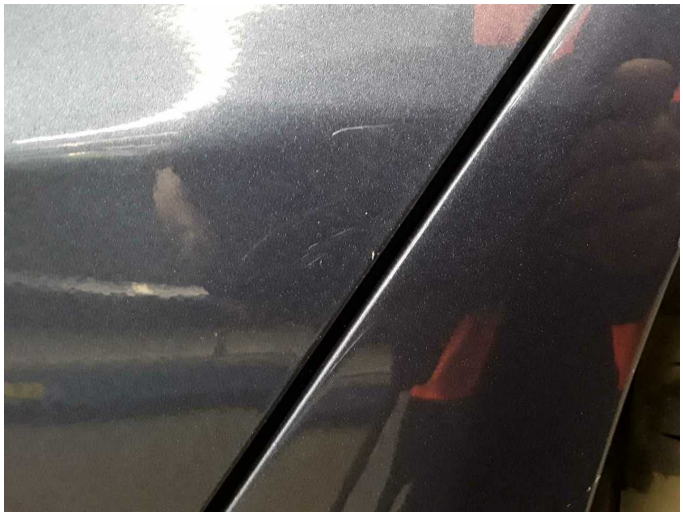
Damage 8: Door - rear left side: Door - Dent / paintcoat damage - Paint

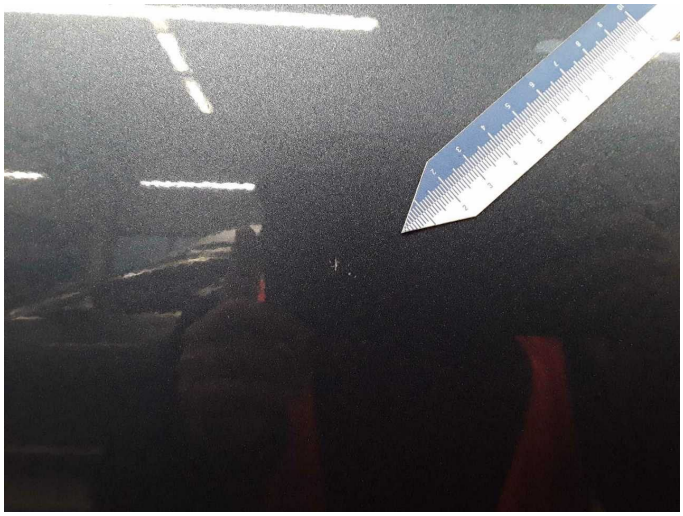
Damage 8: Door - rear left side: Door - Dent / paintcoat damage - Paint

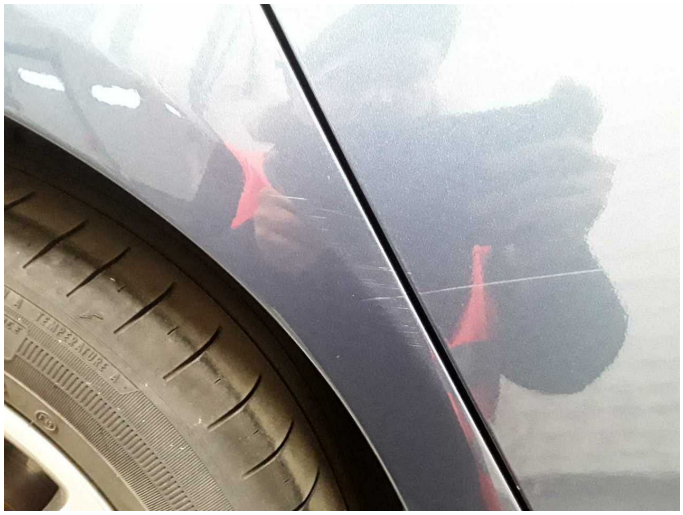
Damage 9: Side panel - rear right side: Side panel - Scratch(es) - Paint

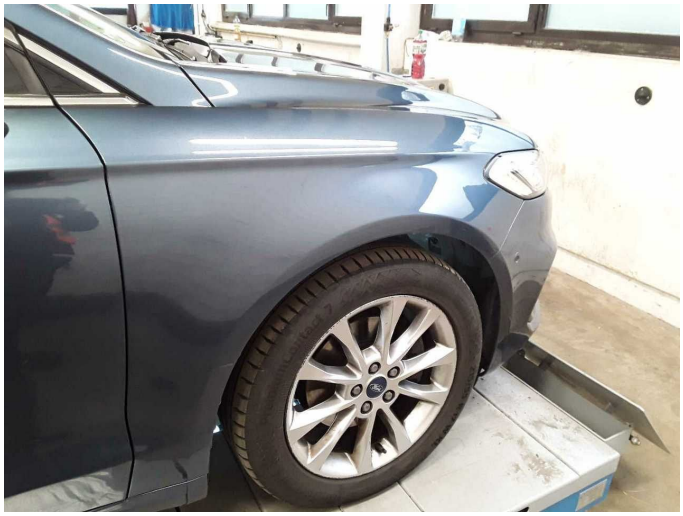
Mudguard - right side	229 µm	Side panel - rear left side	849 µm
Door - front right side	151 µm

Repainting 1: Mudguard - right side, Side panel - rear left side, Door - front right side
