Expertise

Protocol number: 48463018
Order No. / Reference: 27248452
Inspection date: 2 Nov 2026

Manufacturer: Ford	Model: Transit 310 L2H2 Lkw VA Trend Kasten
VIN: WF0EXXTTREKM31795

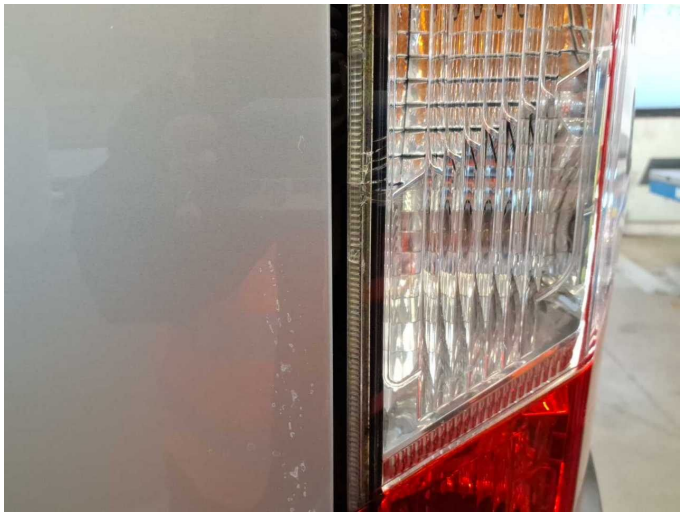
Damage 2: Rear bumper: Reflector - right side - Damaged - Replace

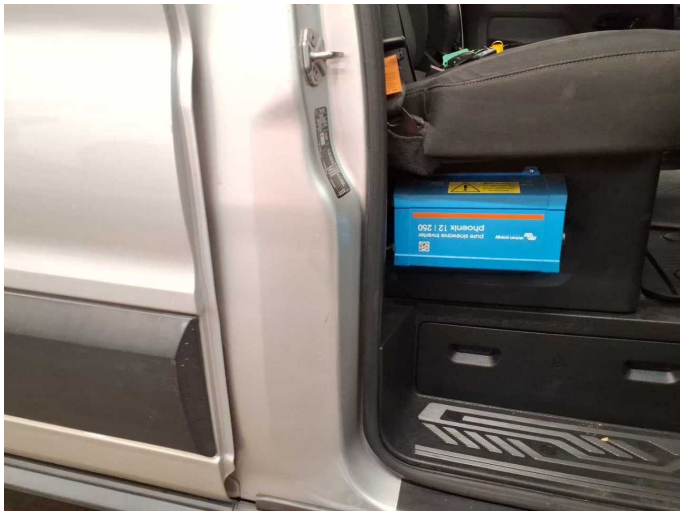
Damage 3: Body: B-pillar - right side - Scratch(es) - Smart repair

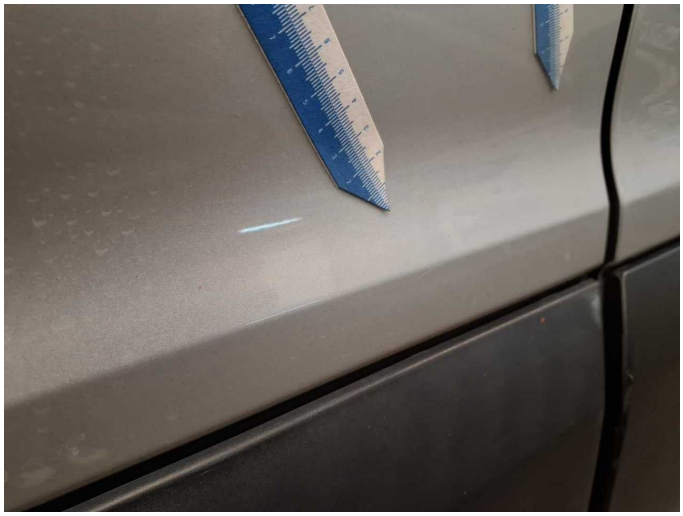
Damage 9: Sliding door, right: Sliding door - Dent / paintcoat damage - Repair and paint

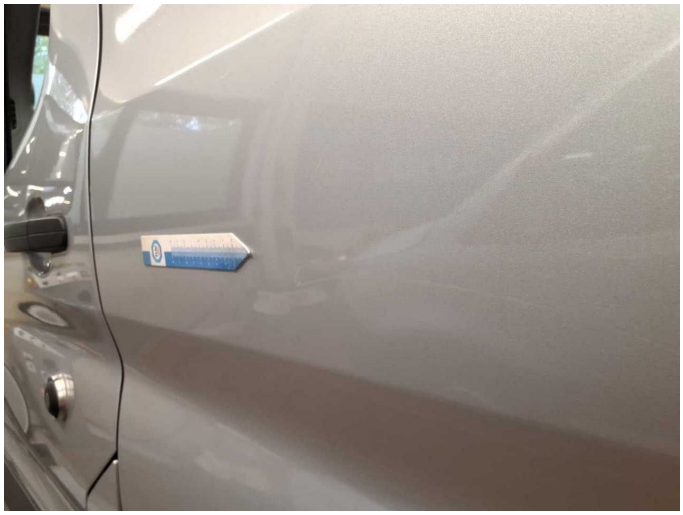
Damage 10: Side panel - rear left side: Side panel - Dent / paintcoat damage - Paint
