Expertise

Protocol number: 45482221
Order No. / Reference: 26258559
Inspection date: 15 May 2026

Manufacturer: Skoda

Model: Octavia Combi 2.0 TDI DSG Sportline

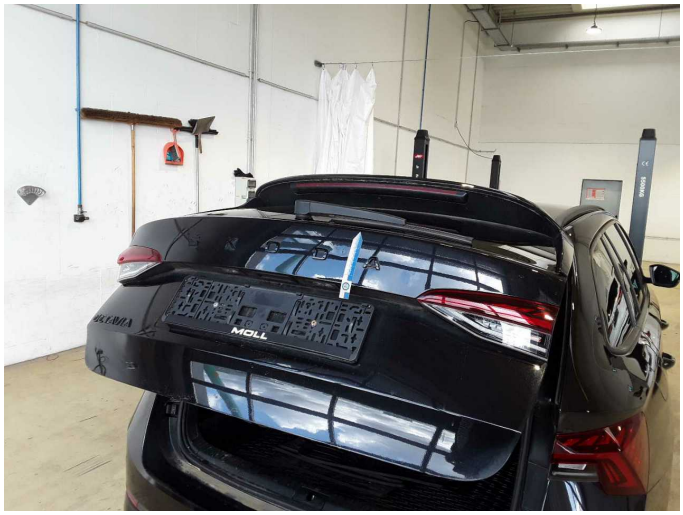
Damage 1: Trim / covers: Boot lid - interior trim - Scratch(es) - Replace

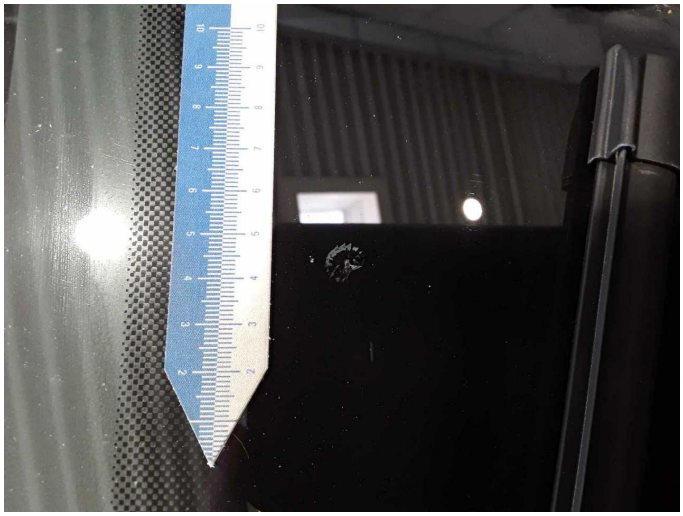
Damage 6: Vehicle glazing: Windscreen - Broken / torn - Replace
