Expertise

Protocol number: 48563653
Order No. / Reference: 27218734
Inspection date: 9 Nov 2026

Manufacturer: Opel	Model: Corsa 1.2 Direct Injection Turbo GS
VIN: VXKUPHNE9R4126537

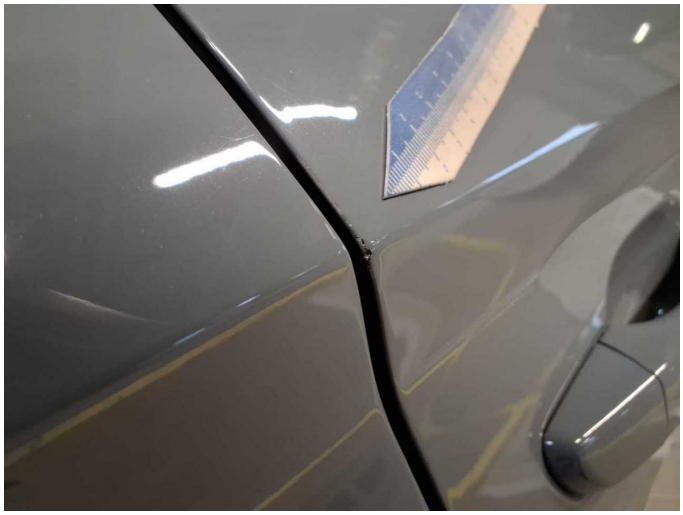
Damage 3: Door - front right side: Door edge - Scratch(es) - Smart repair
