Expertise

Protocol number: 48571835
Order No. / Reference: 27234397
Inspection date: 9 Nov 2026

Manufacturer: Ford	Model: Focus Turnier 1.0 EcoBoost Hybrid Aut. ST-LINE X
VIN: WF0PXXGCHPSK53515

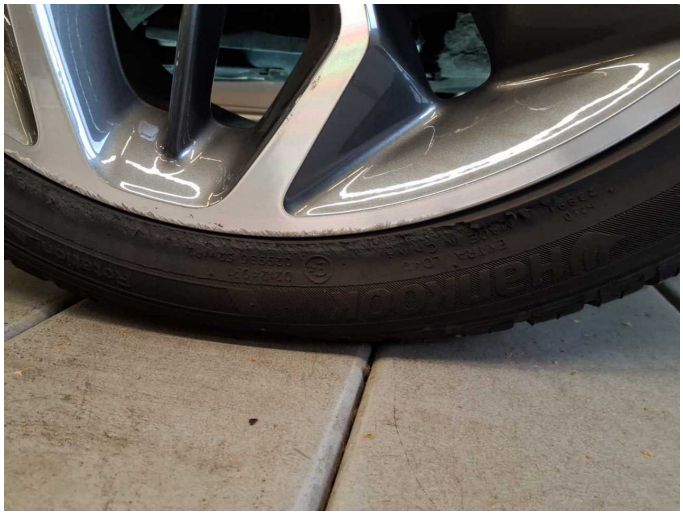
No.	Component group	Description
1	Wheel / tyres	Tyre - front left side - Broken / torn - Replace
2	Wheel / tyres	Tyre - front right side - Broken / torn - Replace
3	Side panel - rear left side	Elbow - Scratch(es) - Smart repair
4	Front axle	Axles / undercarriage (wegen der beschädigten Felgen) - Specify findings - Measure
5	Wheel / tyres	Alloy rim - front left side (Materialabtrag) - Scratched - Replace
6	Wheel / tyres	Alloy rim - front right side - Scratched - Replace

Damage 2: Wheel / tyres: Tyre - front right side - Broken / torn - Replace

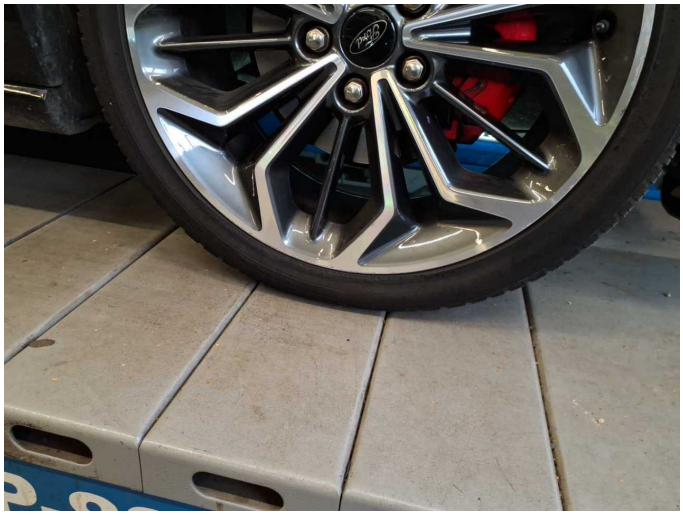
Damage 5: Wheel / tyres: Alloy rim - front left side (Materialabtrag) - Scratched - Replace
