Expertise

Protocol number: 48072722
Order No. / Reference: 27100224
Inspection date: 12 Oct 2026

Manufacturer: Audi	Model: A6 Avant 50 TDI quattro tiptronic sport
VIN: WAUZZZF22PN009321

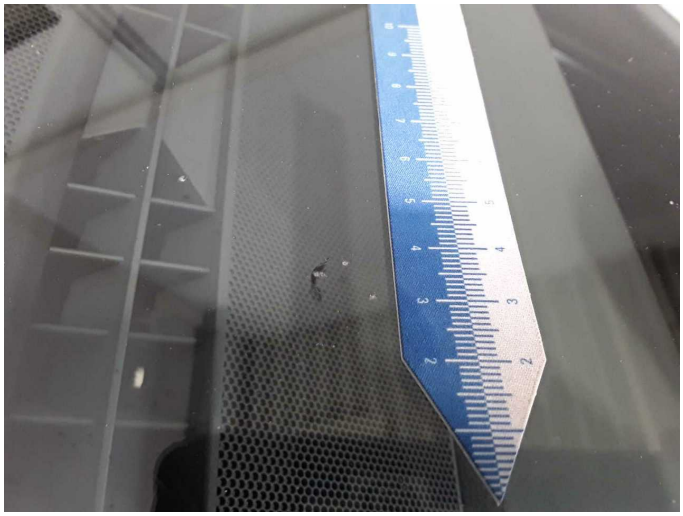
Damage 8: Vehicle glazing: Windscreen - Broken / torn - Replace
