TÜV SÜD Auto Partner GmbH
Wiesenring 2
04159 Leipzig

Expertise

Protocol number: 47546694
Order No. / Reference: 27001026
Inspection date: 11 Sept 2026

Manufacturer: Audi	Model: A6 Avant 40 TDI S tronic
VIN: WAUZZZF21NN052917

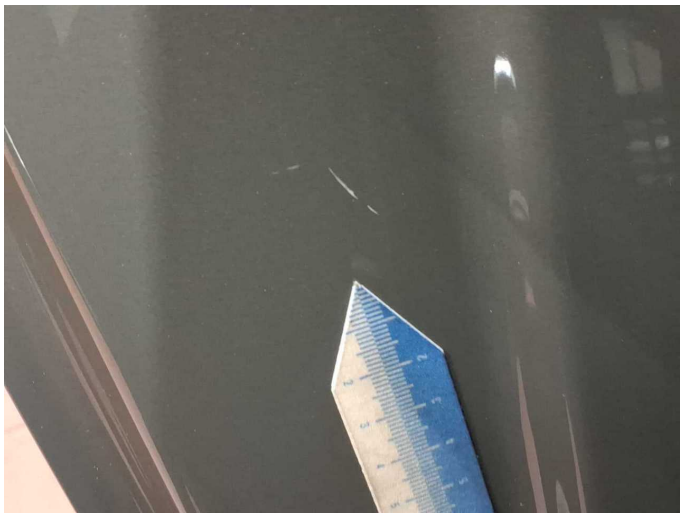
Damage 1: Mudguard - left side: Mudguard - left side - Stone chips - Smart repair
