Expertise

Protocol number: 48300969
Order No. / Reference: 27174429
Inspection date: 23 Oct 2026

Manufacturer: Opel	Model: Insignia Sports Tourer 2.0 Diesel Aut. Business Elegance
VIN: W0VZT8EP1N1028206

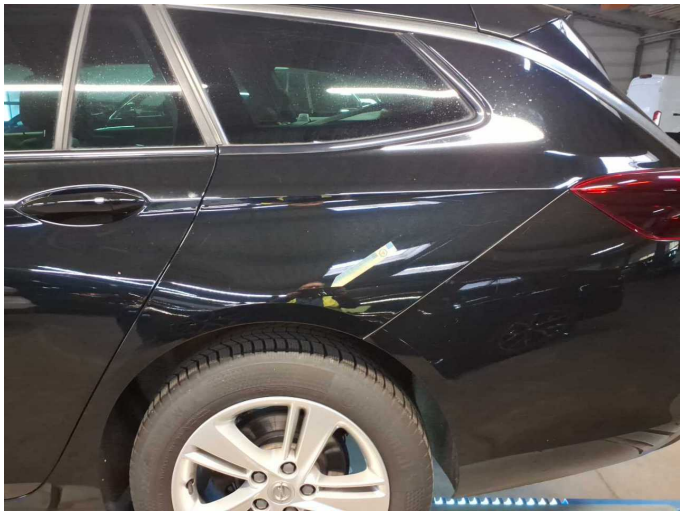
Damage 3: Side panel - rear right side: Side panel - Scratch(es) - Smart repair

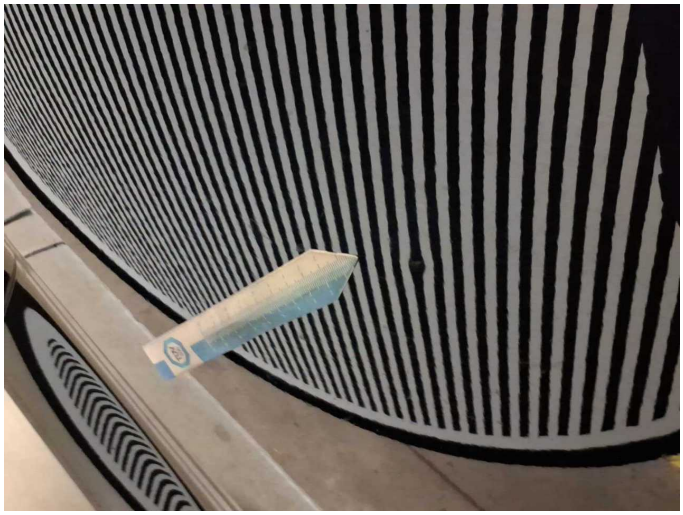
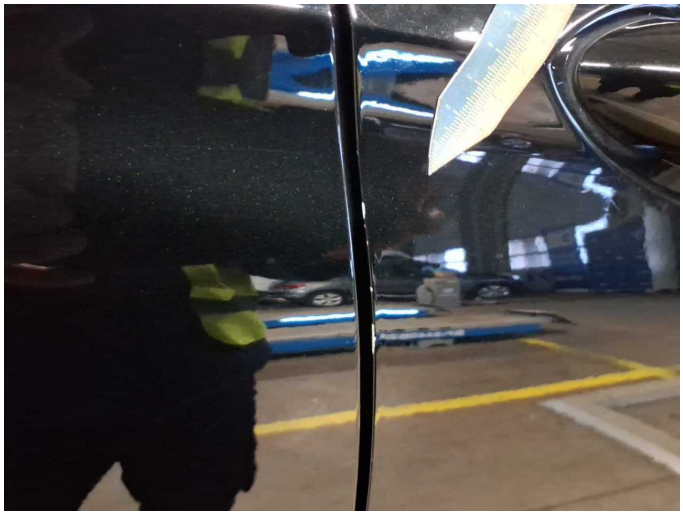
Damage 5: Door - front right side: Door - Dent / paintcoat damage - Repair and paint

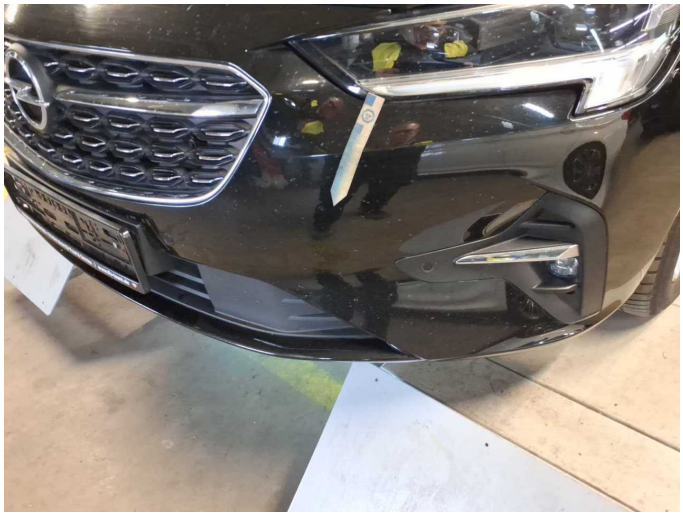
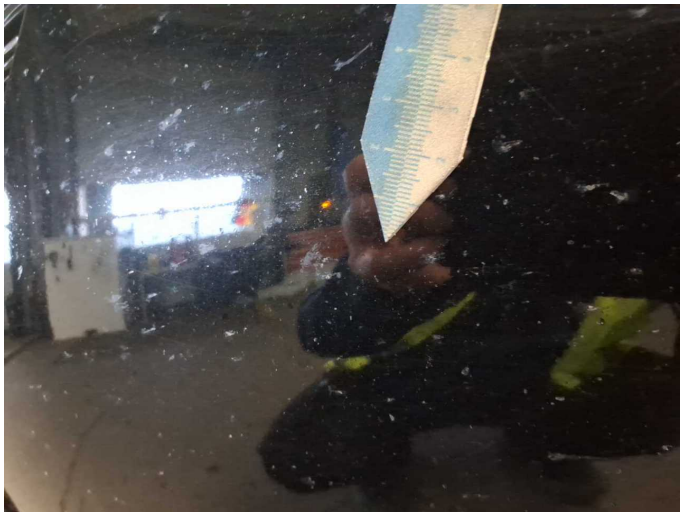
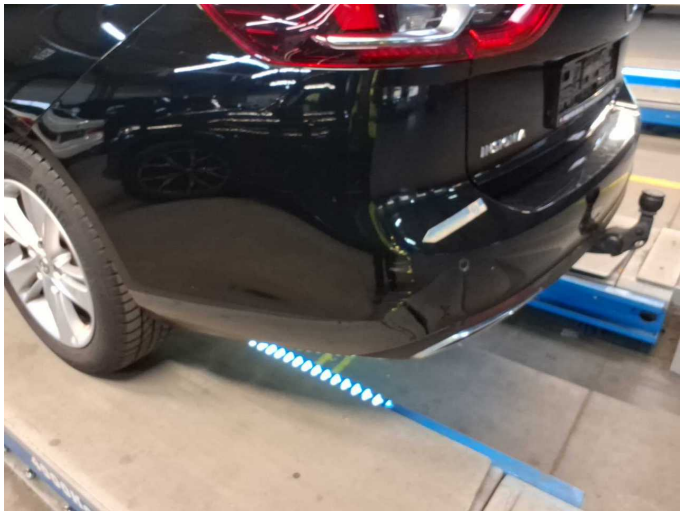
Damage 6: Front bumper: Front bumper (Streusandeffekt) - Stone chips - Paint

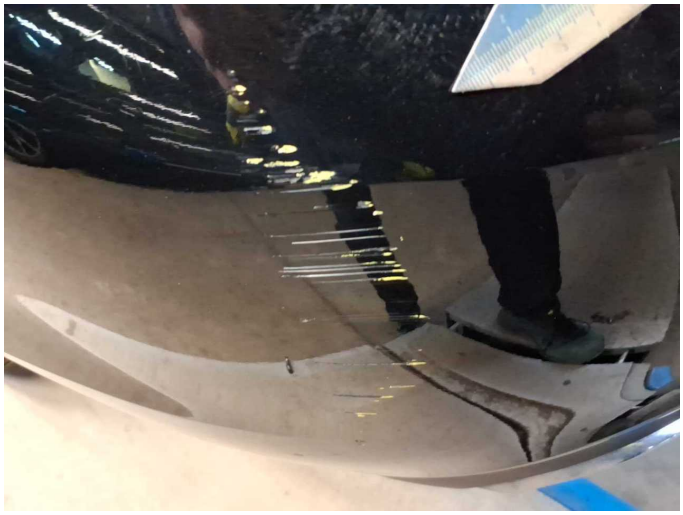
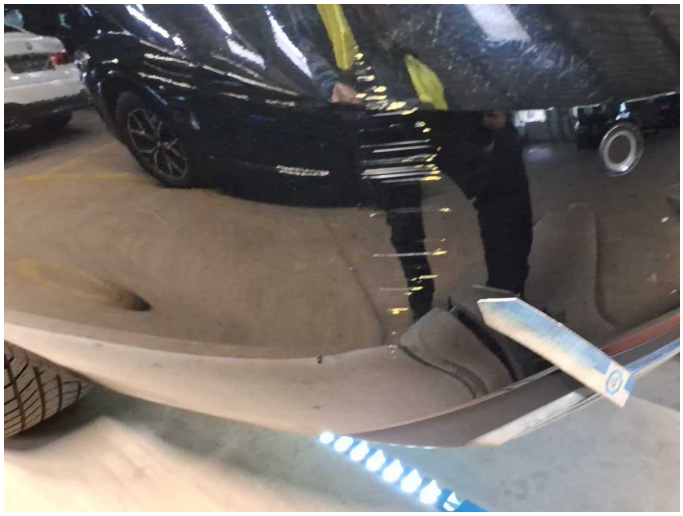
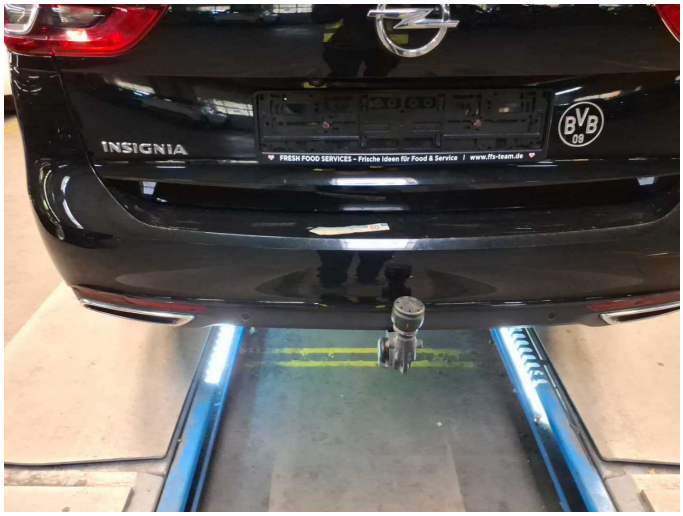
Damage 7: Rear bumper: Rear bumper - Scratched - Paint
