Expertise

Protocol number: 48467702
Order No. / Reference: 26945745
Inspection date: 2 Nov 2026

Manufacturer: Skoda	Model: Octavia Combi 2.0 TDI DSG Style
VIN: TMBJJ8NX5PY022366

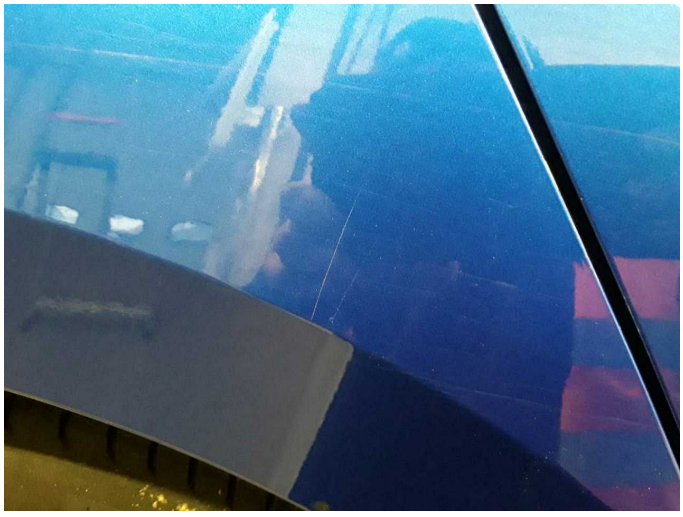
Damage 3: Side panel - rear right side: Side panel - Scratch(es) - Cover / polish

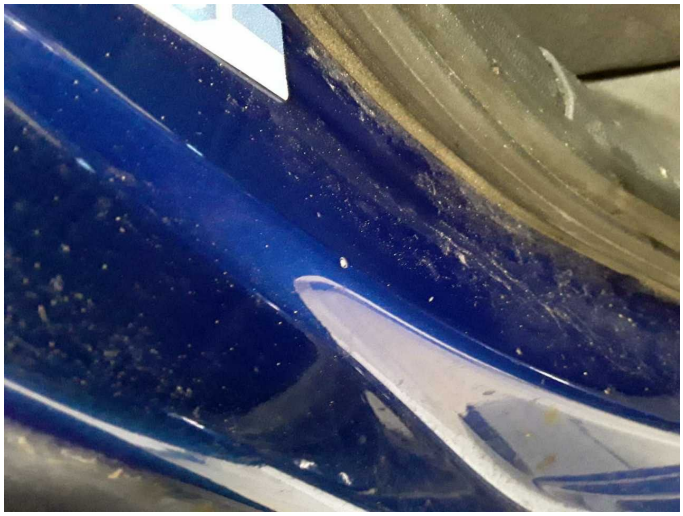
Damage 8: Side panel - rear right side: Sill - Scratch(es) - Smart repair

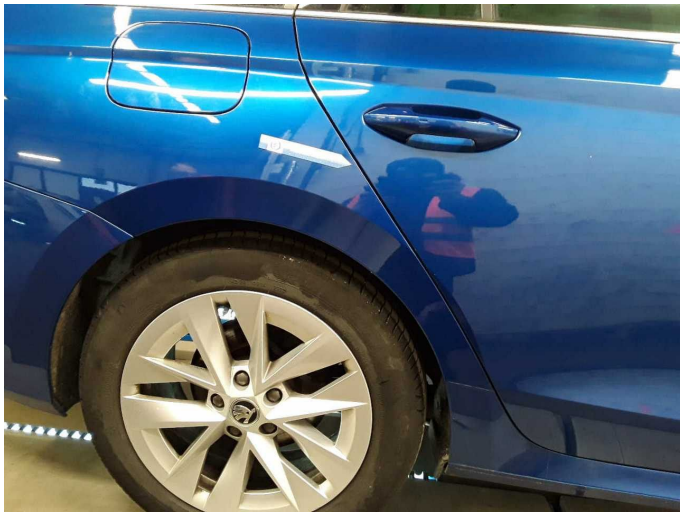
Damage 8: Side panel - rear right side: Sill - Scratch(es) - Smart repair

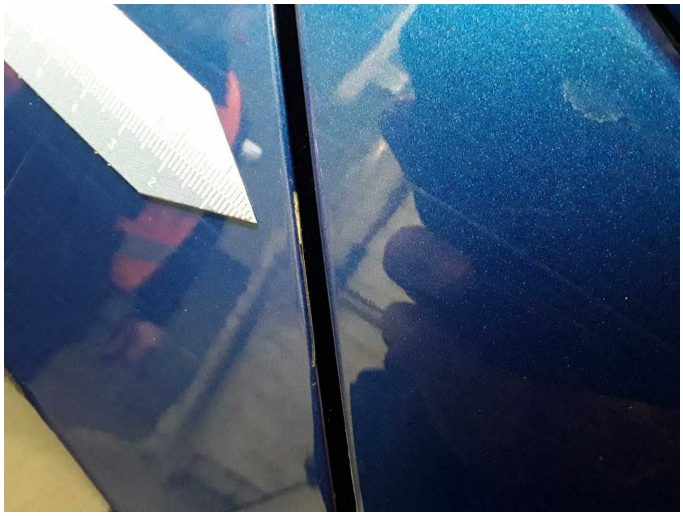
Damage 9: Side panel - rear right side: Side panel - Scratch(es) - Smart repair

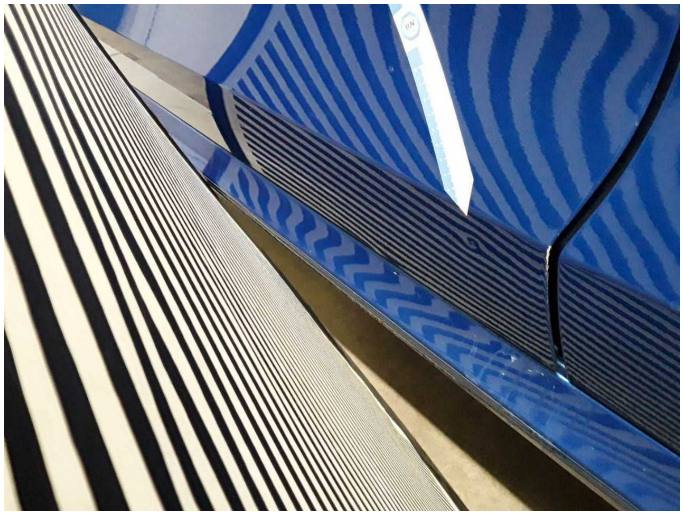
Damage 9: Side panel - rear right side: Side panel - Scratch(es) - Smart repair

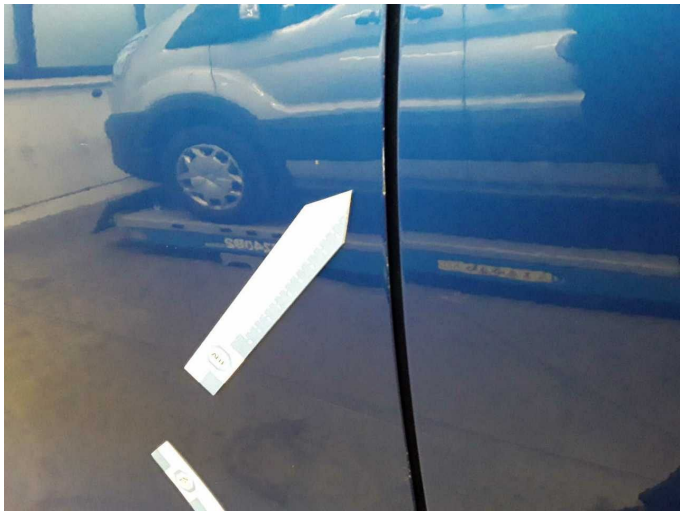
Damage 10: Door - front left side: Door - Dent / paintcoat damage - Repair and paint

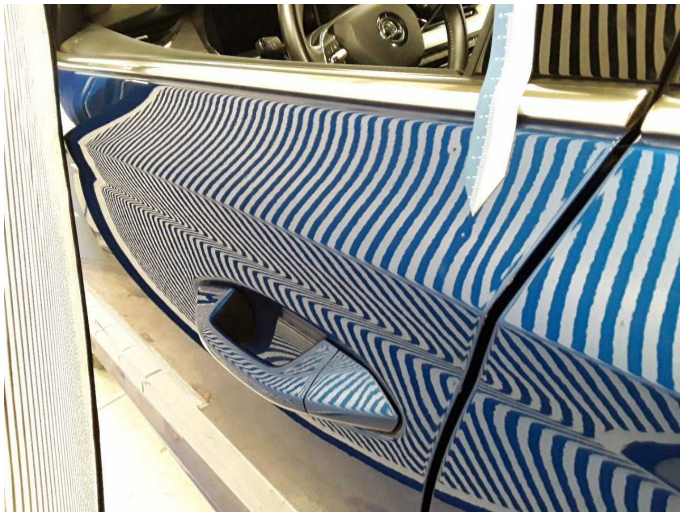
Damage 10: Door - front left side: Door - Dent / paintcoat damage - Repair and paint

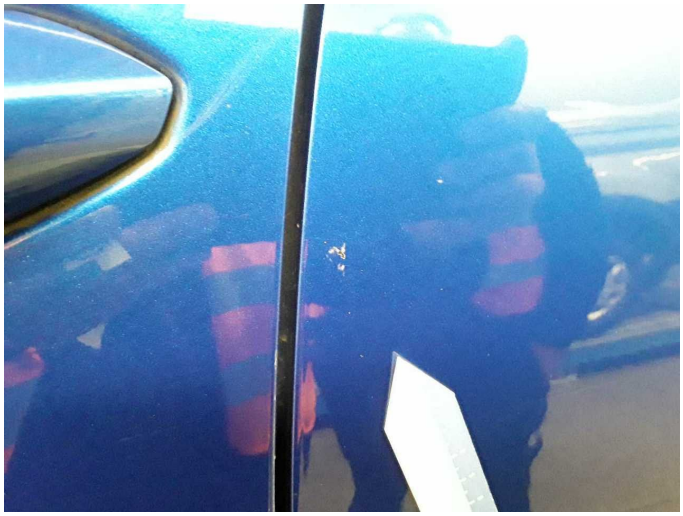
Damage 11: Door - rear left side: Door - Scratch(es) - Paint

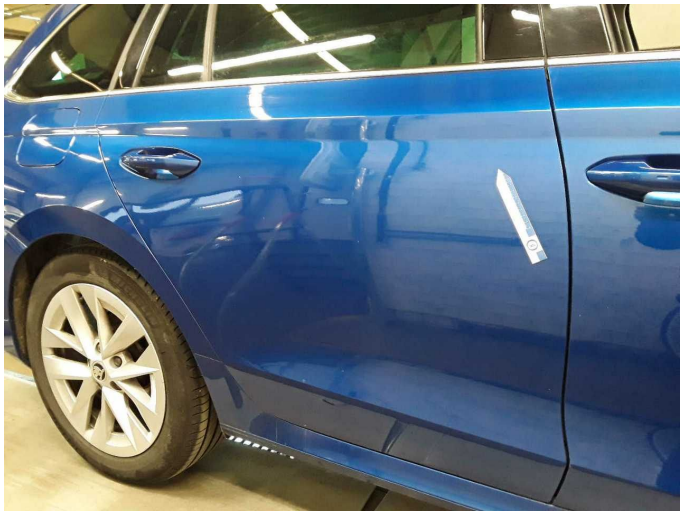
Damage 11: Door - rear left side: Door - Scratch(es) - Paint

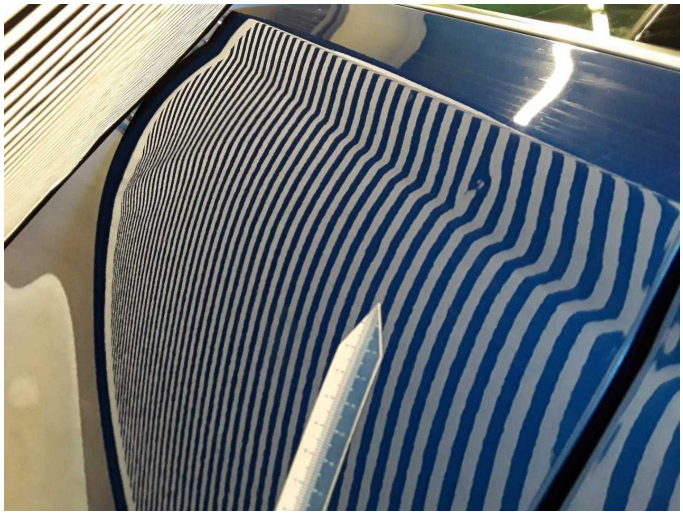
Damage 12: Door - rear right side: Door - Dent / paintcoat damage - Repair and paint

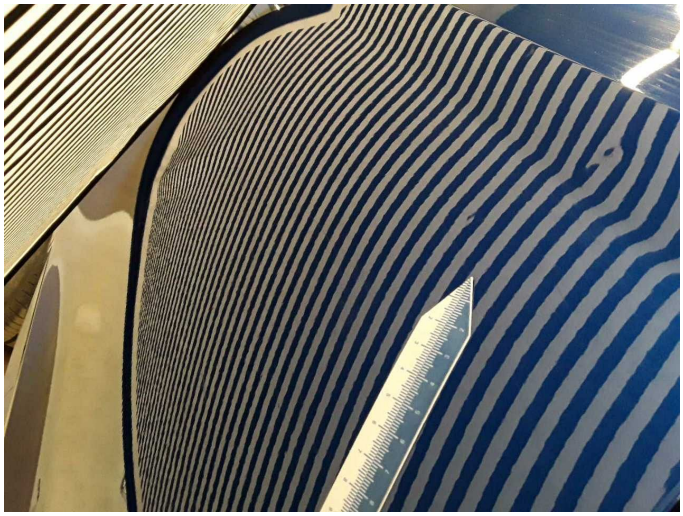
Damage 12: Door - rear right side: Door - Dent / paintcoat damage - Repair and paint

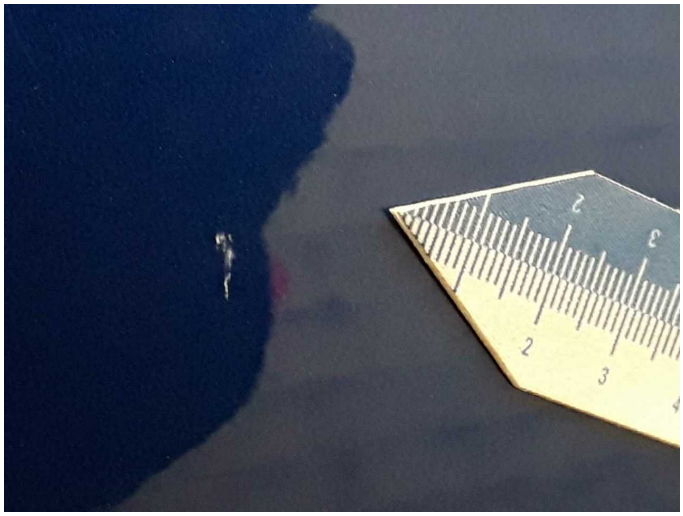
Damage 12: Door - rear right side: Door - Dent / paintcoat damage - Repair and paint

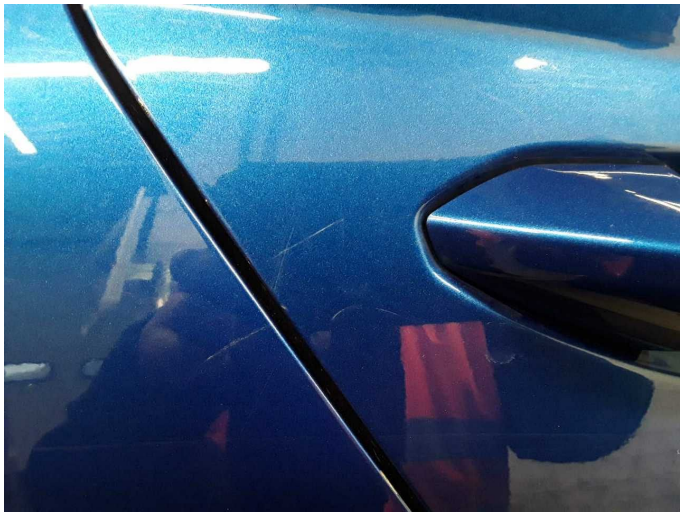
Damage 12: Door - rear right side: Door - Dent / paintcoat damage - Repair and paint

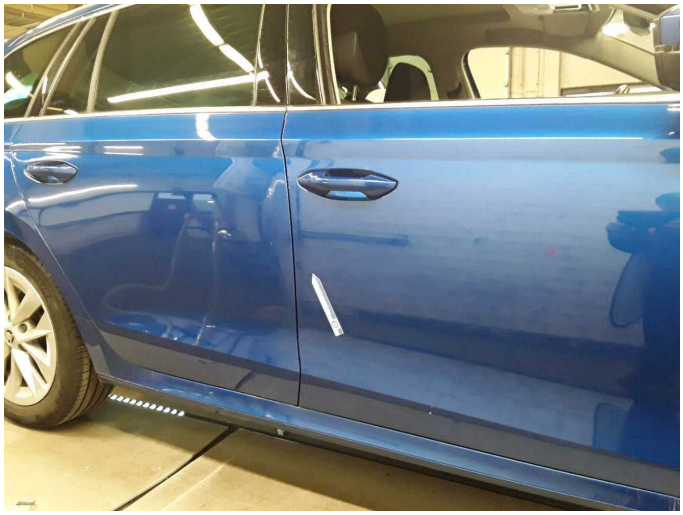
Damage 12: Door - rear right side: Door - Dent / paintcoat damage - Repair and paint

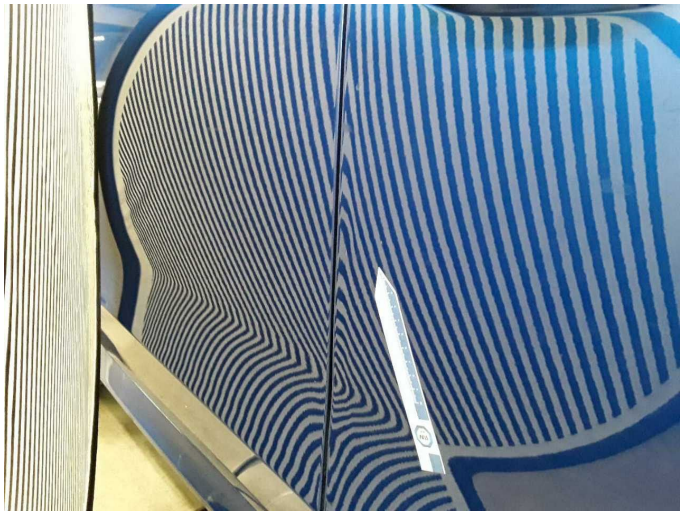
Damage 13: Door - front right side: Door - Dent / paintcoat damage - Repair and paint

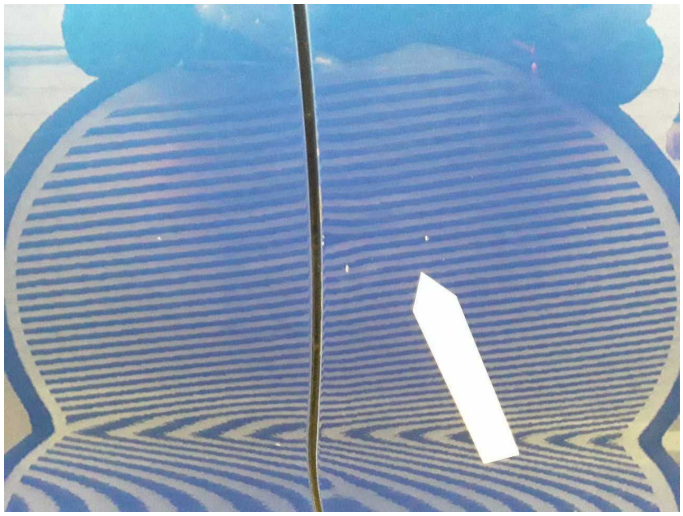
Damage 13: Door - front right side: Door - Dent / paintcoat damage - Repair and paint

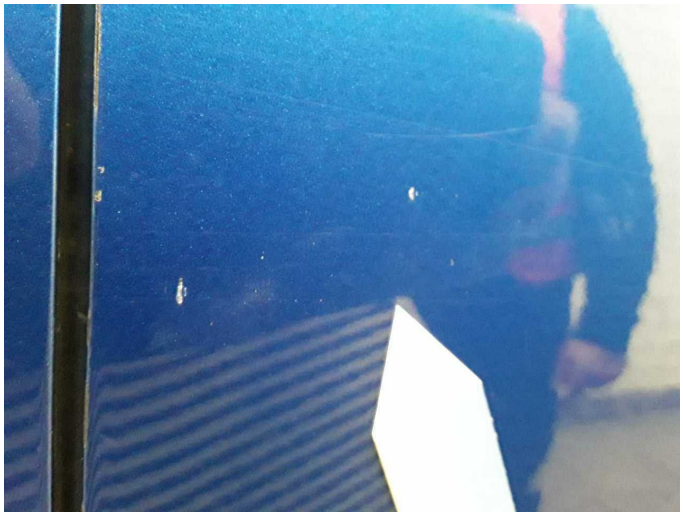
Damage 13: Door - front right side: Door - Dent / paintcoat damage - Repair and paint

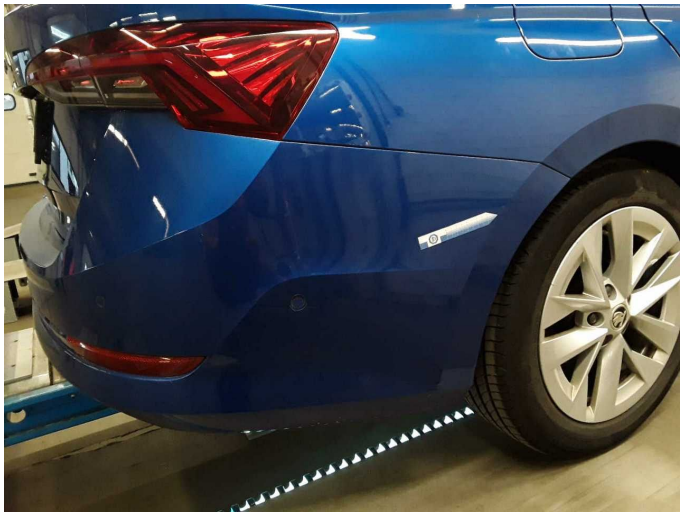
Damage 14: Rear bumper: Rear bumper - Scratch(es) - Paint

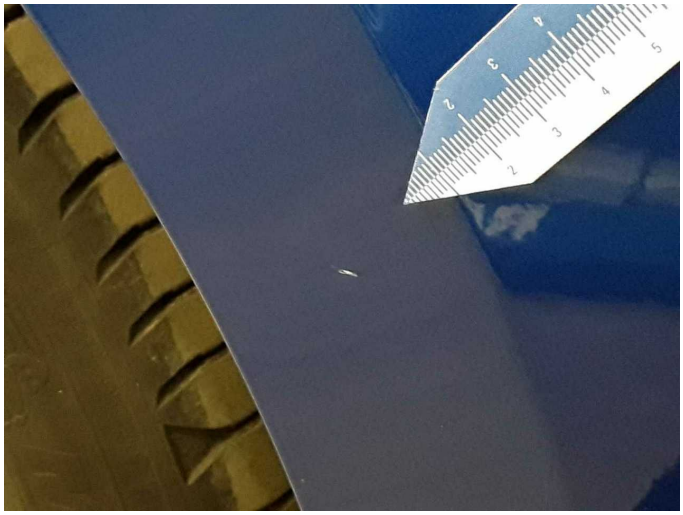
Damage 15: Mudguard - left side: Mudguard - left side - Dent / paintcoat damage - Repair and paint

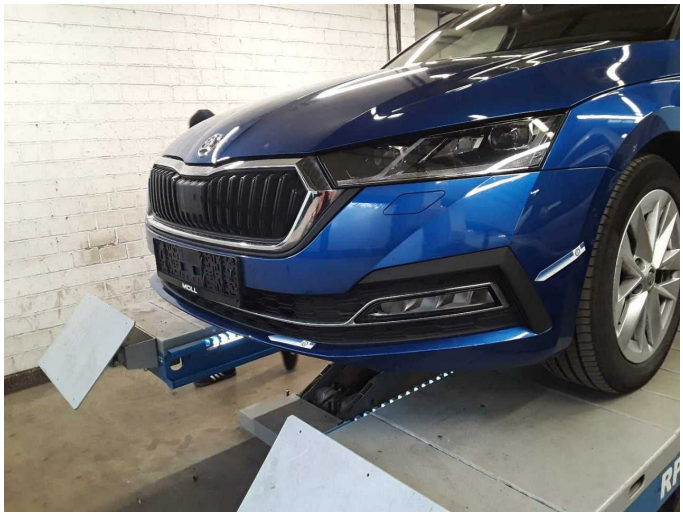
Damage 15: Mudguard - left side: Mudguard - left side - Dent / paintcoat damage - Repair and paint

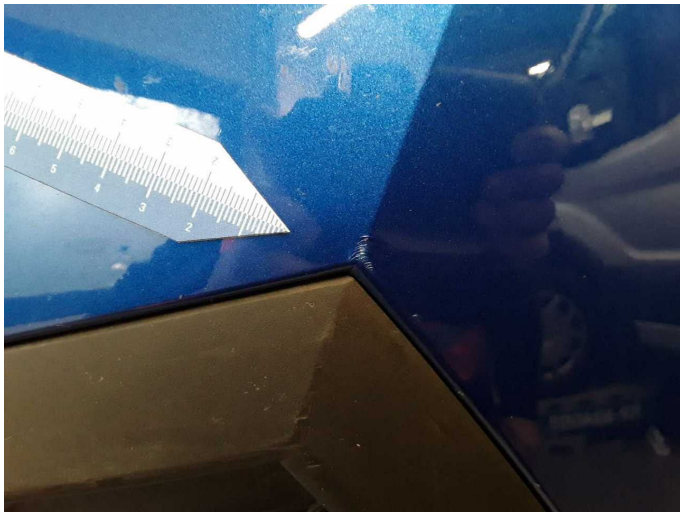
Damage 16: Front bumper: Front bumper - Dent / paintcoat damage - Repair and paint

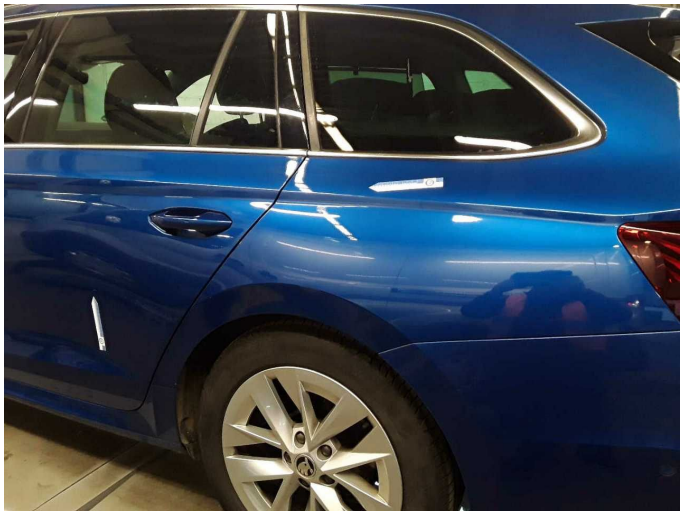
Damage 17: Side panel - rear left side: Side panel - Scratch(es) - Paint

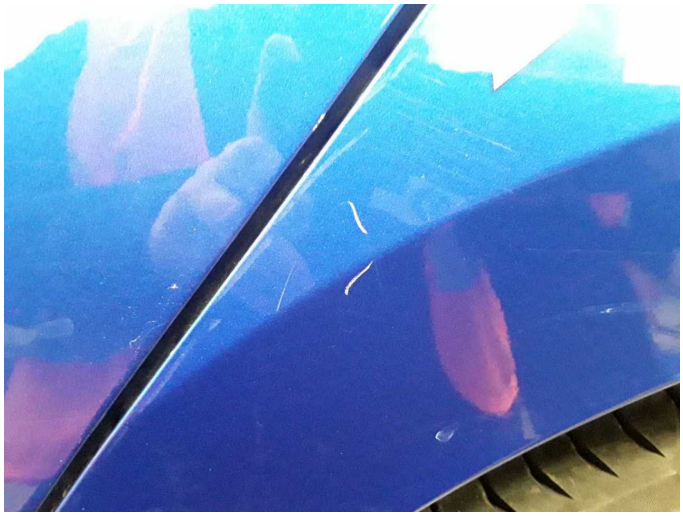
Damage 17: Side panel - rear left side: Side panel - Scratch(es) - Paint
