Expertise

Protocol number: 48306083
Order No. / Reference: 27170270
Inspection date: 22 Oct 2026

Manufacturer: Volkswagen	Model: Golf 2.0 TDI SCR DSG Life
VIN: WVWZZZCD8PW140370

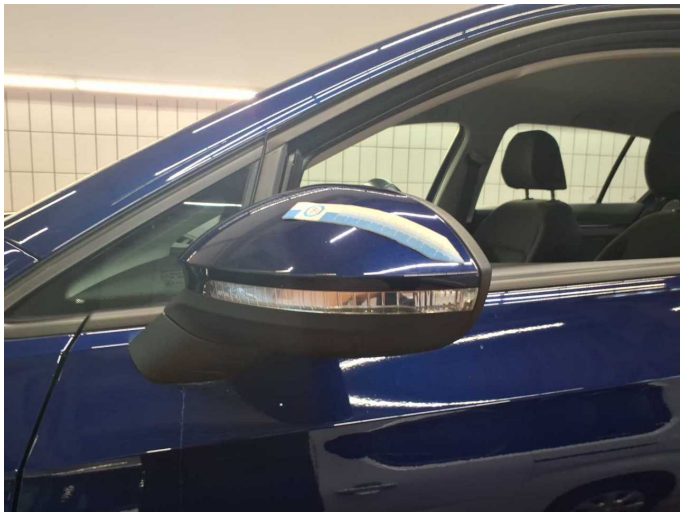
Damage 1: Wing mirror - right side: Cap - Scratch(es) - Smart repair

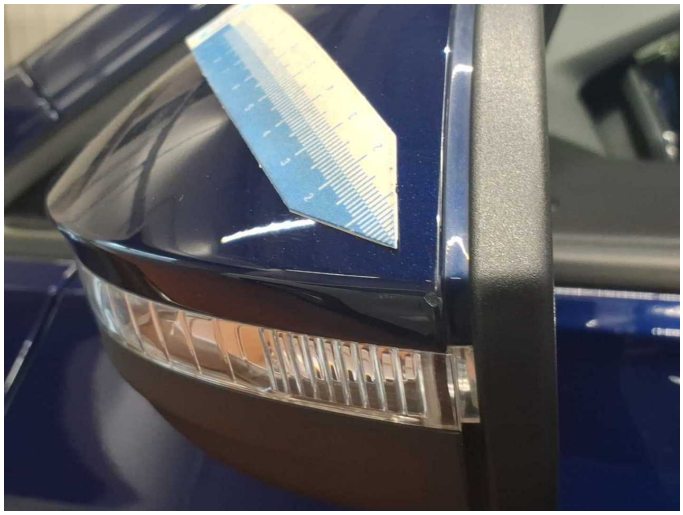
Damage 2: Wing mirror - left side: Cap - Scratch(es) - Smart repair

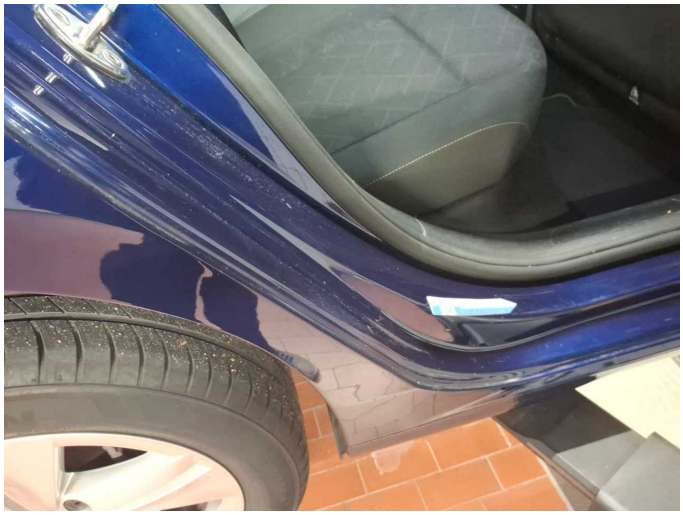
Damage 3: Side panel - rear right side: Sill - Scratch(es) - Smart repair

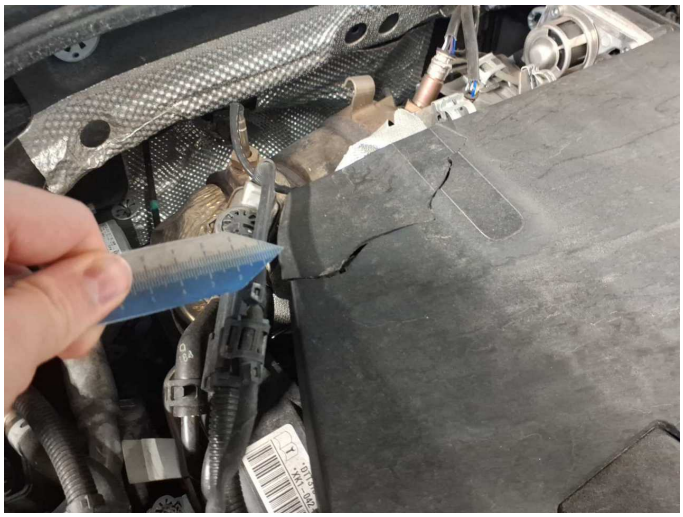
Damage 4: Engine: Engine cover - Broken / torn - Replace

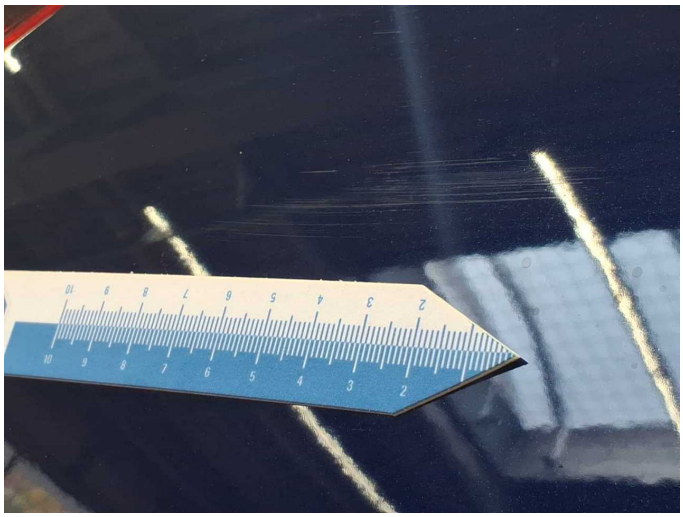
Damage 7: Boot lid / rear door: Boot lid - Scratch(es) - Paint

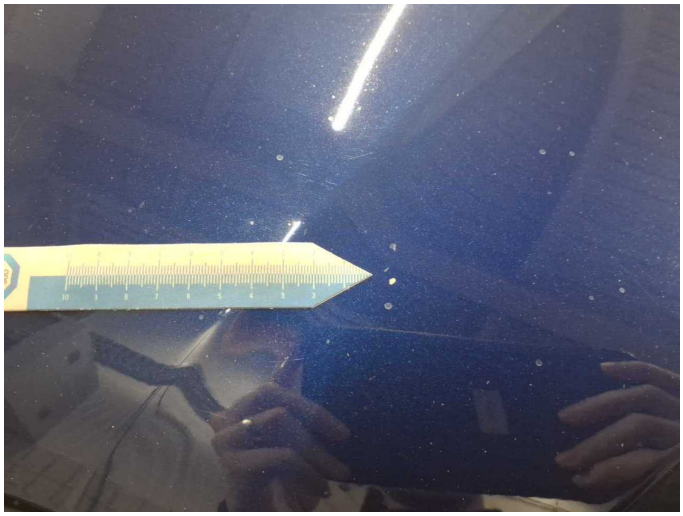
Damage 8: Bonnet: Bonnet - Stone chips - Paint

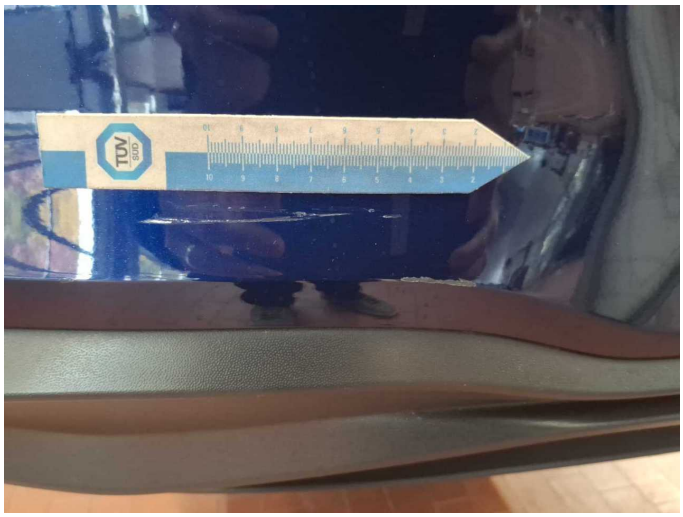
Damage 9: Rear bumper: Rear bumper - Scratch(es) - Paint

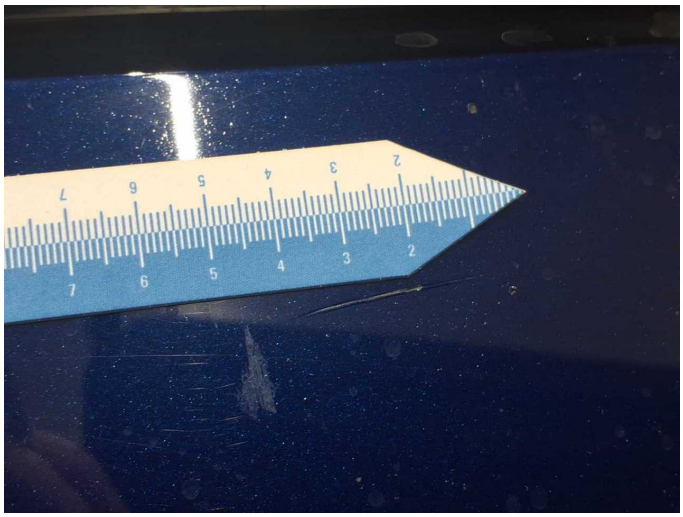
Die beigefügte Reparaturkostenkalkulation wurde nach bestem Wissen und Gewissen unter eingeschränkten Besichtigungsbedingung im demontagefreien Zustand erstellt. Es können aufgrund verdeckter Beschädigung, Mehrkosten und somit Abweichung der für die Stoßstange ausgewiesenen Reparaturkosten nicht ausgeschlossen werden.

Damage 10: Front bumper: Front bumper (+ Blende Vorne Rechts Erneuern) - Scratch(es) - repair according to calculation
