Expertise

Protocol number: 48184968
Order No. / Reference: 27134610
Inspection date: 12 Oct 2026

Manufacturer: Volkswagen	Model: Tiguan 2.0 TDI SCR 4MOTION DSG R-Line
VIN: WVGZZZ5NZNW529187

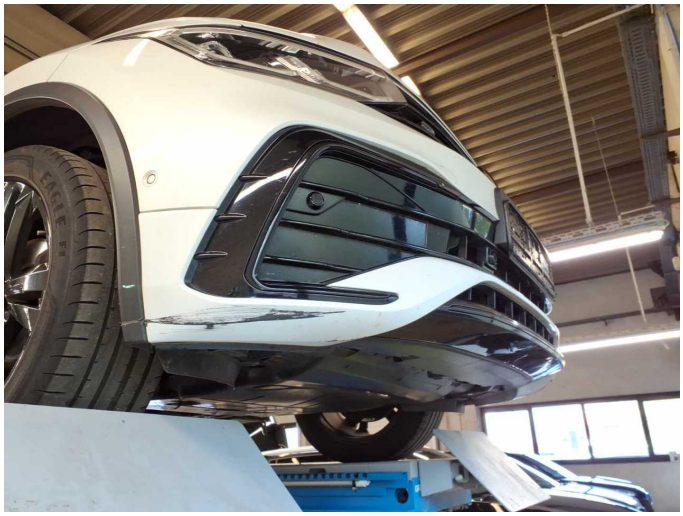
Damage 5: Mudguard - right side: Wheel well extension - Scratched - Replace

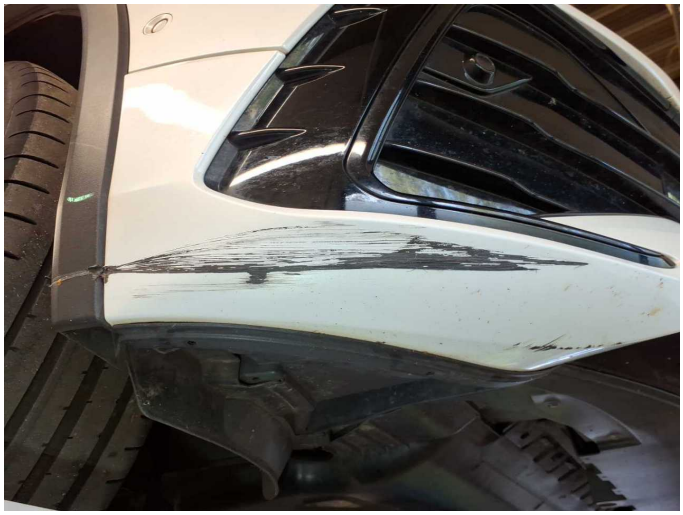
Damage 6: Front bumper: Front bumper - Scratched - Repair and paint

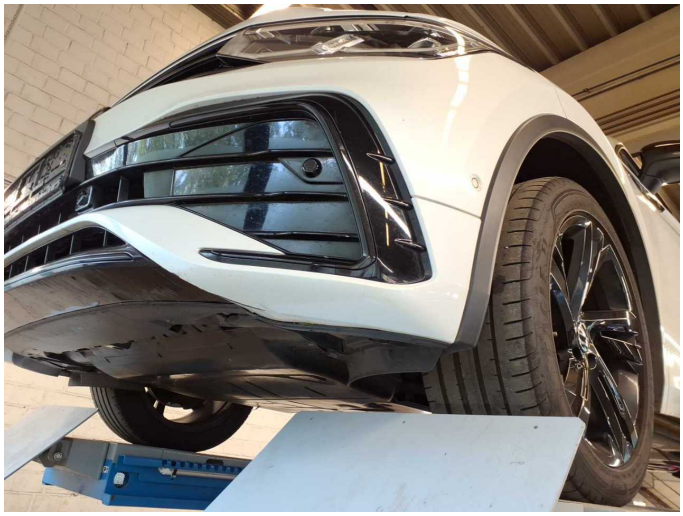
Damage 6: Front bumper: Front bumper - Scratched - Repair and paint
