Expertise

Protocol number: 48439674
Order No. / Reference: 27217260
Inspection date: 28 Oct 2026

Manufacturer: Ford	Model: Transit 350 L4 VA Trend Kofferaufbau mit Ladebordwand
VIN: WF0AXXTTRAMD38626

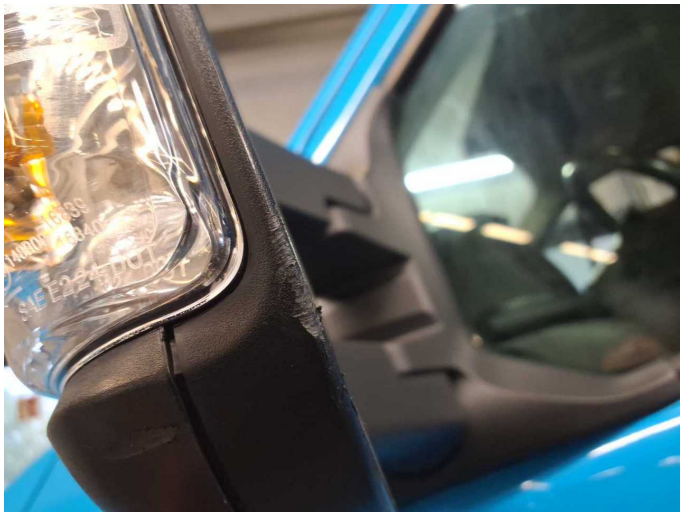
Damage 5: Wing mirror - left side: Chassis (Materialabtrag) - Scratched - Loss in value

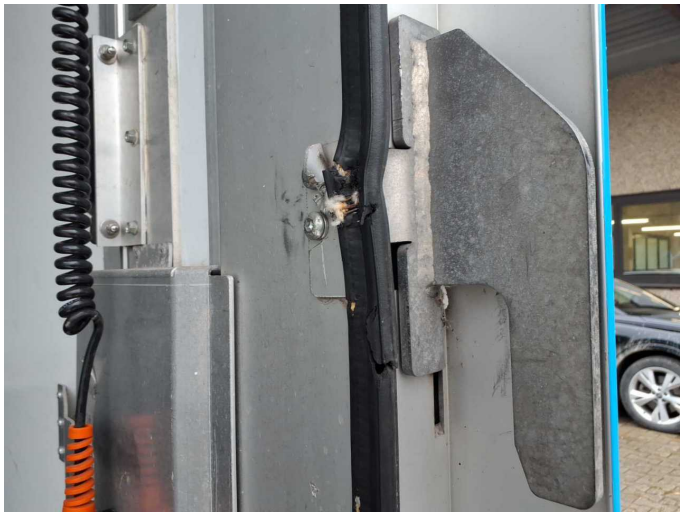
Damage 6: Boot lid / rear door: Seal (Links/rechts) - Broken / torn - Replace

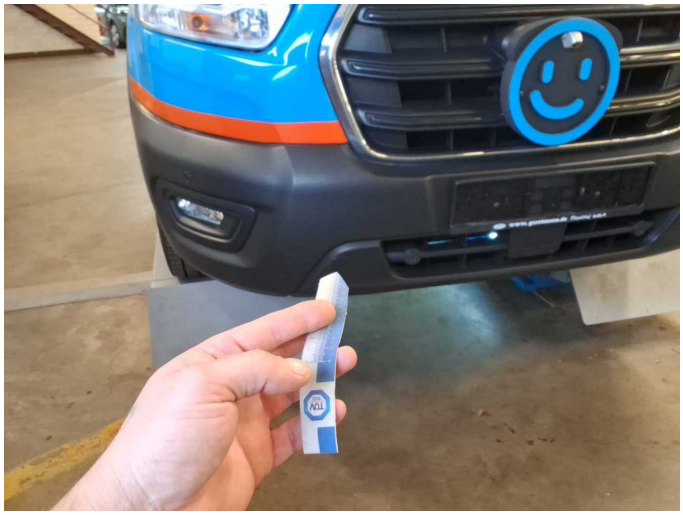
Damage 7: Misc.: Inspection / maintenance - Due - Perform

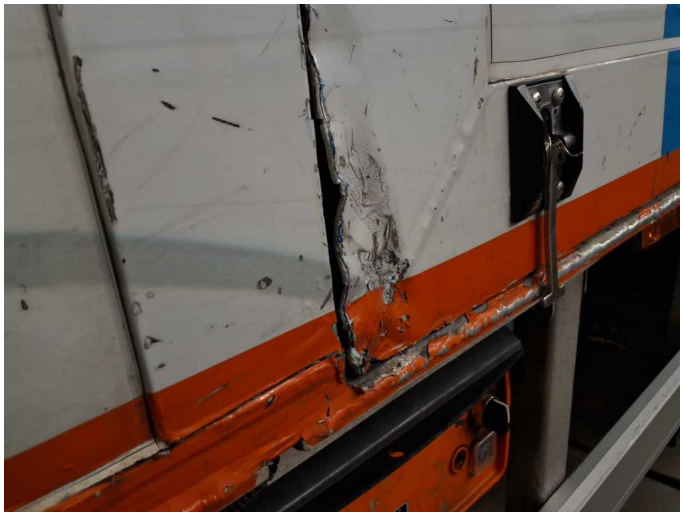
Damage 9: Boot lid / rear door: Boot lid (Oberteil) - Broken / torn - Repair and paint

Damage 11: Door - rear right side: Door - Deformed - Repair and paint

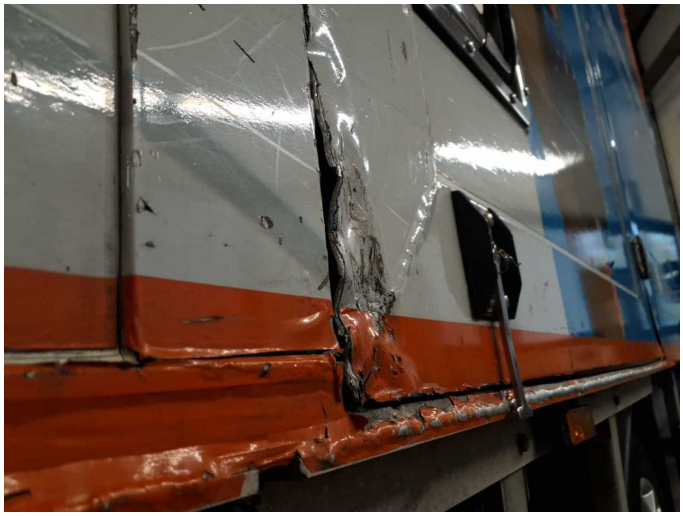
Damage 11: Door - rear right side: Door - Deformed - Repair and paint
