AUDI Q4 SPORTBACK E-TRON

Vehicle information

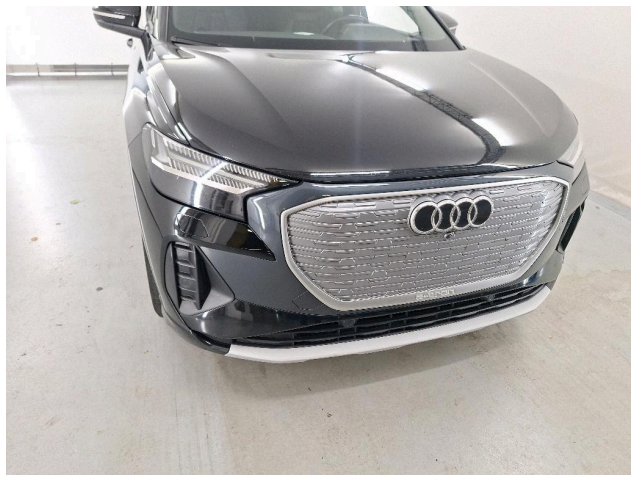
Bodywork
Damaged
Acceptable
Roof & others

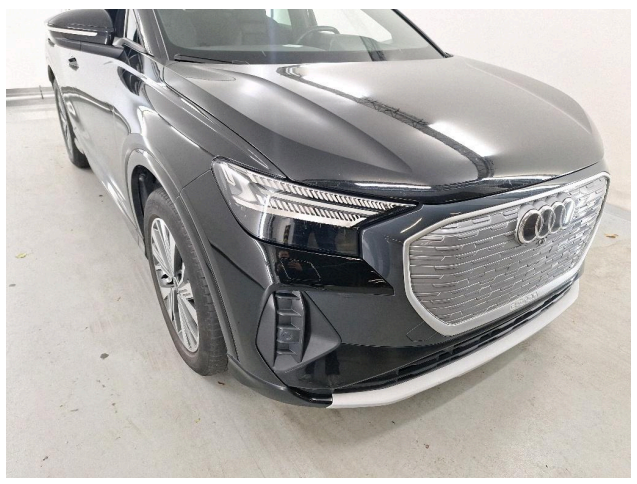
Bumper F
Dent(s) and scratch(es)
Paint
Front

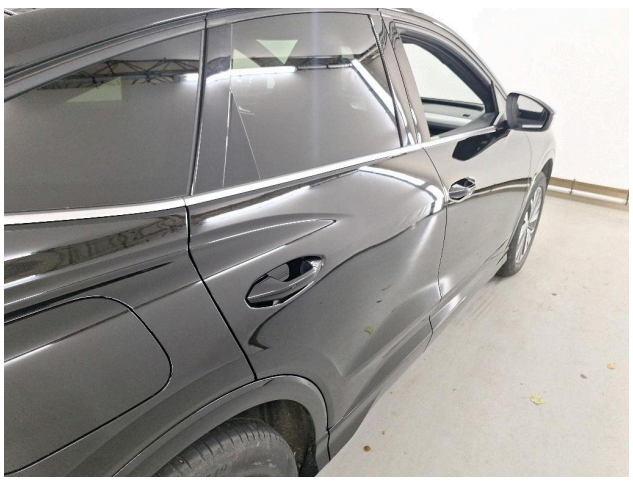
Door RR
Repaired
No repair
Right

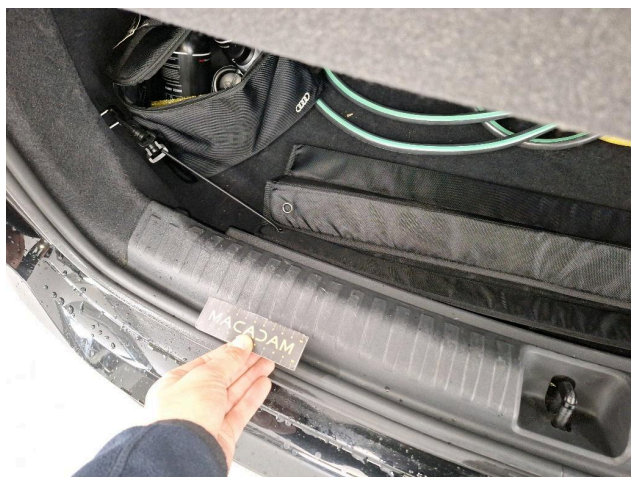
Interior
Damaged
Acceptable
Interior
