Expertise

Protocol number: 48517847
Order No. / Reference: 27256920
Inspection date: 5 Nov 2026

Manufacturer: Polestar	Model: 2 Long Range Dual Motor 78kWh
VIN: YSMVSEDE1PL133401

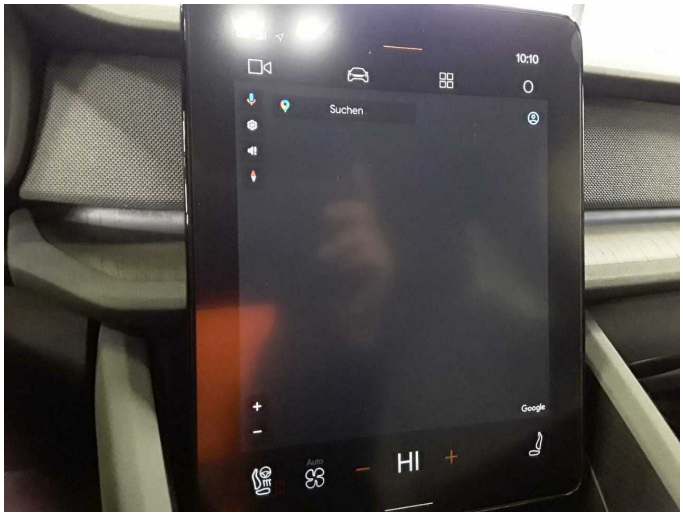
Figure 19: Navigation

No.	Component group	Description
1	Multimedia system	Navigation system (o. Fkt., Mehrkosten möglich) - Electrical fault - Perform diagnosis
2	Side panel - rear left side	Side panel - Scratch(es) - Smart repair
3	Sill - left side	Sill - Dent / paintcoat damage - Smart repair

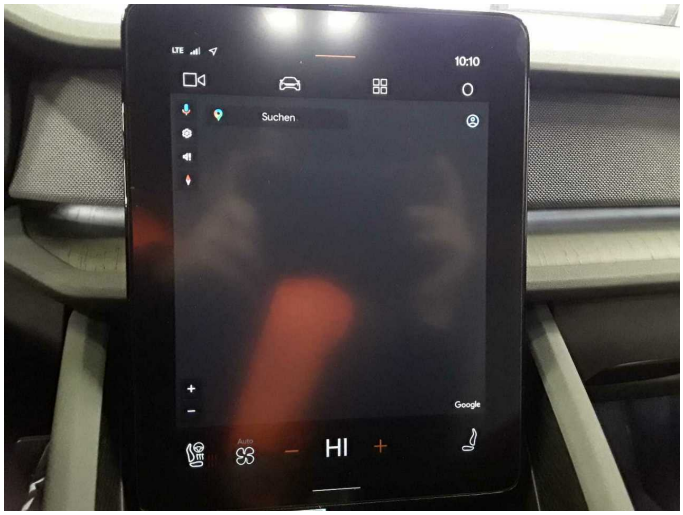
Damage 1: Multimedia system: Navigation system (o. Fkt., Mehrkosten möglich) - Electrical fault - Perform diagnosis
