Expertise

Protocol number: 48054639
Order No. / Reference: 26981579
Inspection date: 23 Sept 2026

Manufacturer: Volvo	Model: V60 B4 D Geartronic Momentum Pro
VIN: YV1ZWK5VDN2495893

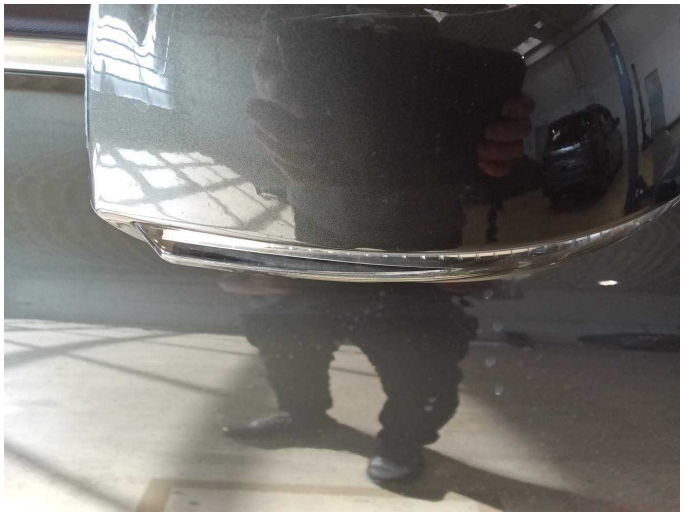
Damage 5: Door - front right side: Door - Scratch(es) - Smart repair

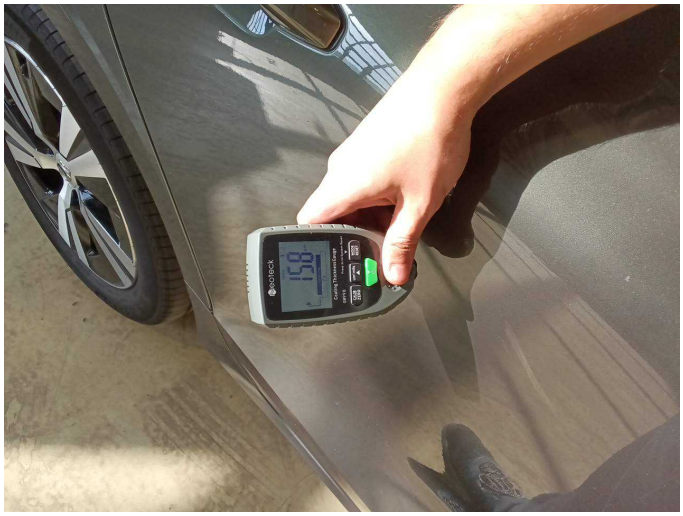
Damage 9: Front bumper: Bumper - front right side - Scratched - Paint
