Expertise

Protocol number: 48070453
Order No. / Reference: 27108796
Inspection date: 12 Oct 2026

Manufacturer: Skoda	Model: Kodiaq 2.0 TSI 4x4 DSG RS
VIN: TMBLU7NS4P8048066

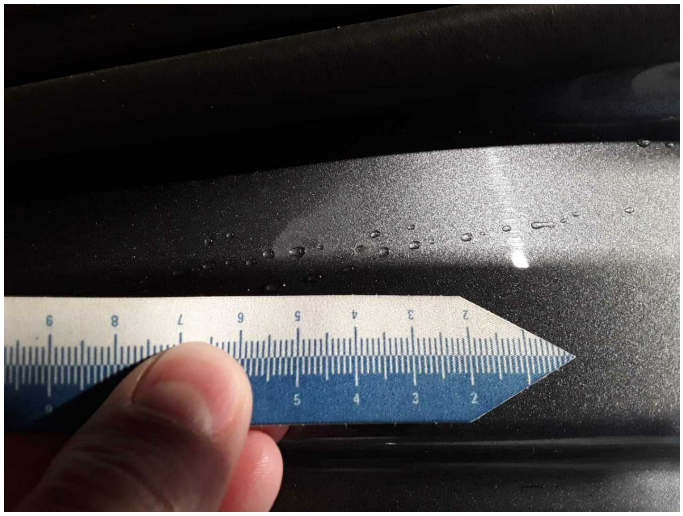
Damage 2: Trim / covers: Floor mats - Damaged - Replace

Damage 3: Side panel - rear left side: Sill - Scratch(es) - Smart repair

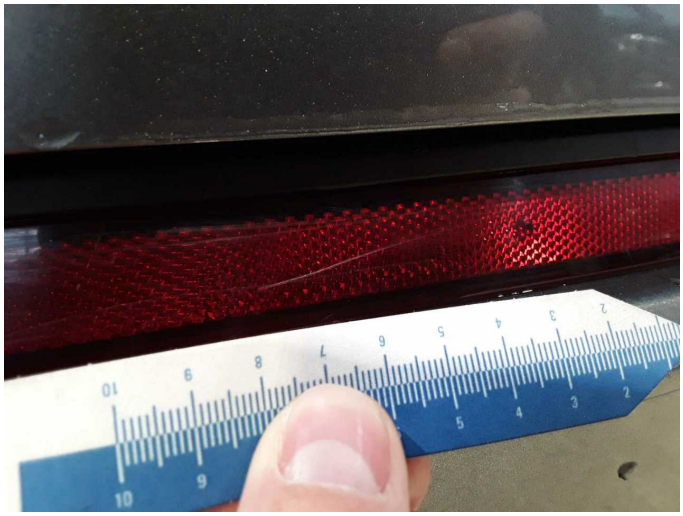
Damage 5: Boot lid / rear door: Boot lid - Dent / paintcoat damage - Smart repair

Damage 6: Boot lid / rear door: Reflectors - Scratch(es) - Replace

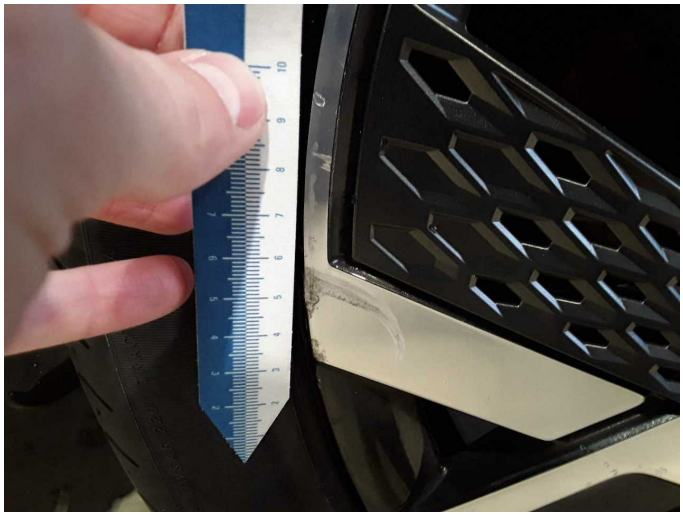
Damage 8: Trim / covers: Carpet - front left side - Damaged - Replace

Damage 9: Wheel / tyres: Alloy rim - rear left side - Scratch(es) - Replace

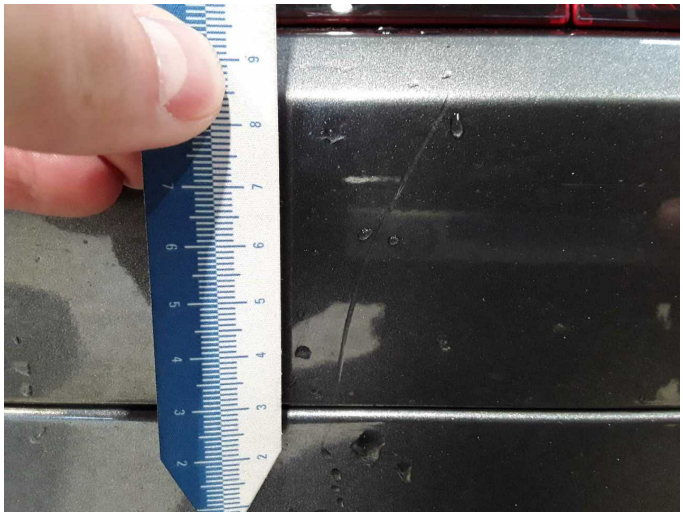
Damage 11: Side panel - rear right side: Side panel - Scratch(es) - Paint

Damage 12: Rear bumper: Rear bumper - Scratch(es) - Paint

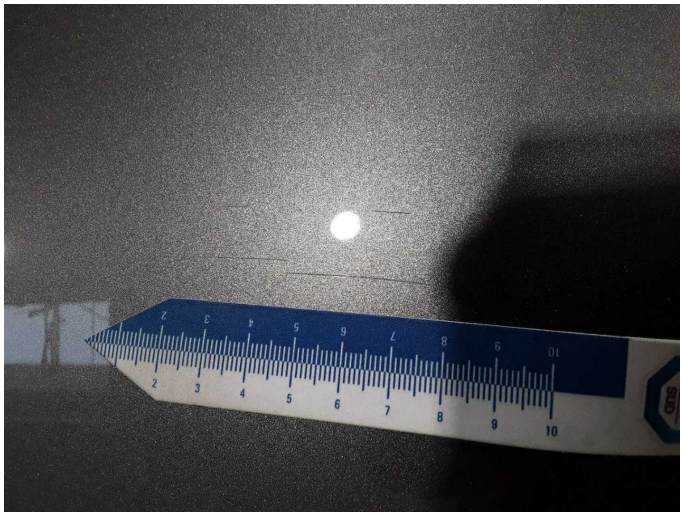
Damage 12: Rear bumper: Rear bumper - Scratch(es) - Paint

Damage 13: Bonnet: Bonnet - Scratch(es) - Paint

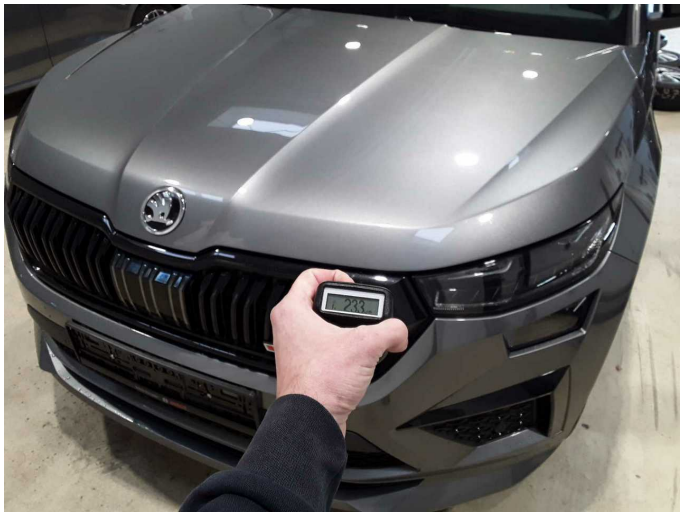
Bonnet	233 µm	Door - front left side	164 µm

Damage 13: Bonnet: Bonnet - Scratch(es) - Paint

Repainting 1: Bonnet

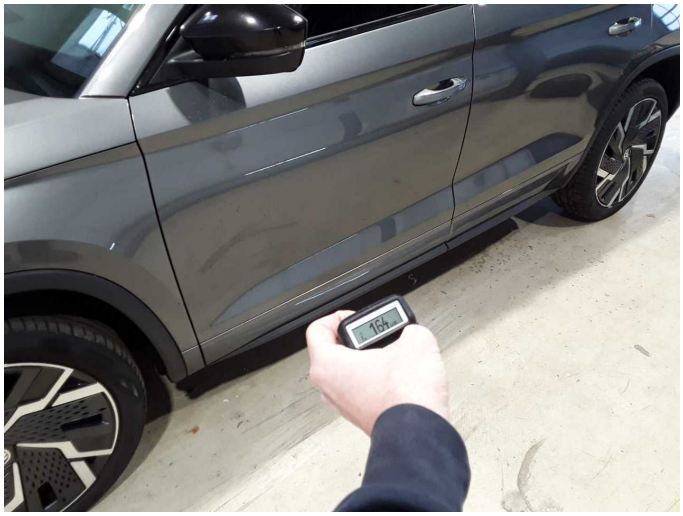
Repainting 1: Bonnet

Repainting 2: Door - front left side
