Expertise

Protocol number: 48504994
Order No. / Reference: 27252960
Inspection date: 3 Nov 2026

Manufacturer: Volvo	Model: XC40 B4 B AWD DKG Plus Bright
VIN: YV1XZK8V4P2028845

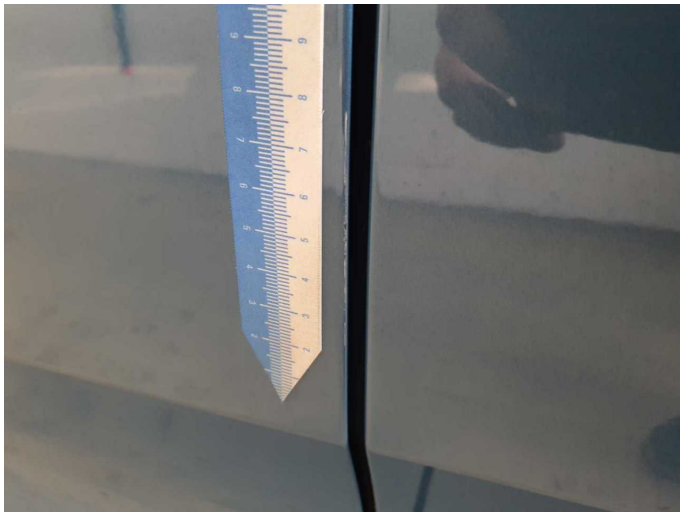
Damage 1: Door - front left side: Door edge - Scratch(es) - Smart repair

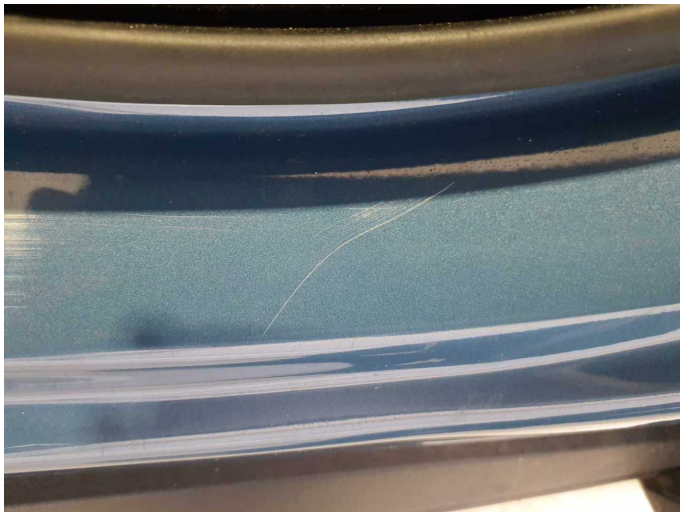
Damage 2: Side panel - rear left side: Side panel - dent(s) - Smooth repair work

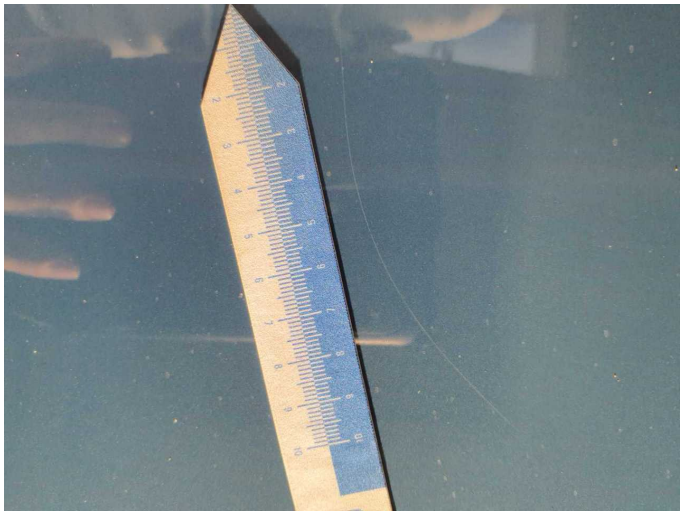
Damage 5: Roof: Roof (Anätzung) - Paint defect - Conditioning

Damage 6: Wheel / tyres: Alloy rim - rear right side - Scratch(es) - Loss in value

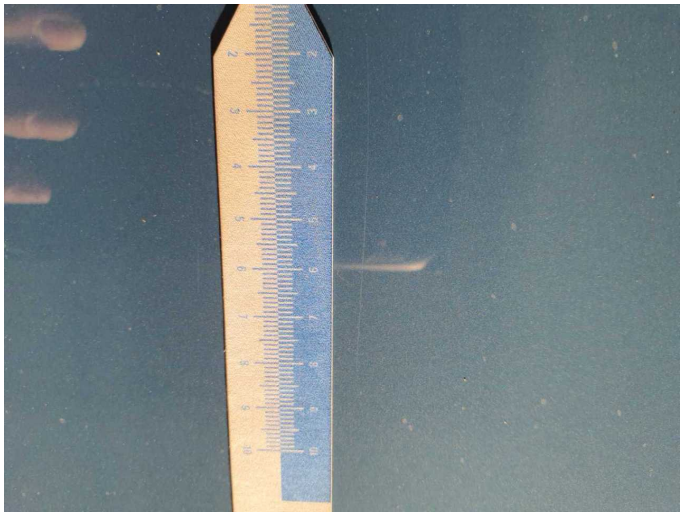
Damage 7: Bonnet: Bonnet - Scratch(es) - Paint
