Expertise

Protocol number: 48243492
Order No. / Reference: 27138057
Inspection date: 21 Oct 2026

Manufacturer: Mercedes-Benz	Model: GLE 350 de 4Matic 9G-TRONIC Exclusive
VIN: W1N1671171A733238

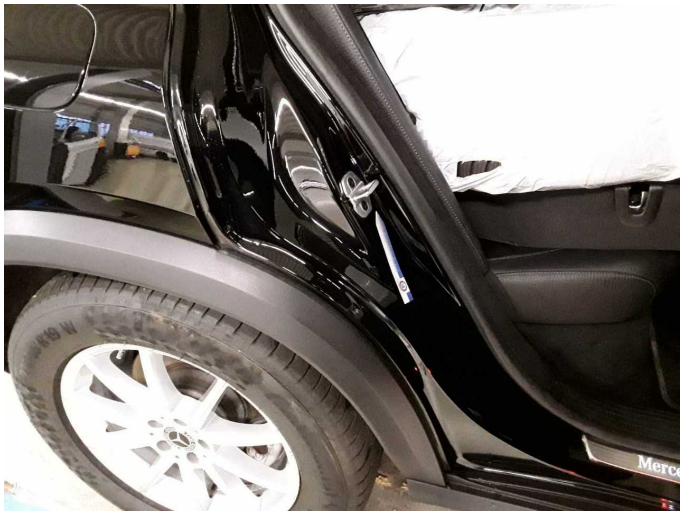
Damage 2: Side panel - rear left side: Sill - Scratch(es) - Smart repair
