Expertise

Protocol number: 48250619
Order No. / Reference: 27000585
Inspection date: 21 Oct 2026

Manufacturer: Skoda	Model: Kodiaq 2.0 TDI 4x4 DSG L&K
VIN: TMBLN7NS2N8041613

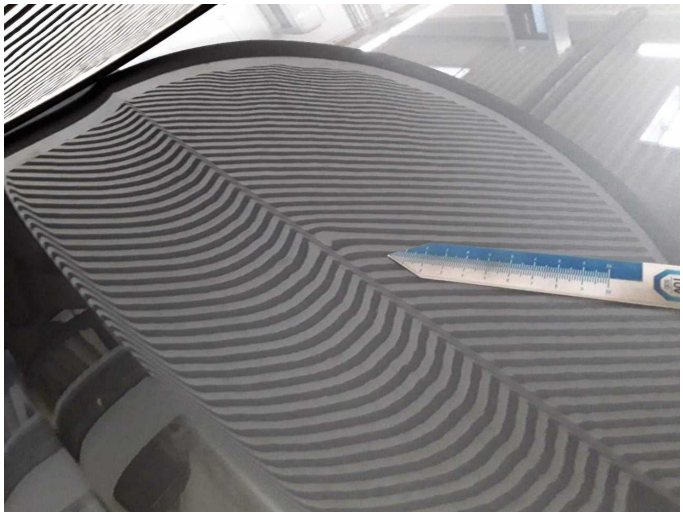
Damage 1: Bonnet: Bonnet - dent(s) - Smart repair

Damage 2: Engine: Engine cowling - lower - Broken / torn - Replace

Damage 3: Door - rear left side: Door - Dent / paintcoat damage - Smart repair

Damage 4: Braking system: Brake discs and pads - rear - Worn - Replace

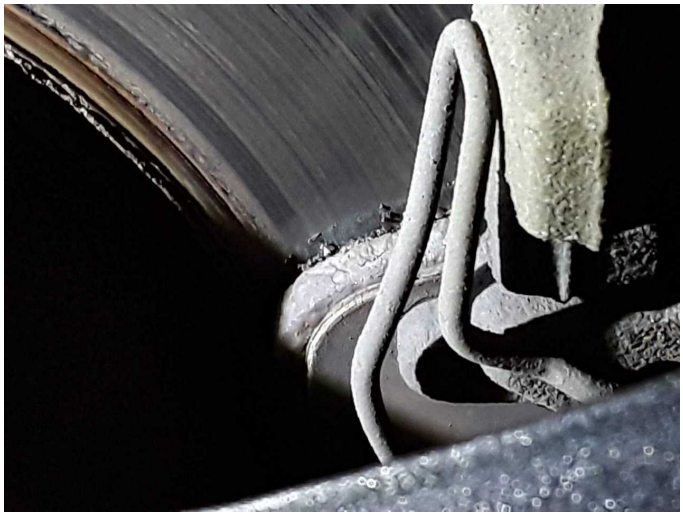
Damage 4: Braking system: Brake discs and pads - rear - Worn - Replace

Damage 5: Rear bumper: Bumper with Parktronic - Scratch(es) - Paint

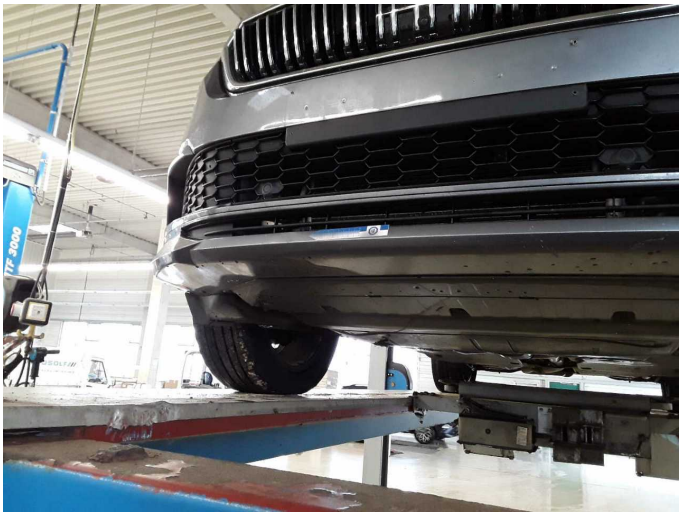
Damage 5: Rear bumper: Bumper with Parktronic - Scratch(es) - Paint

Damage 6: Front bumper: Spoiler - Deformed - Replace

Damage 7: Side panel - rear left side: Side panel - dent(s) - Repair and paint
