MACADAM

BYD Atto 3 '22 BEV

Vehicle information

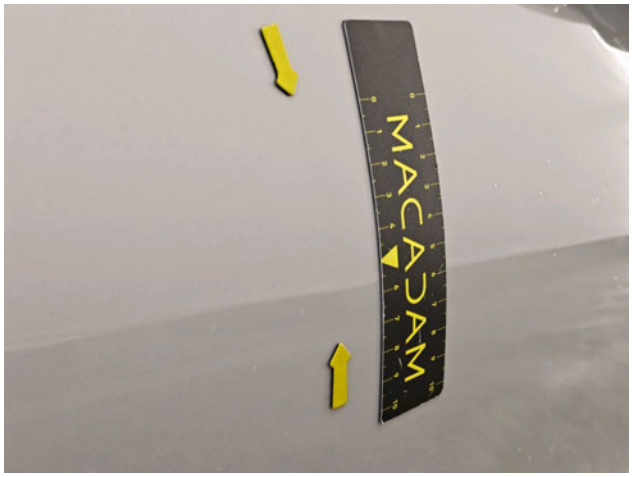
Alloy rim FR
Scratch(es)
Repair and paint (complete)
Right

Bonnet
Chemical polution
Repair and paint (complete)
Front

Boot lid covering R
Scratch(es)
Smart repair
Rear

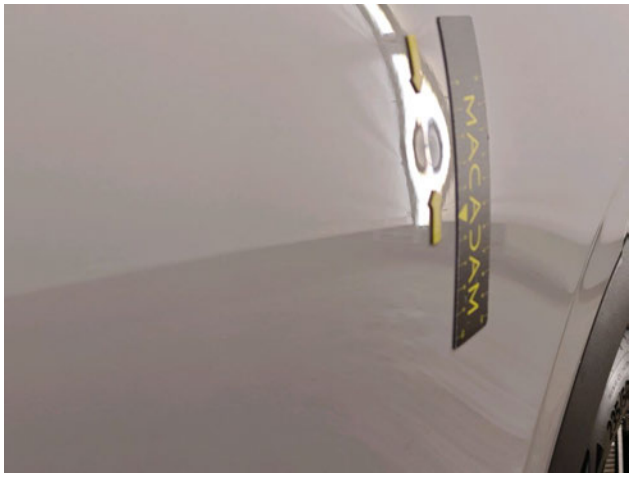
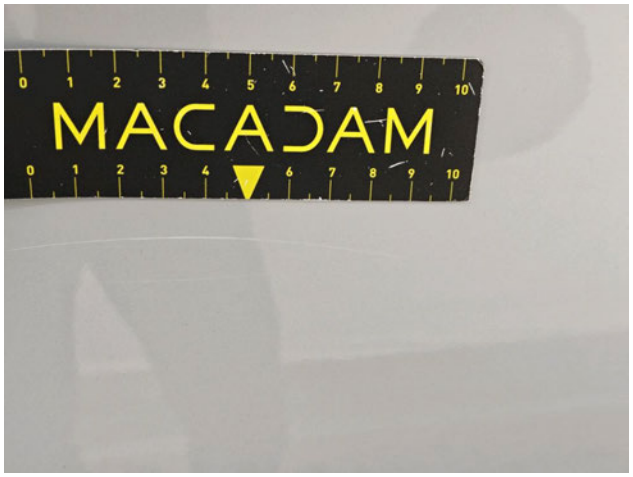
Bumper moulding F
Scratch(es)
Replace and paint
Front

Door FL
Dent(s) and scratch(es)
Repair and paint (complete)
Left

Door FR
Dent(s) and scratch(es)
Repair and paint (complete)
Right
