Expertise

Protocol number: 48410376
Order No. / Reference: 27154015
Inspection date: 21 Oct 2026

Manufacturer: Mercedes-Benz	Model: GLC-Coupe 200 4Matic 9G-TRONIC Avantgarde Advanced
VIN: W1NKJ5BBXRF099866

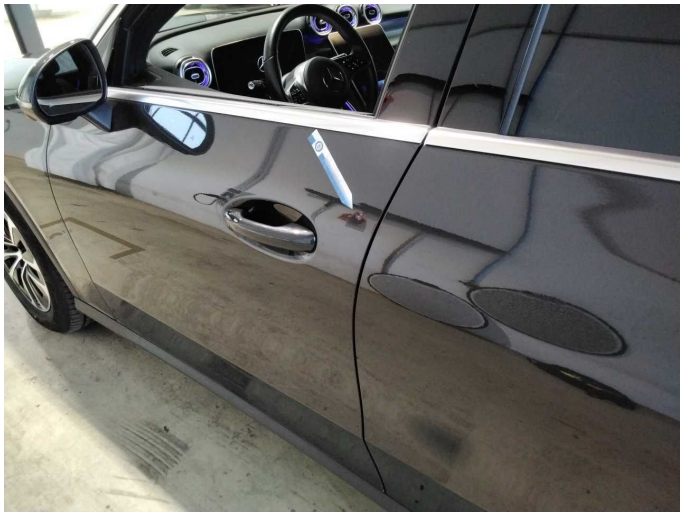
No.	Component group	Description
1	Sill - left side	Sill - Scratch(es) - Smart repair
2	Side panel - rear right side	Sill - Scratch(es) - Smart repair
3	Door - front left side	Door - Dent / paintcoat damage - Paint

Damage 3: Door - front left side: Door - Dent / paintcoat damage - Paint
