Expertise

Protocol number: 48439589
Order No. / Reference: 27175875
Inspection date: 2 Nov 2026

Manufacturer: Volkswagen	Model: ID.4 4Motion GTX
VIN: WVGZZZE2ZPE020896

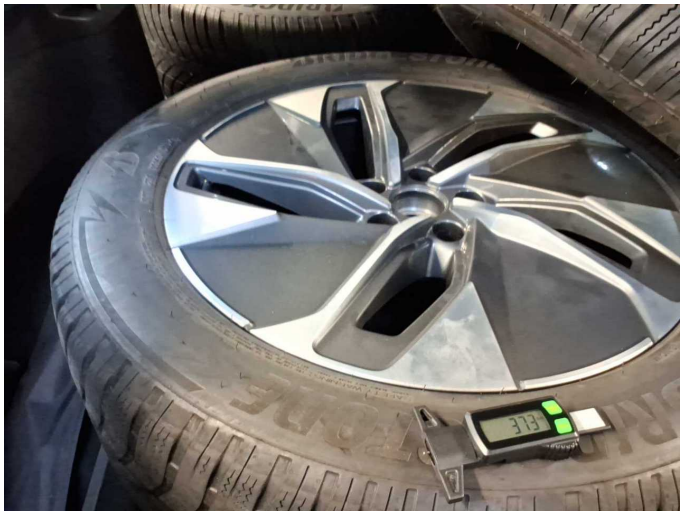
No.	Component group	Description
1	Door - front left side	Door edge - Scratch(es) - Smart repair
2	2nd wheel set	1 tyre - Does not meet the leasing specifications - Replace
3	2nd wheel set	1 tyre - Does not meet the leasing specifications - Replace

Damage 2: 2nd wheel set: 1 tyre - Does not meet the leasing specifications - Replace
