2CHT824

INSPECTION REPORT

End of contract

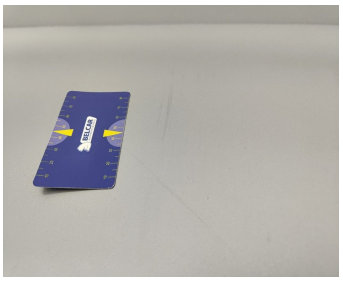
Front Bonnet // Polish-scratch

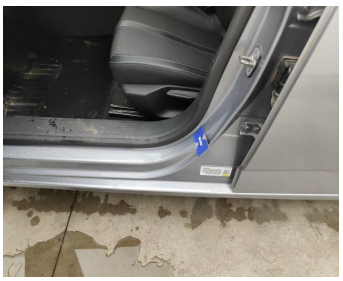
Door Front Left // Smart Repair Small-scratch
