TÜV SÜD Auto Partner GmbH
Wiesenring 2
04159 Leipzig

Expertise

Protocol number: 48197210
Order No. / Reference: 26850366
Inspection date: 15 Oct 2026

Manufacturer: Volkswagen	Model: Tiguan Allspace 2.0 TDI SCR DSG Life
VIN: WVGZZZ5N3PM020148

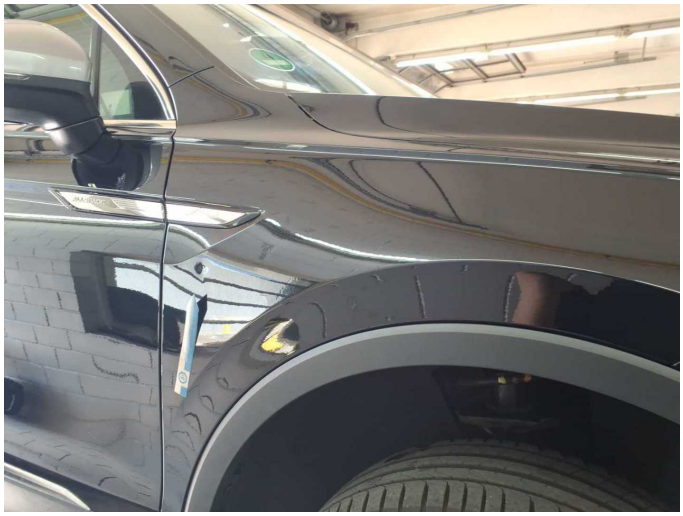
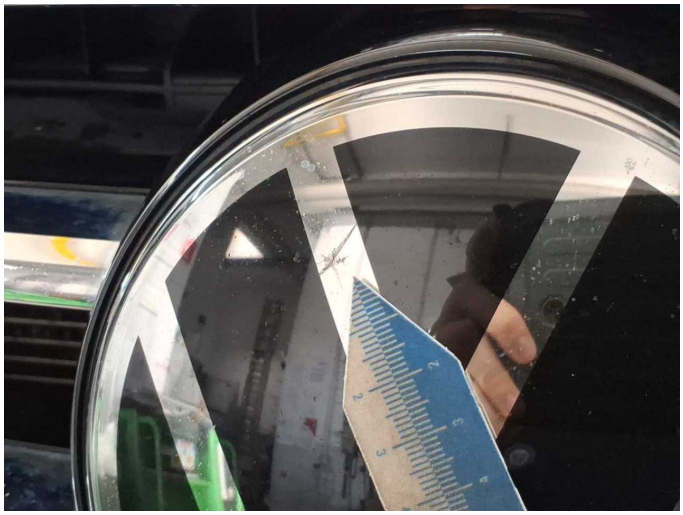
No.	Component group	Description
1	Mudguard - right side	Mudguard - right side - dent(s) - Smooth repair work
2	Front structure	Emblem - Broken / torn - Replace
3	Trim / covers	D-pillar - trim - interior, right side - Scratched - Replace
4	Rear bumper	Rear bumper - Scratch(es) - Paint

Damage 1: Mudguard - right side: Mudguard - right side - dent(s) - Smooth repair work

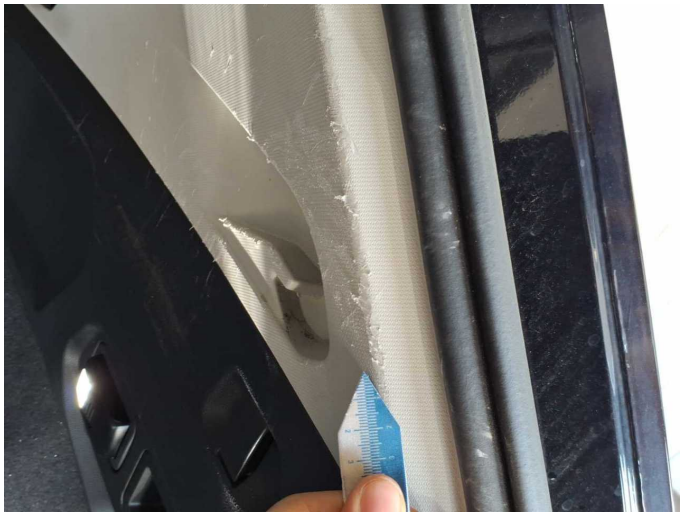
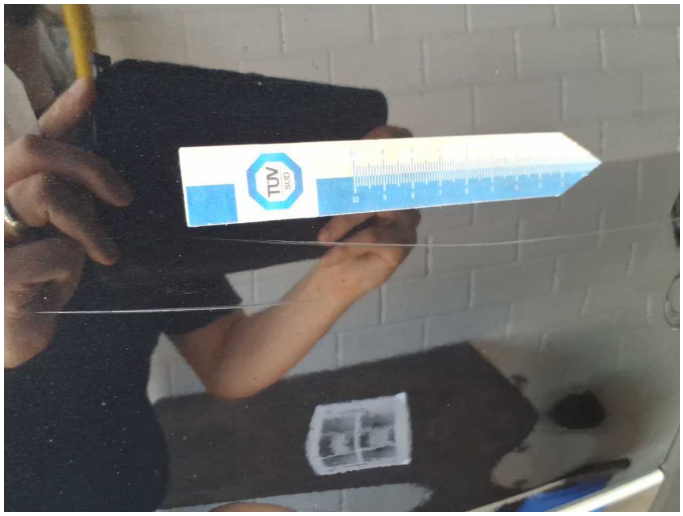
Damage 3: Trim / covers: D-pillar - trim - interior, right side - Scratched - Replace

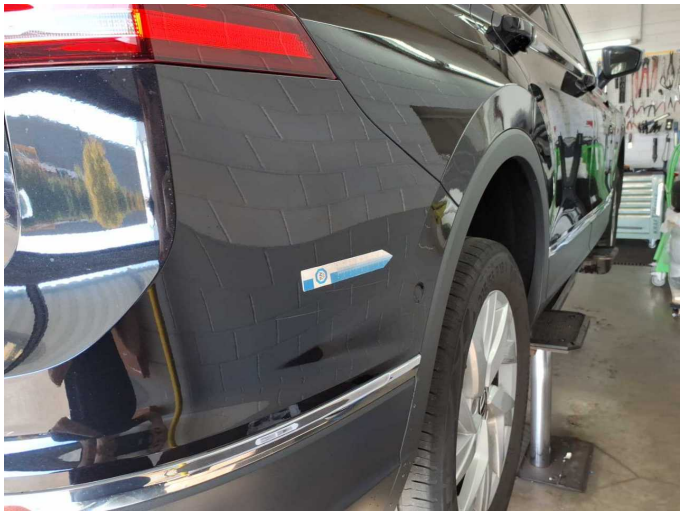
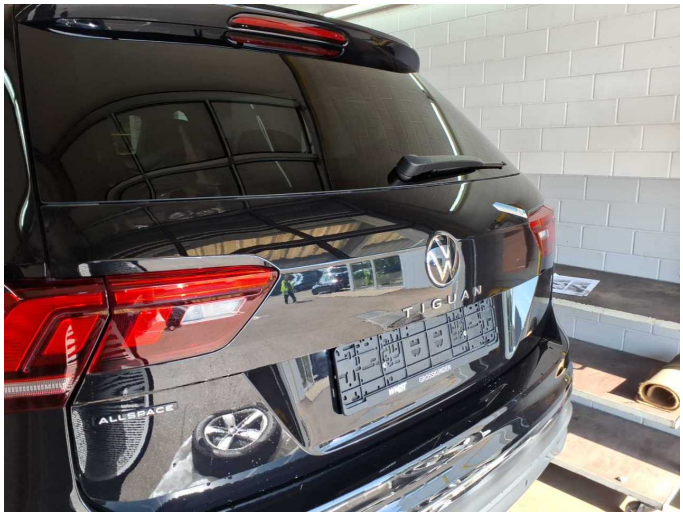
Damage 4: Rear bumper: Rear bumper - Scratch(es) - Paint
