Expertise

Protocol number: 47789798
Order No. / Reference: 26942042
Inspection date: 25 Sept 2026

Manufacturer: Volkswagen	Model: Passat Variant 2.0 TDI SCR DSG Business
VIN: WVWZZZ3CZNE039797

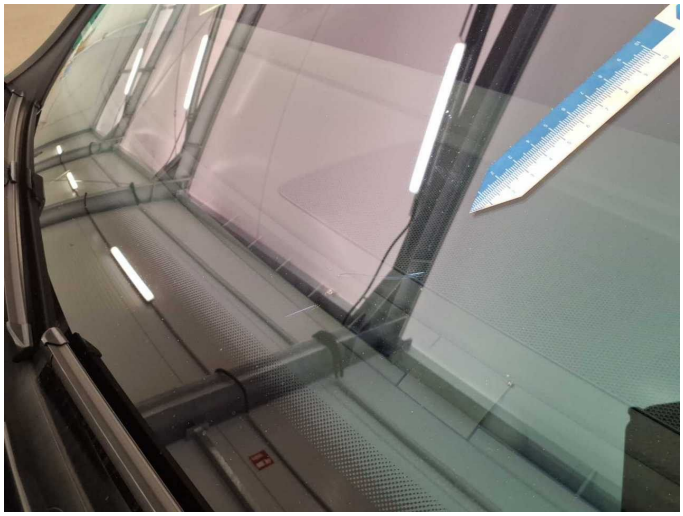
Damage 3: Vehicle glazing: Windscreen (Mit Rissbildung) - Stone chips - Replace

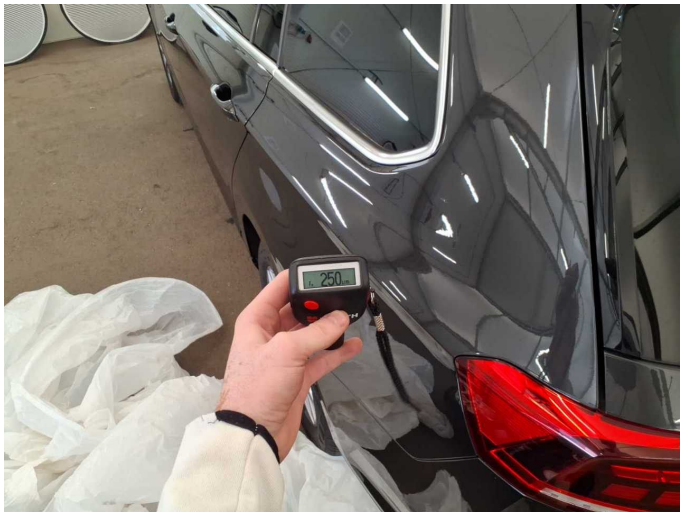
No.	Repainting
1	Side panel - rear left side

Repainting 1: Side panel - rear left side
