Expertise

Protocol number: 48493515
Order No. / Reference: 27049068
Inspection date: 22 Oct 2026

Manufacturer: Opel	Model: Insignia Sports Tourer 2.0 Diesel Aut. Ultimate
VIN: W0VZS8GP7N1048136

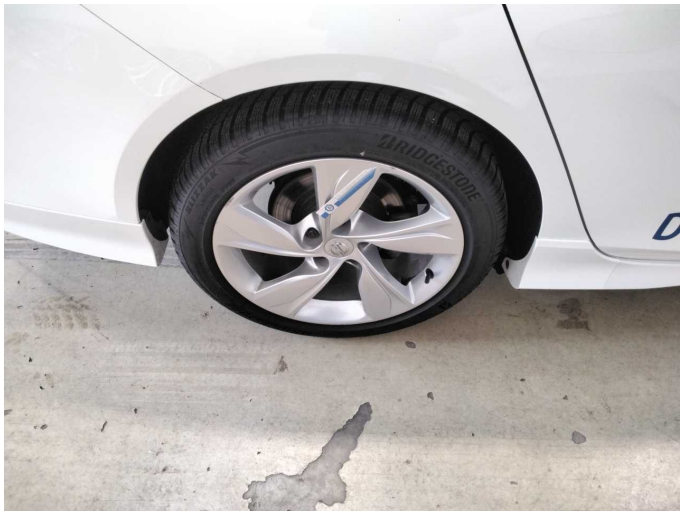
No.	Component group	Description
1	Wing mirror - right side	Cap - Scratch(es) - Smart repair
2	Rear bumper	Rear bumper - Scratch(es) - Smart repair
3	Wheel / tyres	Alloy rim - rear right side - Scratch(es) - Loss in value
4	Wheel / tyres	Alloy rim - front right side - Scratch(es) - Loss in value
5	Body	Body - Glued / labelled - De-glue / neutralise
6	2nd wheel set	1 alloy rim - Scratch(es) - Replace
7	2nd wheel set	1 alloy rim - Scratch(es) - Replace
8	2nd wheel set	1 alloy rim - Scratch(es) - Replace

Damage 2: Rear bumper: Rear bumper - Scratch(es) - Smart repair

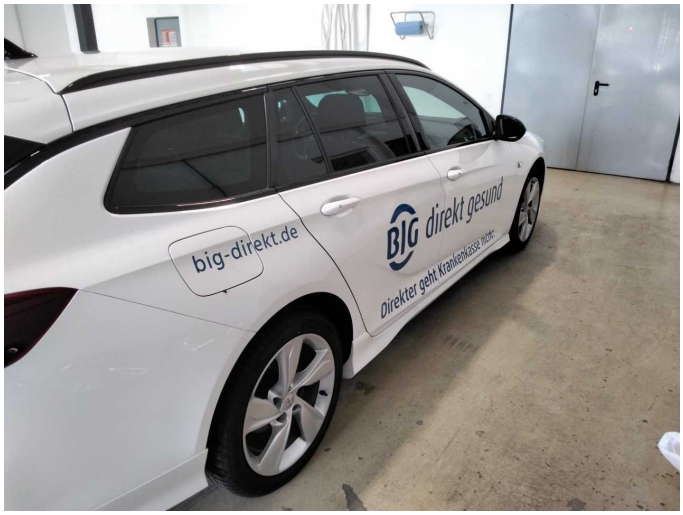
Damage 5: Body: Body - Glued / labelled - De-glue / neutralise
