Expertise

Protocol number: 48232157
Order No. / Reference: 27119350
Inspection date: 21 Oct 2026

Manufacturer: Skoda	Model: Octavia Combi 2.0 TDI DSG Tour
VIN: TMBJJ8NX8PY116631

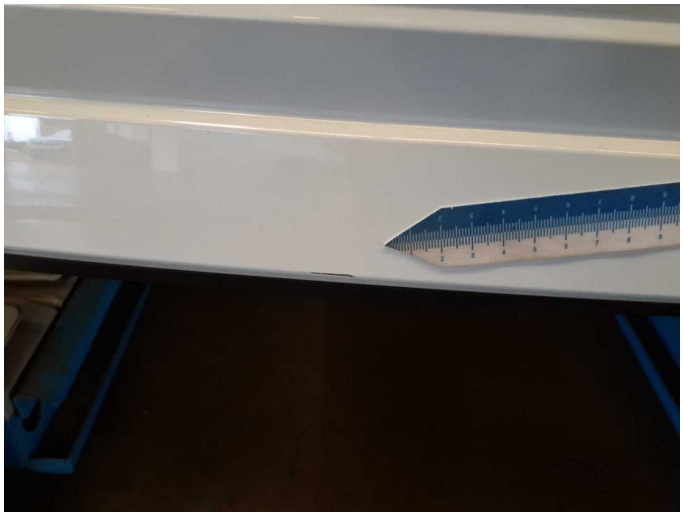
No.	Component group	Description
1	Misc.	Inspection / maintenance - No evidence - No deduction
2	Braking system	Brake fluid - No evidence - No deduction
3	Rear bumper	Rear bumper - Scratch(es) - Paint

Damage 3: Rear bumper: Rear bumper - Scratch(es) - Paint
