Expertise

Protocol number: 48476106
Order No. / Reference: 27216113
Inspection date: 30 Oct 2026

Manufacturer: Ford	Model: Kuga 2.5 Duratec PHEV COOL&CONNECT
VIN: WF0FXXWPMHPD64219

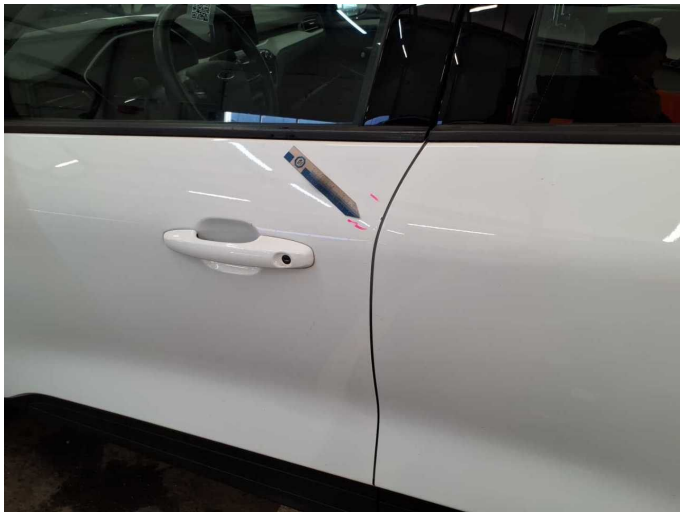
Damage 2: Door - front left side: Door edge - Scratch(es) - Smart repair

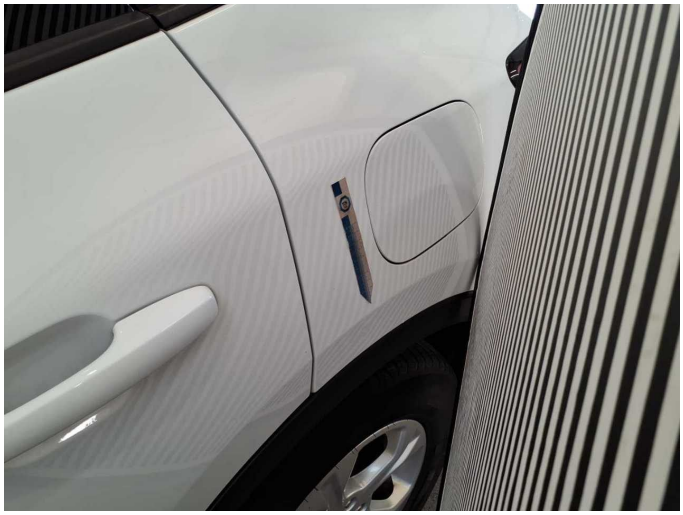
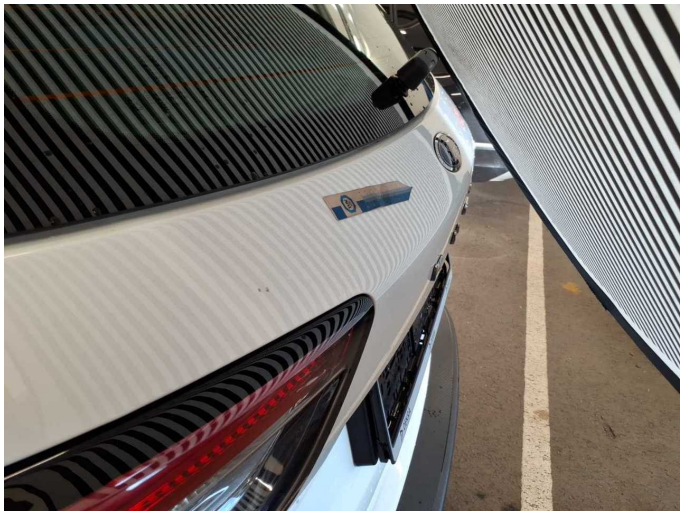
Damage 4: Side panel - rear left side: Side panel - dent(s) - Smooth repair work

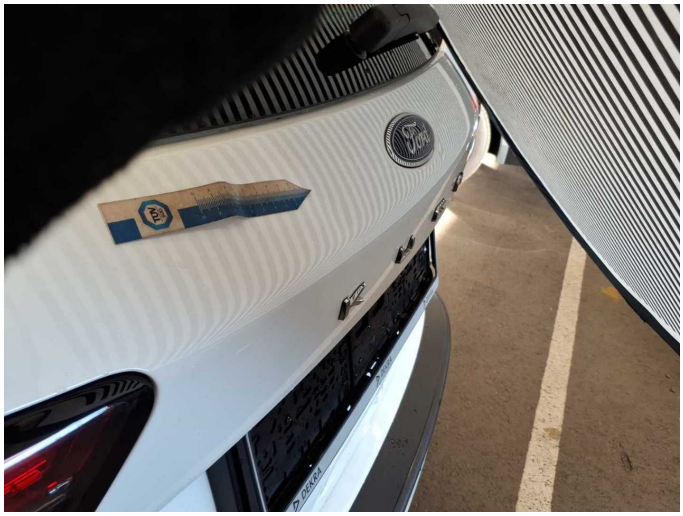
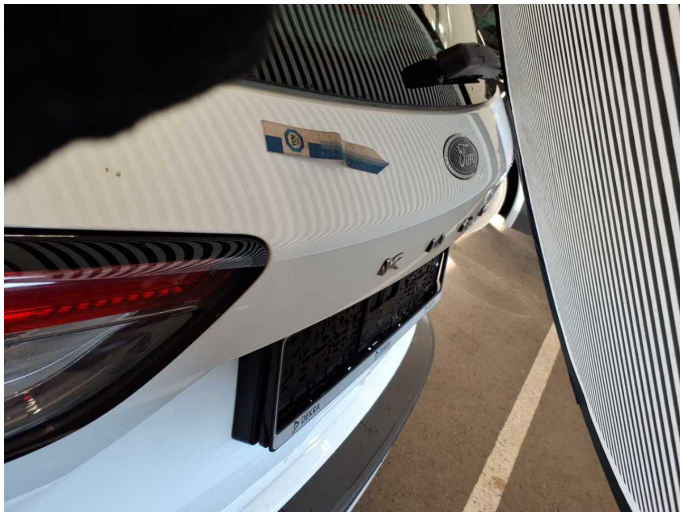
Damage 5: Boot lid / rear door: Boot lid - dent(s) - Smooth repair work

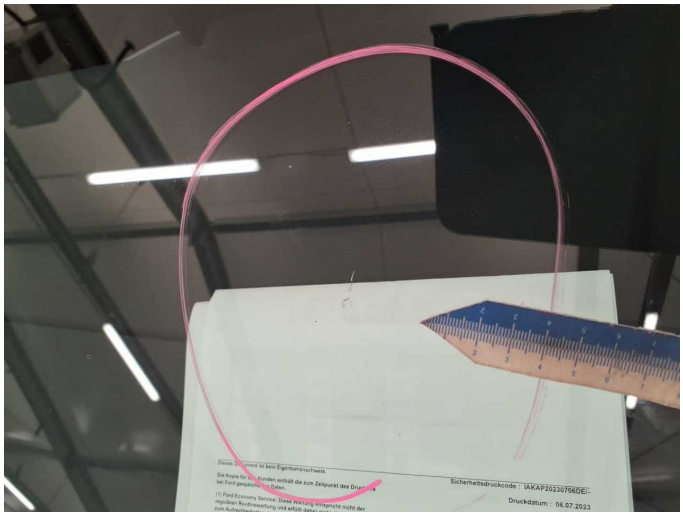
Damage 10: Vehicle glazing: Windscreen (Mit Rissbildung) - Stone chips - Replace
