TÜV SÜD Auto Partner GmbH
Wiesenring 2
04159 Leipzig

Expertise

Protocol number: 48357875
Order No. / Reference: 26859474-1
Inspection date: 27 Oct 2026

Manufacturer: Volkswagen	Model: Golf Variant 2.0 TDI SCR DSG Style
VIN: WVWZZZCDZMW520984

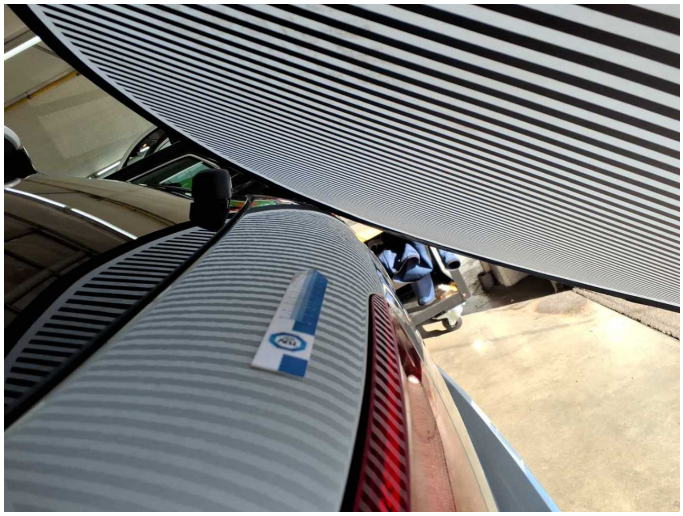
No.	Component group	Description
1	Front bumper	Front bumper - Scratch(es) - No deduction
2	2nd wheel set	Alloy rim set - complete - Scratch(es) - No deduction
3	Boot lid / rear door	Boot lid - dent(s) - No deduction
4	Trim / covers	Boot lid - interior trim - Scratch(es) - No deduction
5	Sill - left side	Sill - Scratch(es) - No deduction

Wear and tear 3: Boot lid / rear door: Boot lid - dent(s) - No deduction
