Iveco DAILY 35S16V 2.3 410L H3, Double Cabin

ZCFC735B605364956 · lot Costs

VEHICLE DATA & SPECIFICATIONS

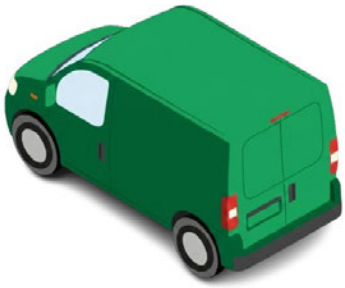
Interior — Moderate

Electrical

Check engine light!

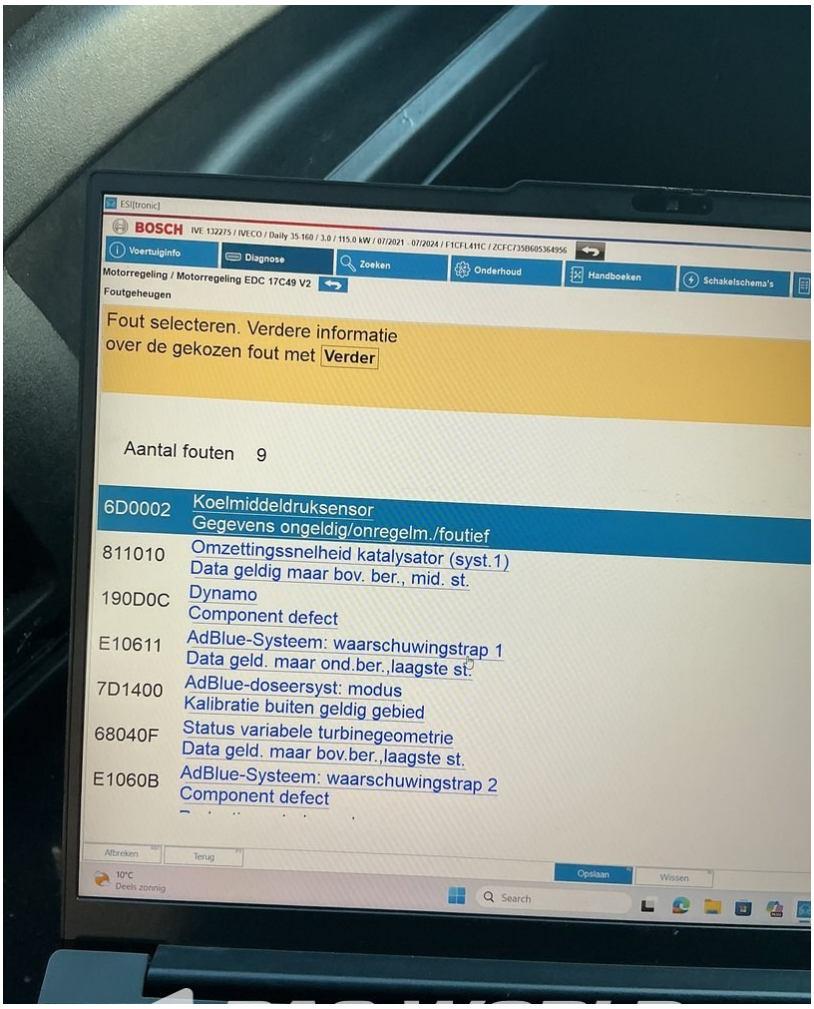
11°C
03 Jan
Motorstoring
maak afspraak
bij werkplaats
AdBlue 90%
171376 km
Trip A
0 km
km/h
rpm
x100

ESI[tronic]
BOSCH
Voertuiginfo
Diagnose
Zoeken
Onderhoud
Handboeken
Schakelschema's
Motorregeling / Motorregeling EDC 17C49 V2
Foutgeheugen
Fout selecteren. Verdere informatie
over de gekozen fout met Verder
Aantal fouten 9
6D0002 Koelmiddeldruksensor
Gegevens ongeldig/onregelm./foutief
811010 Omzettingssnelheid katalysator (syst.1)
Data geldig maar bov. ber., mid. st.
190D0C Dynamo
Component defect
E10611 AdBlue-Systeem: waarschuwingstrap 1
Data geld. maar ond.ber.,laagste st.
7D1400 AdBlue-doseersyst: modus
Kalibratie buiten geldig gebied
68040F Status variabele turbinegeometrie
Data geld. maar bov.ber.,laagste st.
E1060B AdBlue-Systeem: waarschuwingstrap 2
Component defect
Afbreken
Terug
Opslaan
Wissen
Search

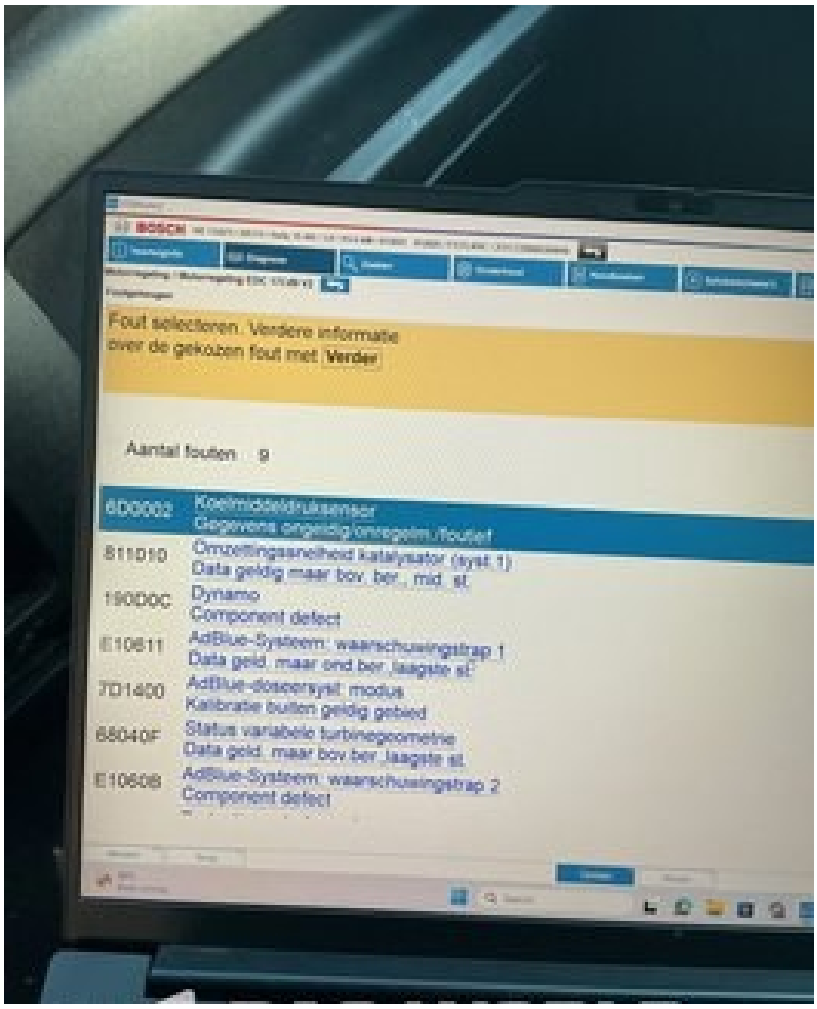
BOSCH
Fout selecteren. Verdere informatie
over de gekozen fout met Verder
Aantal fouten : 9
6D0002 Koelmiddeldruksensor
Gegevens ongeldig/onregelm./foutief
811D10 Omzettingseenheid katalysator (syst.1)
Data geldig maar bov. ber., mid. st.
190D0C Dynamo
Component defect
E10B11 AdBlue-Systeem: waarschuwingstrap 1
Data geld. maar ond.ber.,laagste st.
7D1400 AdBlue-doseersyst: modus
Kalibratie buiten geldig gebied
68040F Status variabele turbinegeometrie
Data geld. maar bov.ber.,laagste st.
E10B0B AdBlue-Systeem: waarschuwingstrap 2
Component defect
