Expertise

Protocol number: 47468151
Order No. / Reference: 26913311
Inspection date: 21 Aug 2026

Manufacturer: Opel	Model: Insignia Sports Tourer 2.0 Diesel Aut. Elegance
VIN: W0VZT8EP5N1025499

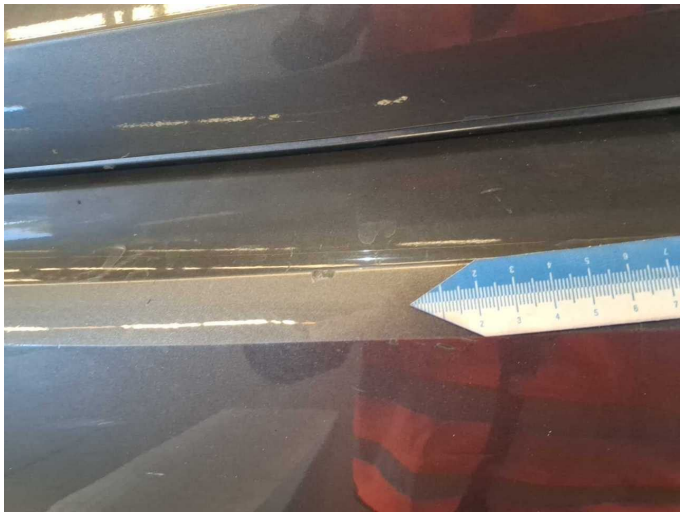
Damage 2: Rear bumper: Rear bumper - Scratched - Paint

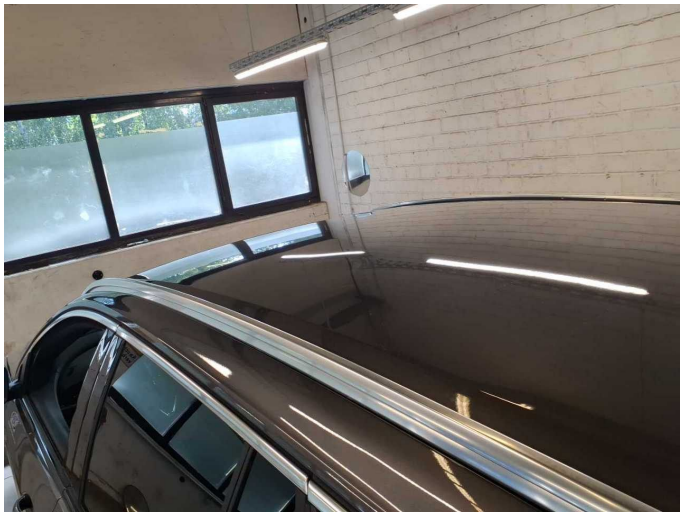
Damage 3: Roof: Roof - Deformed - Repair and paint

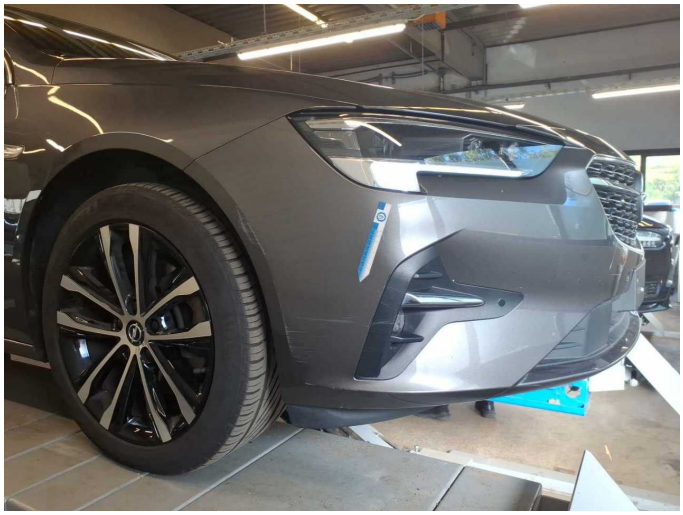
No.	Accident
1	Front, Side right

Accident 1: Front, Side right

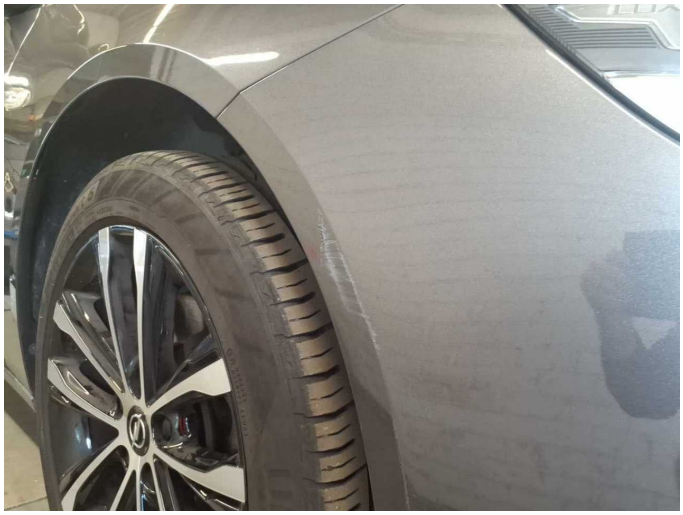
Accident 1: Front, Side right

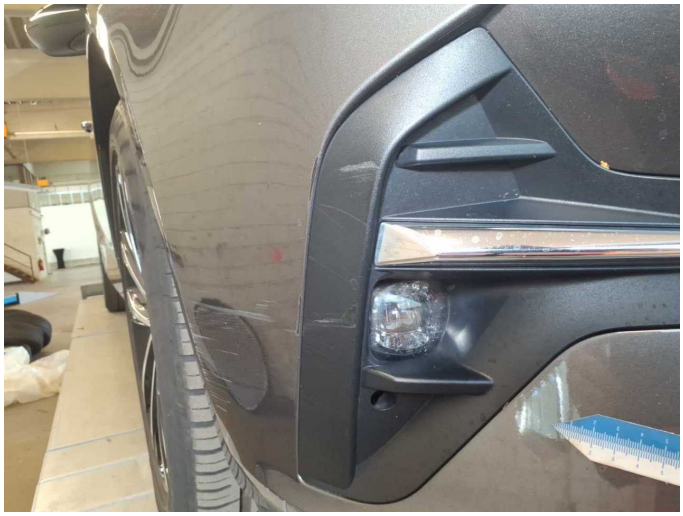
Accident 1: Front, Side right
