Expertise

Protocol number: 48116332
Order No. / Reference: 27041248
Inspection date: 14 Oct 2026

Manufacturer: Volkswagen	Model: ID.5 Pro Performance Upgrade Pro
VIN: WVGZZZE2ZPP520505

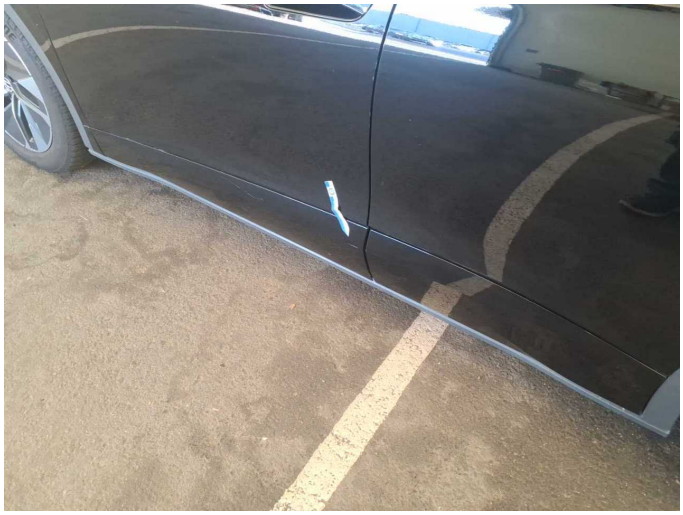
No.	Component group	Description
1	Interior	Cargo area floor - Soiled - Clean
2	Door - front left side	Brightware - lower - Scratched - Smart repair
3	Door - front left side	Door - Scratched - Smart repair
4	Front bumper	Front bumper (+ Luftgitter+Spoiler erneuern) - Damaged - repair according to calculation

Damage 1: Interior: Cargo area floor - Soiled - Clean

Damage 2: Door - front left side: Brightware - lower - Scratched - Smart repair

Damage 3: Door - front left side: Door - Scratched - Smart repair

Damage 4: Front bumper: Front bumper (+ Luftgitter+Spoiler erneuern) - Damaged - repair according to calculation

Die beigefügte Reparaturkostenkalkulation wurde nach bestem Wissen und Gewissen unter eingeschränkten Besichtigungsbedingung im demontagefreien Zustand erstellt. Es können aufgrund verdeckter Beschädigung, Mehrkosten und somit Abweichung der für die Stoßstange ausgewiesenen Reparaturkosten nicht ausgeschlossen werden.
