Expertise

Protocol number: 48502710
Order No. / Reference: 27244469
Inspection date: 3 Nov 2026

Manufacturer: CUPRA	Model: Leon Sportstourer 1.4 e-Hybrid (150 kW System)
VIN: VSSZZZKL5PR019737

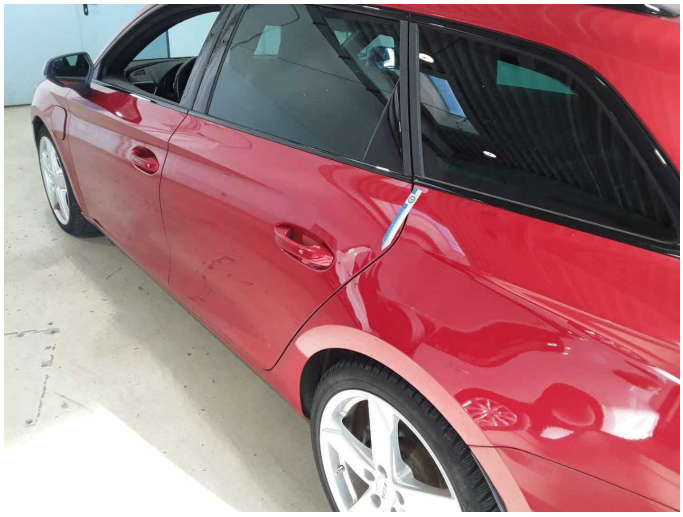
Damage 2: Side panel - rear right side: Side panel - Scratch(es) - Smart repair

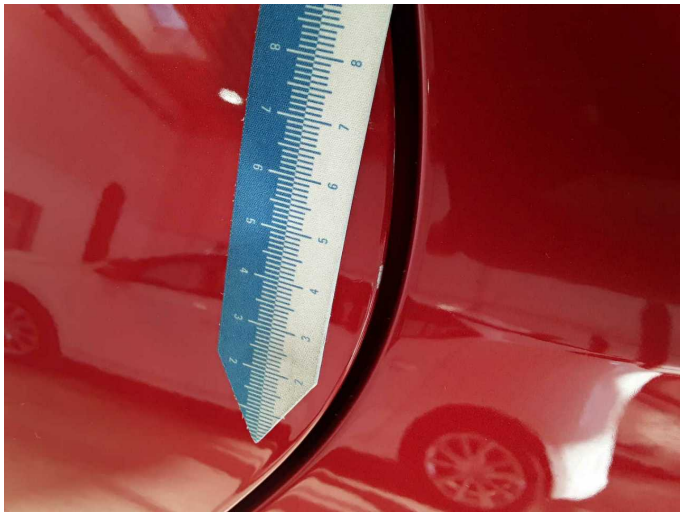
Damage 3: Door - rear left side: Door edge - Scratch(es) - Smart repair

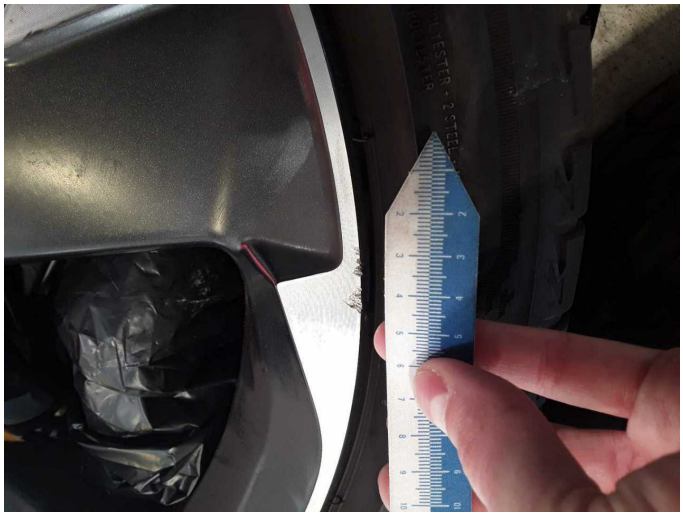
Damage 4: 2nd wheel set: 1 alloy rim - Scratch(es) - Loss in value

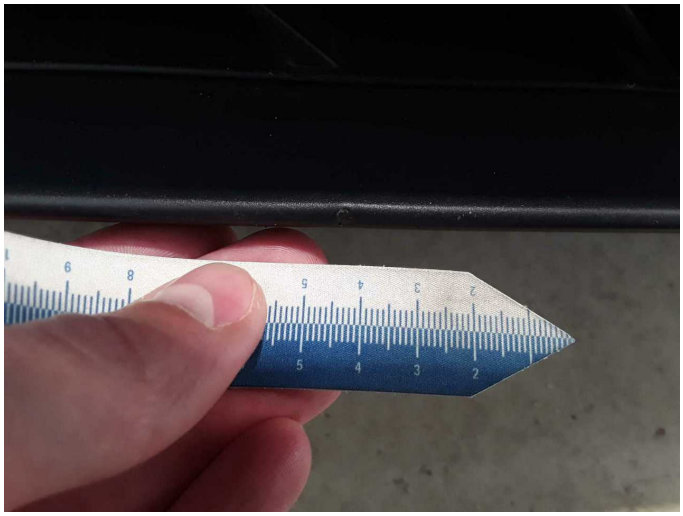
Wear and tear 3: Front bumper: Spoiler - Scratch(es) - No deduction
