Expertise

Protocol number: 48102254
Order No. / Reference: 27000639
Inspection date: 14 Oct 2026

Manufacturer: Skoda	Model: Karoq 2.0 TDI SCR 4x4 DSG Sportline
VIN: TMBLJ7NU3P5039810

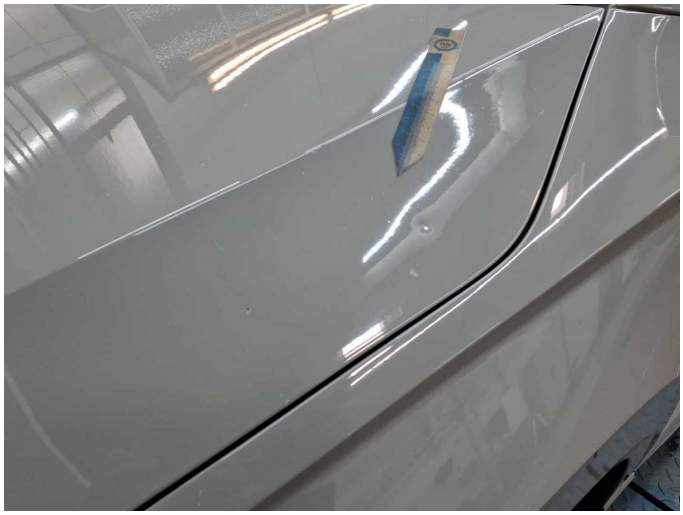
Damage 3: Mudguard - right side: Mudguard - right side - Scratch(es) - Smart repair

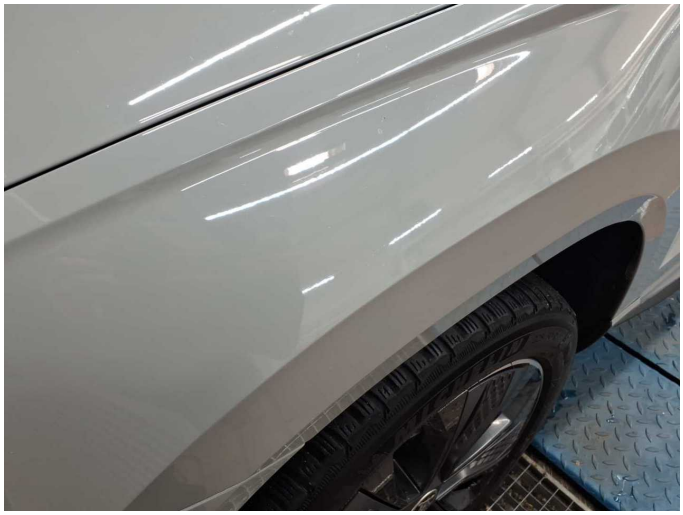
Damage 4: Mudguard - left side: Mudguard - left side (Spaltmaß zwischen Motorhaube und Kotflügel) - Perform diagnosis

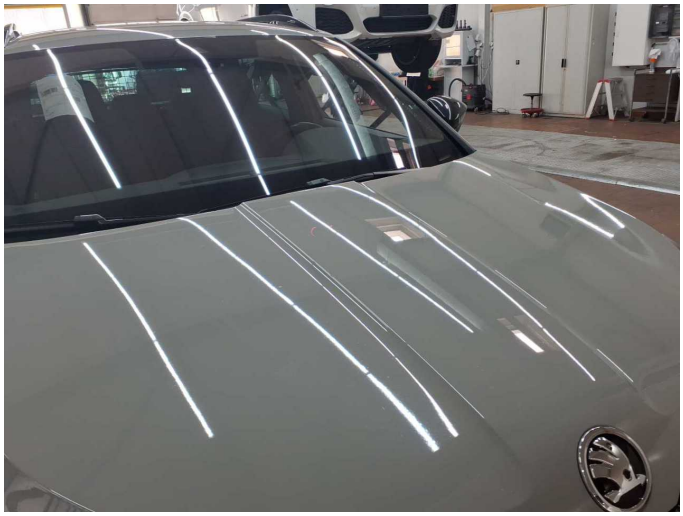
Damage 6: Bonnet: Bonnet - Scratch(es) - Loss in value

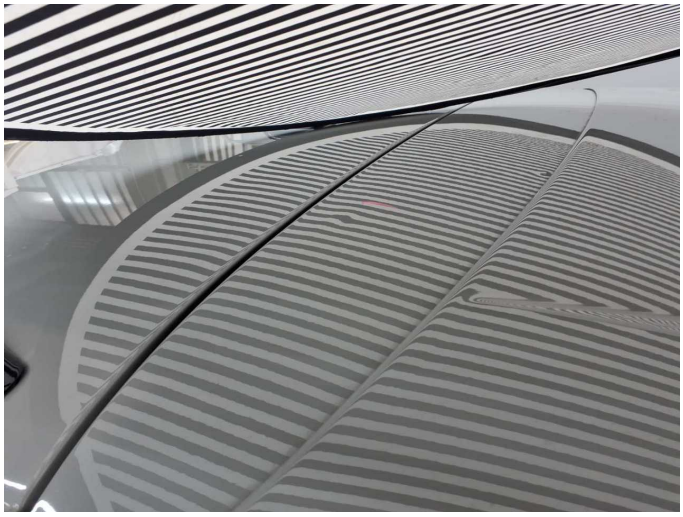
Die beigefügte Reparaturkostenkalkulation wurde nach bestem Wissen und Gewissen im demontagefreien Zustand erstellt. Es können Mehrkosten und somit Abweichung der für den Hagelschaden ausgewiesener Reparaturkosten nicht ausgeschlossen werden.

Damage 7: Body: Body - Damage by hail - repair according to calculation

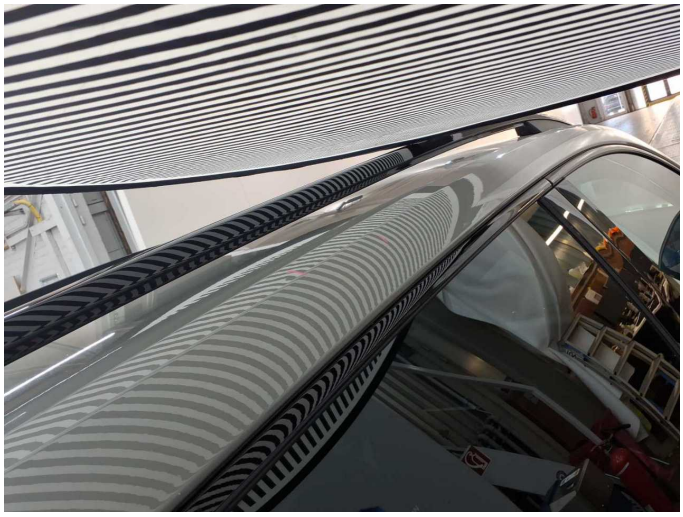
Damage 7: Body: Body - Damage by hail - repair according to calculation

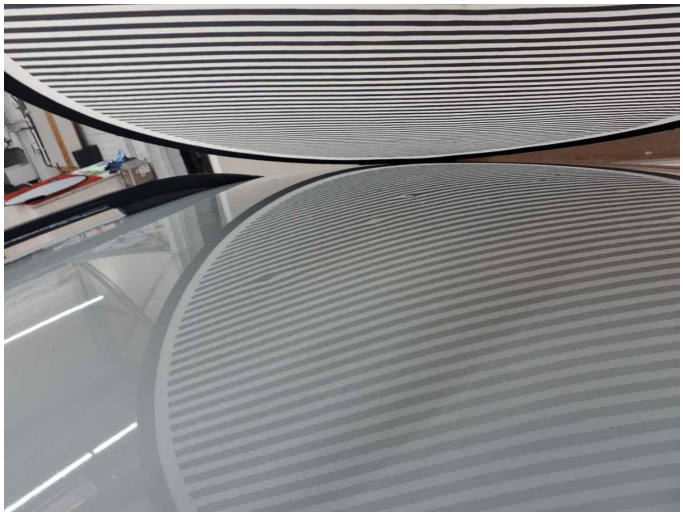
Damage 7: Body: Body - Damage by hail - repair according to calculation

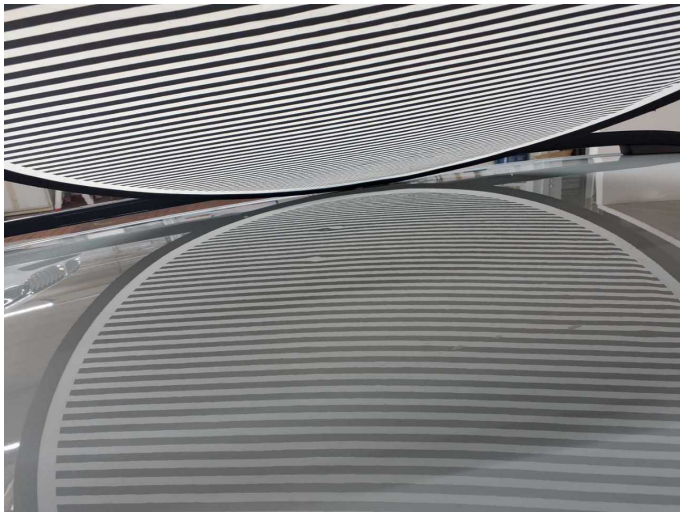
Damage 7: Body: Body - Damage by hail - repair according to calculation
