Expertise

Protocol number: 48466140
Order No. / Reference: 27213750
Inspection date: 3 Nov 2026

Manufacturer: Volkswagen	Model: Tiguan 1.4 eHybrid OPF DSG Elegance
VIN: WVGZZZ5NZNW408066

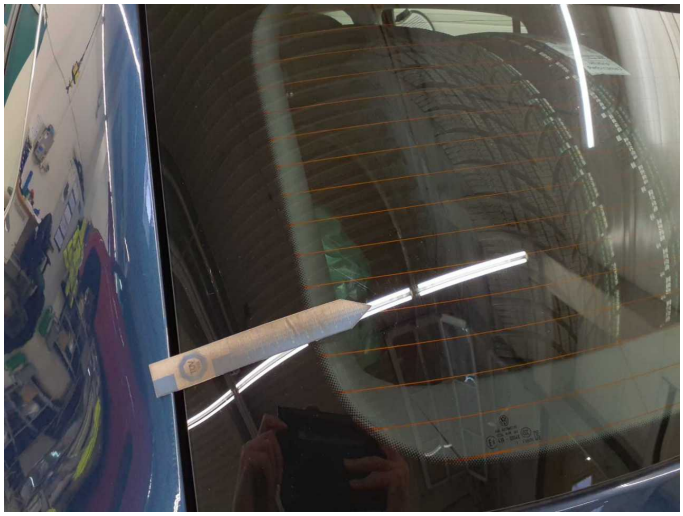
Damage 3: Vehicle glazing: Rear window - Scratch(es) - Loss in value

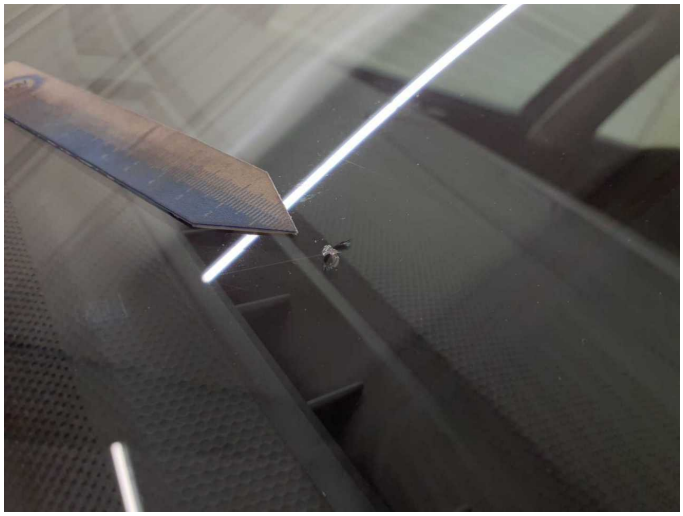
Damage 5: Vehicle glazing: Windscreen - Stone chips - Replace
