Expertise

Protocol number: 48543025
Order No. / Reference: 26792265
Inspection date: 4 Nov 2026

Manufacturer: Mercedes-Benz	Model: CLA 180 180 Shooting Brake
VIN: W1K5M8EB1PN424356

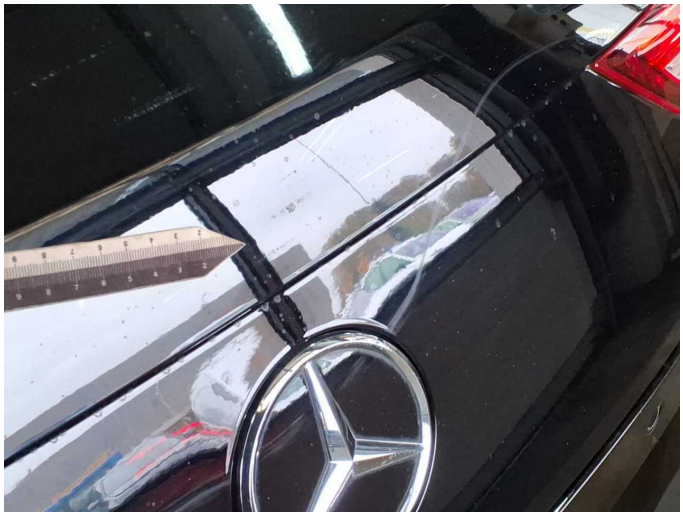
Damage 6: Boot lid / rear door: Boot lid - Scratch(es) - Smart repair
