Expertise

Protocol number: 48600983
Order No. / Reference: 27205724
Inspection date: 9 Nov 2026

Manufacturer: Ford	Model: Transit Connect 230 L2 Autm. Trend
VIN: WF0SXXWPGSNR59774

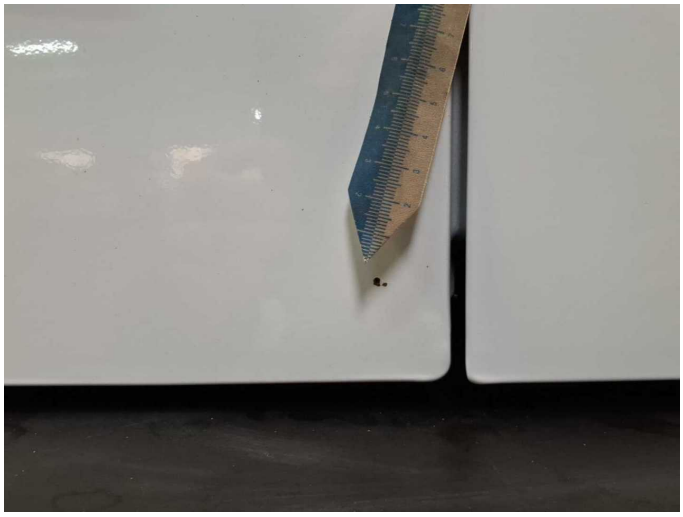
Damage 4: Sill - right side: Sill - Scratch(es) - Smart repair
