ARVAL
BNP PARIBAS GROUP

INSPECTION REPORT

End of contract

File	324230
License plate	2CKM616
Vehicle identification number	TMBJP7NX2NY097872
Dossier	2021063069
Make	Skoda Oct.Com.1.0 eTec 81kW Cl
Mileage	113916
First registration	25/08/2022
client availability date	15/10/2026
inspectionDate	20/10/2026

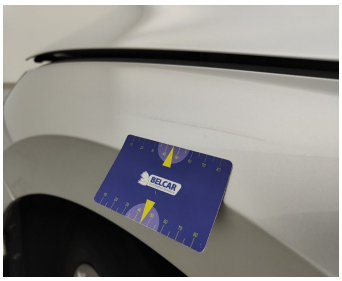
Wing Front right // Polish-scratch

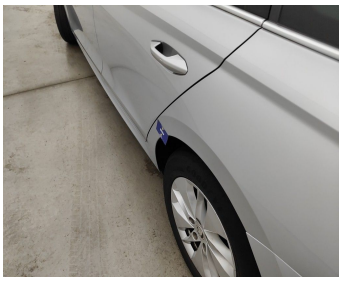
Rear Right Door Interior Coating // Repair-scratch

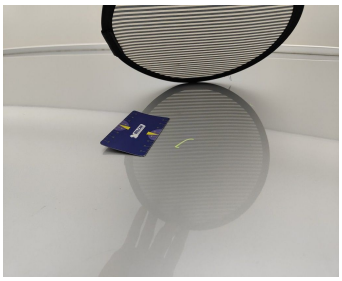
Rocker Panel Right // Smart Repair Medium-dent

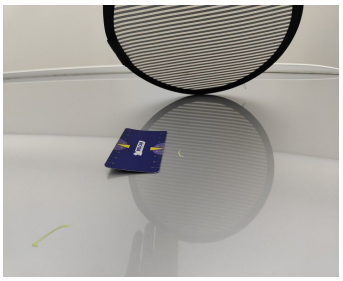
Wing Rear Right // Smart Repair Small-dent

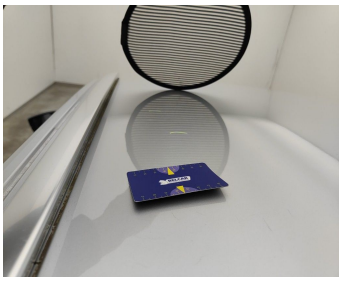
Roof // Smart Repair Medium-scratch + dent

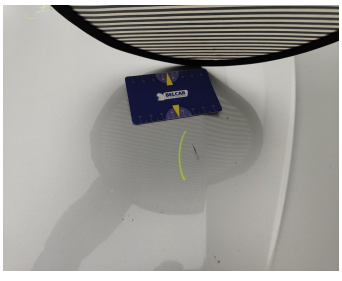
Door Front Left // Painting-scratch
