TÜV SÜD Auto Partner GmbH
Wiesenring 2
04159 Leipzig

Expertise

Protocol number: 48475068
Order No. / Reference: 27238444
Inspection date: 2 Nov 2026

Manufacturer: Opel	Model: Astra Sports Tourer 1.5 D Automatik Business Elegance
VIN: VXKFCYHZTP1054927

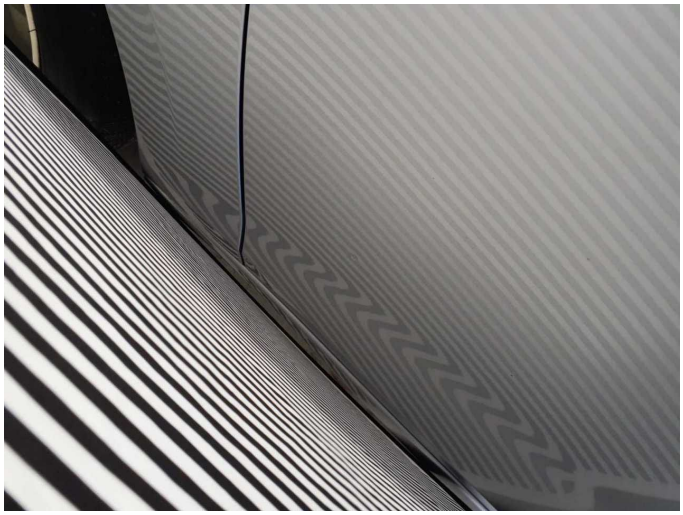
Damage 6: Door - front left side: Door - dent(s) - Smart repair

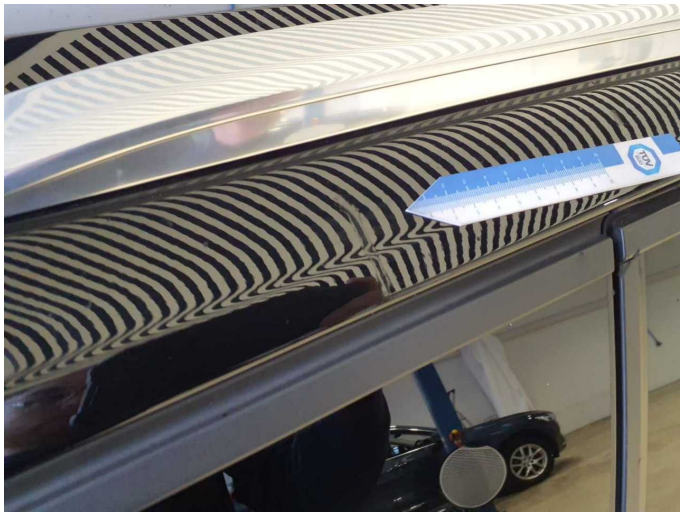
Damage 7: Roof: Roof rail - right side (Anätzung) - Paint defect - Conditioning

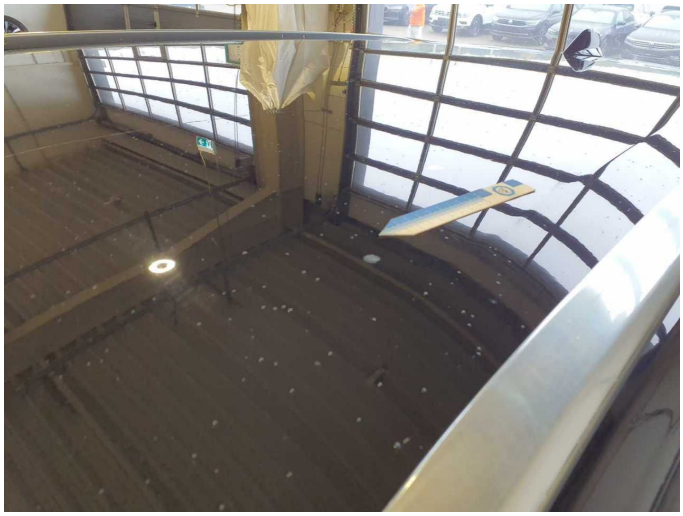
Mudguard - left side	277 µm

Damage 9: Mudguard - left side: Mudguard - left side (Einschluss und wellig) - Unprofessionally repaired - Repair and paint

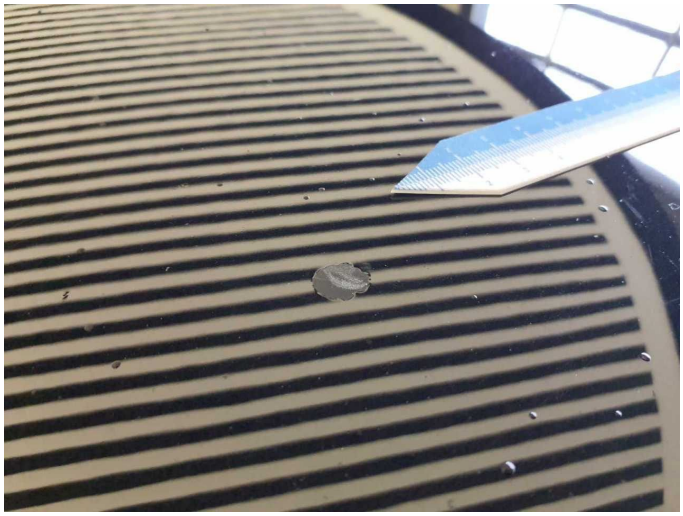
Damage 10: Roof: Roof (Anätzung und Dellen) - Paint defect - Repair and paint

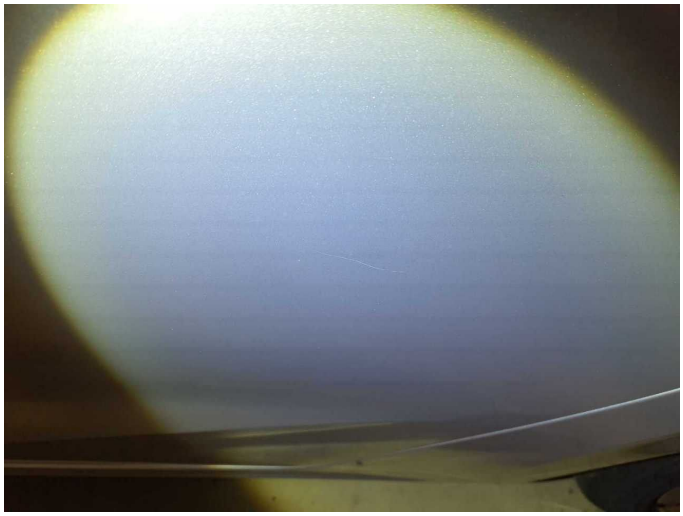
Damage 10: Roof: Roof (Anätzung und Dellen) - Paint defect - Repair and paint
