Expertise

Protocol number: 48525285
Order No. / Reference: 27212191
Inspection date: 4 Nov 2026

Manufacturer: Opel	Model: Corsa-e GS
VIN: VXKUHZKW5R4240101

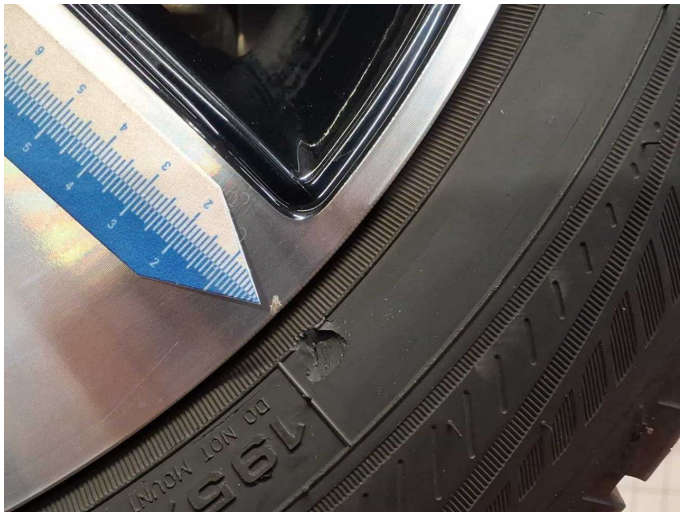
No.	Component group	Description
1	Wheel / tyres	Tyre - rear left side (nicht fahrbereit) - Broken / torn - Replace
2	Rear axle	Rear axle (wegen der beschädigten Felge) - Specify findings - Measure
3	Wheel / tyres	Alloy rim - rear left side (Materialabtrag) - Scratched - Replace

Damage 1: Wheel / tyres: Tyre - rear left side (nicht fahrbereit) - Broken / torn - Replace

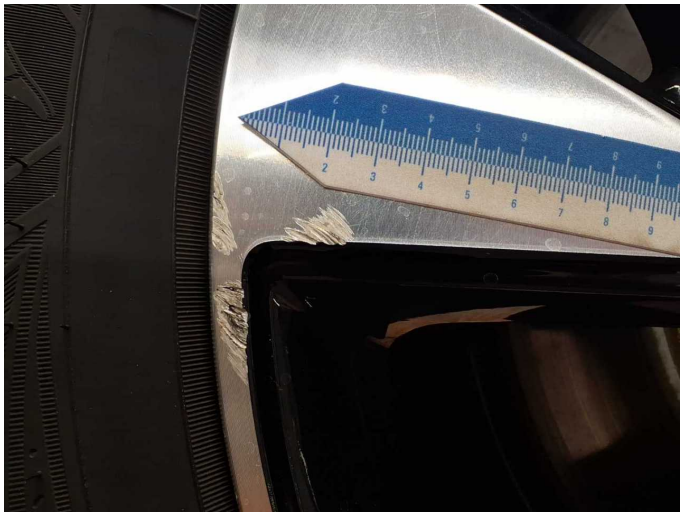
Damage 3: Wheel / tyres: Alloy rim - rear left side (Materialabtrag) - Scratched - Replace
