Expertise

Protocol number: 47969545
Order No. / Reference: 26684276
Inspection date: 5 Oct 2026

Manufacturer: Citroën	Model: Spacetourer XL 2.0 BlueHDi 180 EAT8 Plus
VIN: VF7VKEHZ5RZ100494

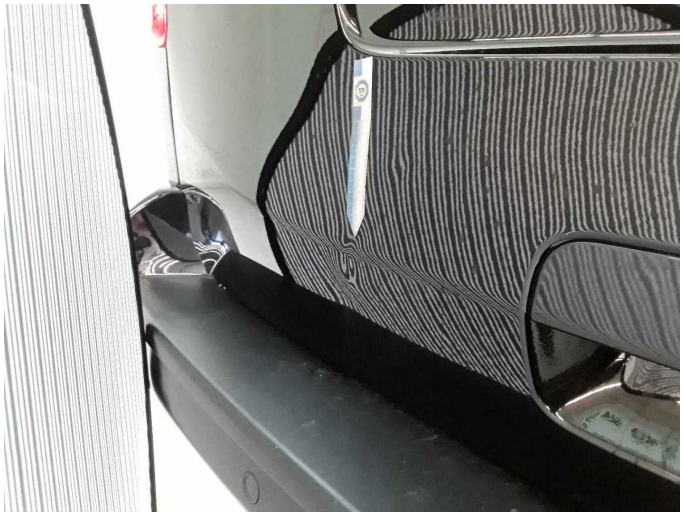
Damage 1: Boot lid / rear door: Boot lid - dent(s) - Smart repair

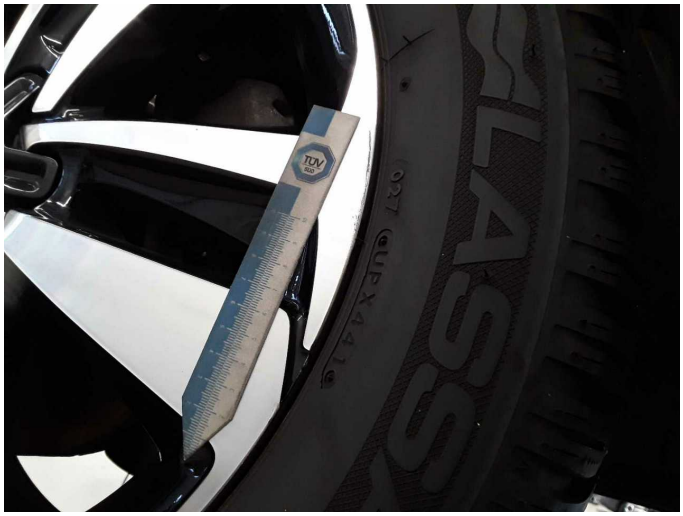
Damage 2: Wheel / tyres: Alloy rim - front left side - Scratched - Replace

Damage 3: Wheel / tyres: Alloy rim - rear left side - Scratched - Replace

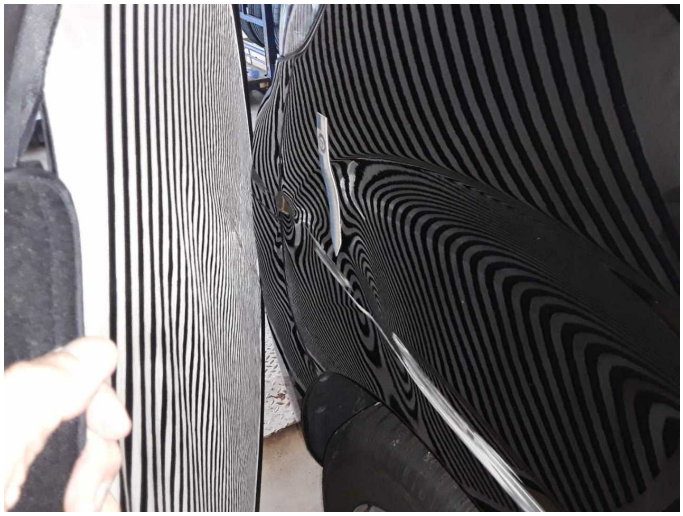
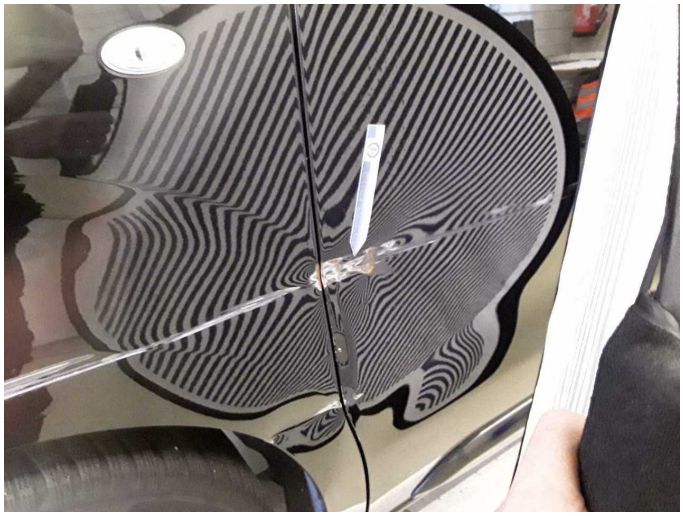
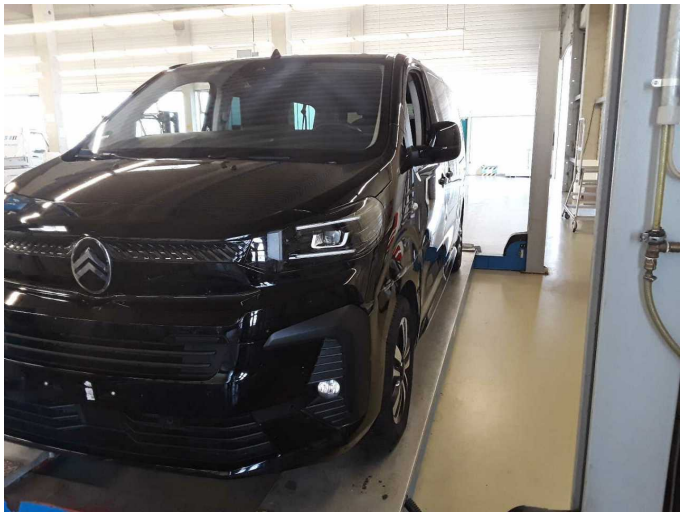
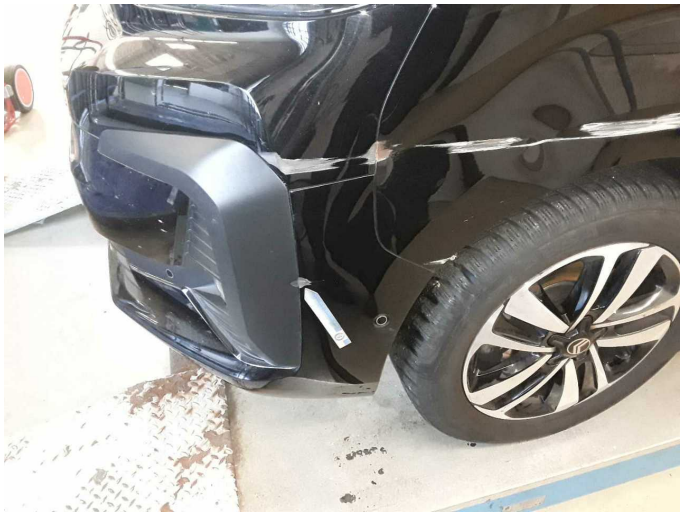
No.	Accident
1	Side - left

Accident 1: Side - left
