AUDI Q4 SPORTBACK E-TRON

Vehicle information

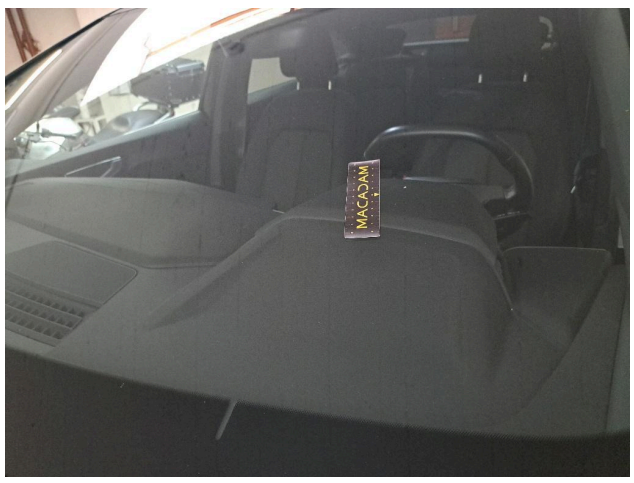
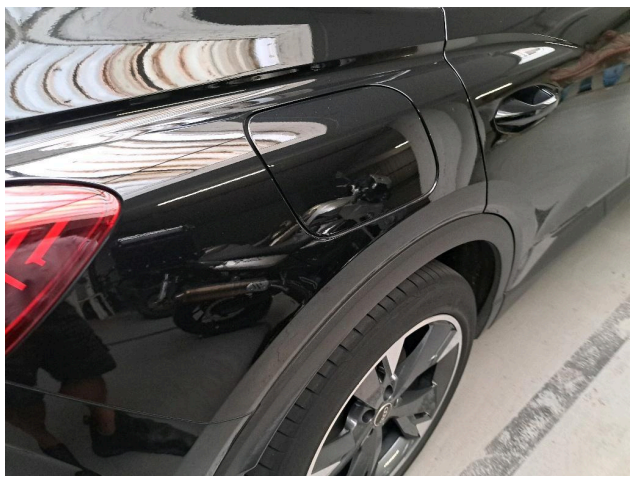
Bodywork
Damaged
Acceptable
Roof & others

Charging cable (normal)
Missing
Check
Rear

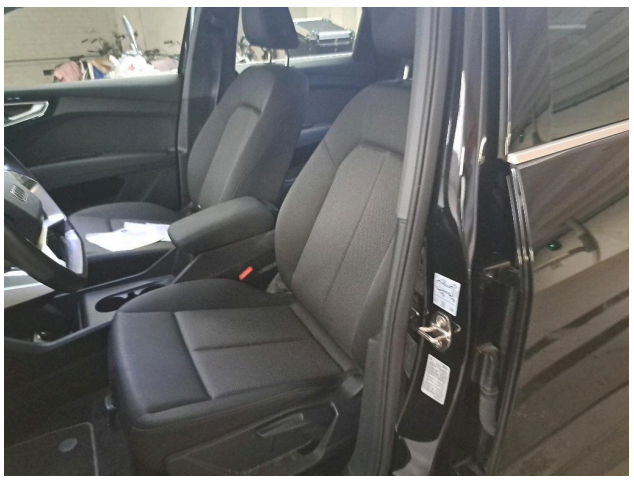
Interior
Damaged
Acceptable
Interior

Seat cover R
Stain
Cleaning
Interior
