Peugeot

VIN: VR3UDYHSKNJ720494

Statement details

Inspection loc PARC HÖDLMAYR TONGEREN	**Statement date** 21/10/2026	**Inspection approval date** 22/10/2026

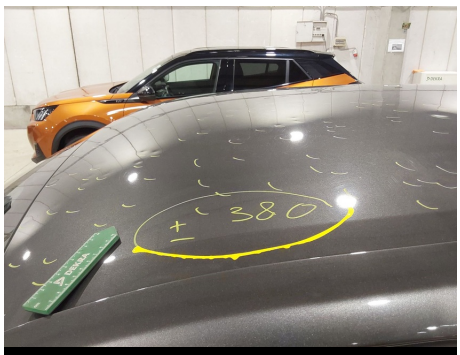
#	Element	Defect	Correction
001	Exterior complete / - [1]	Hail dent	Repair

[1] + - 515 deukjes <25mm +- 10 deukjes >25mm

Exterior complete / - / Hail dent
