Expertise

Protocol number: 48543437
Order No. / Reference: 27266162
Inspection date: 5 Nov 2026

Manufacturer: Ford	Model: Transit 310 L2H2 Lkw VA Trend
VIN: WF0EXXTTREKM31790

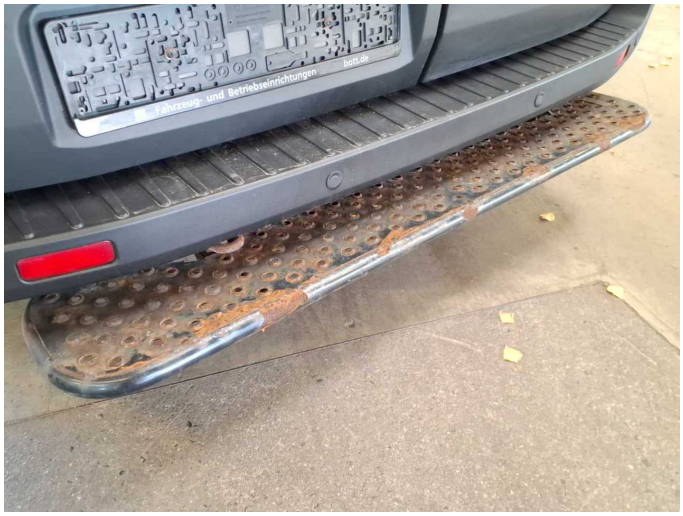
No.	Component group	Description
1	Seat - front	Seat cover - left side (Positionsregler) - Missing - Replace
2	Rear of vehicle	Foot plate - Corrosion - Loss in value

Damage 1: Seat - front: Seat cover - left side (Positionsregler) - Missing - Replace

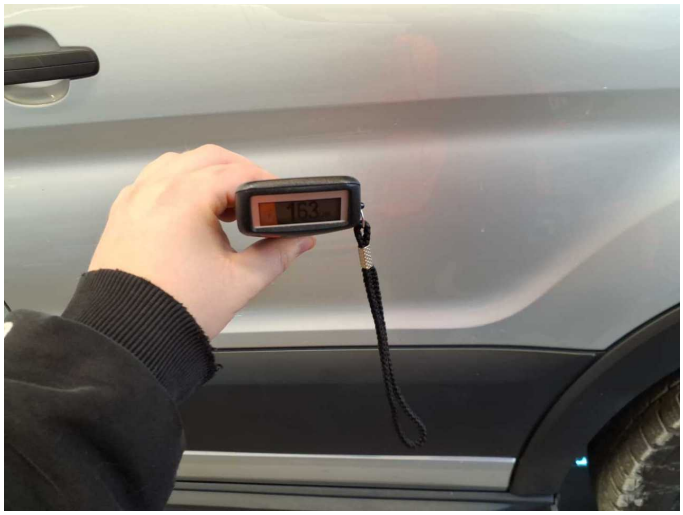
No.	Component group	Description
1	Side panel - rear right side	Wheel well extension - Scratch(es) - No deduction

Wear and tear 1: Side panel - rear right side: Wheel well extension - Scratch(es) - No deduction
