Expertise

Protocol number: 48201592
Order No. / Reference: 26830968
Inspection date: 16 Oct 2026

Manufacturer: Volvo	Model: XC40 B4 B DKG Core
VIN: YV1XZK8V1R2206634

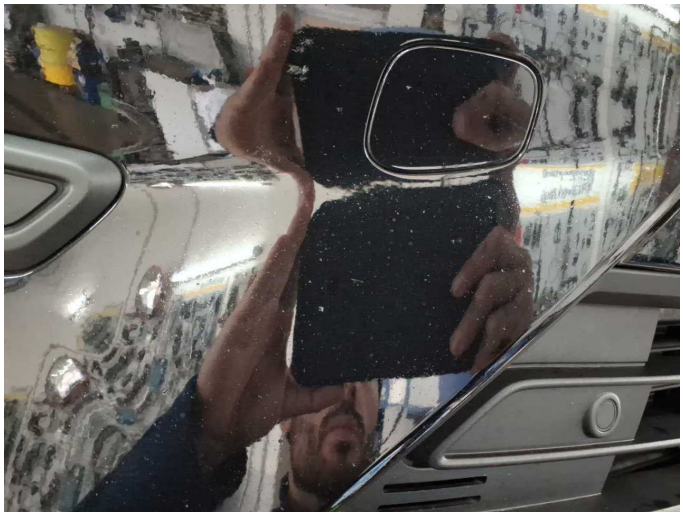
Damage 4: Front bumper: Front bumper - Stone chips - Paint

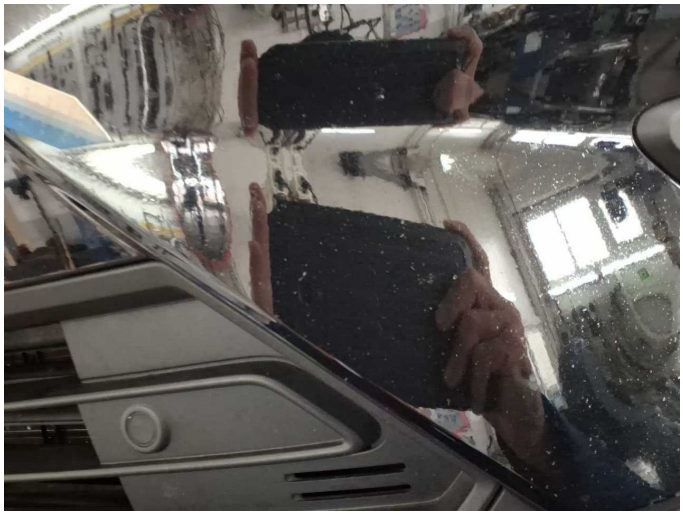
Damage 4: Front bumper: Front bumper - Stone chips - Paint

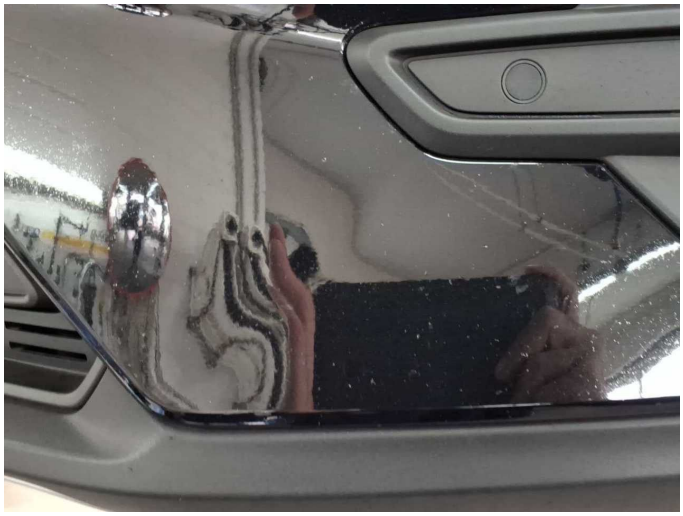
Damage 4: Front bumper: Front bumper - Stone chips - Paint

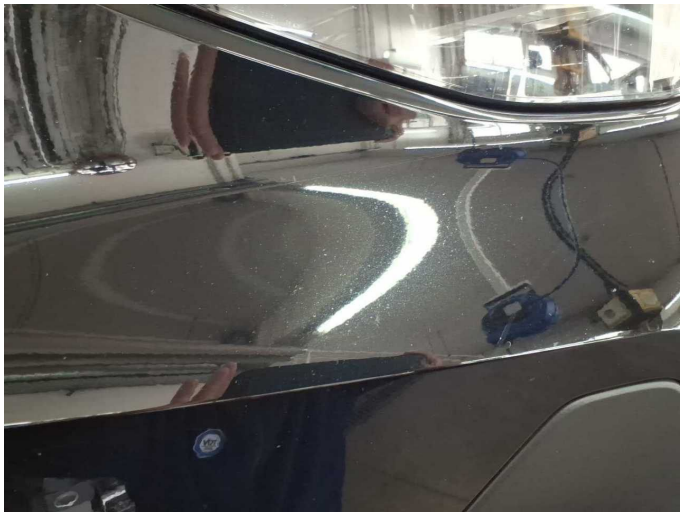
Damage 4: Front bumper: Front bumper - Stone chips - Paint

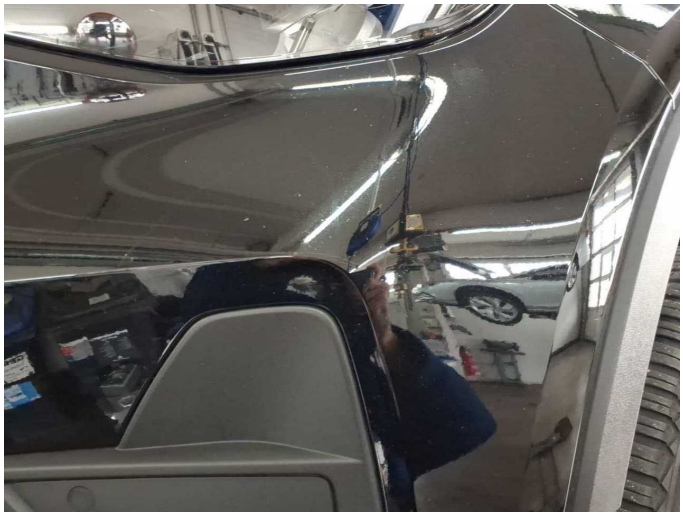
Damage 4: Front bumper: Front bumper - Stone chips - Paint

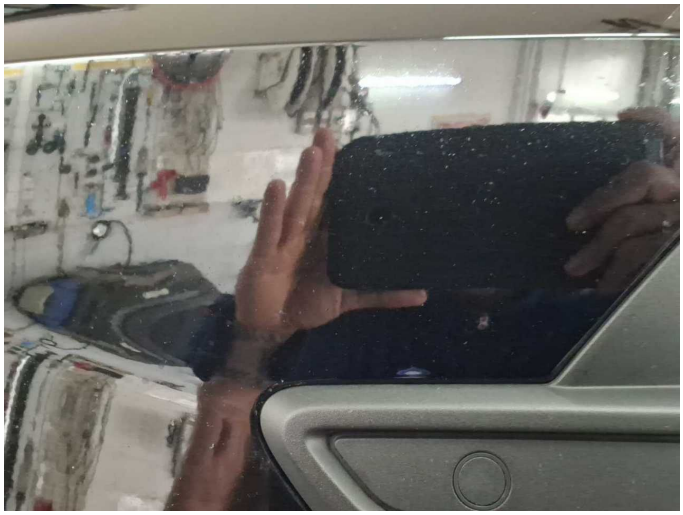
Damage 4: Front bumper: Front bumper - Stone chips - Paint
